Internationales Symposium INTERPRAEVENT 2004 – RIVA / TRIENT

RESULTS FROM SURVEY MAPPING OF THE RISK FOR LAND-SLIDES AND DEBRIS FLOWS IN TILL AND COARSE-GRAINED SOILS IN SWEDEN

Karin Rankka¹, Jan Fallsvik², Ann-Christine Hågeryd³, Leif Viberg⁴,
Siegfried Sauermoser⁵ and Margareta Nisser⁶.

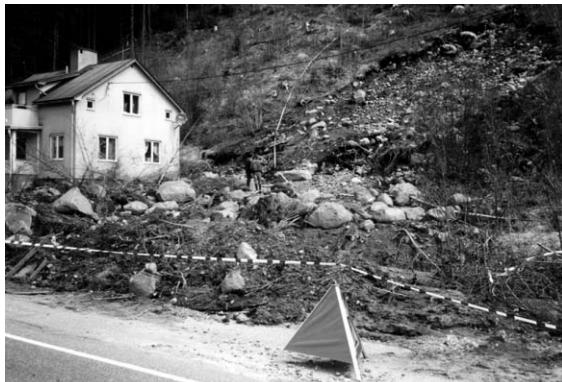
Fig 1. Landslide in a deforested slope covered by till. Sysslebäck, County of Värmland. Photo: E., Ottosson, SGI

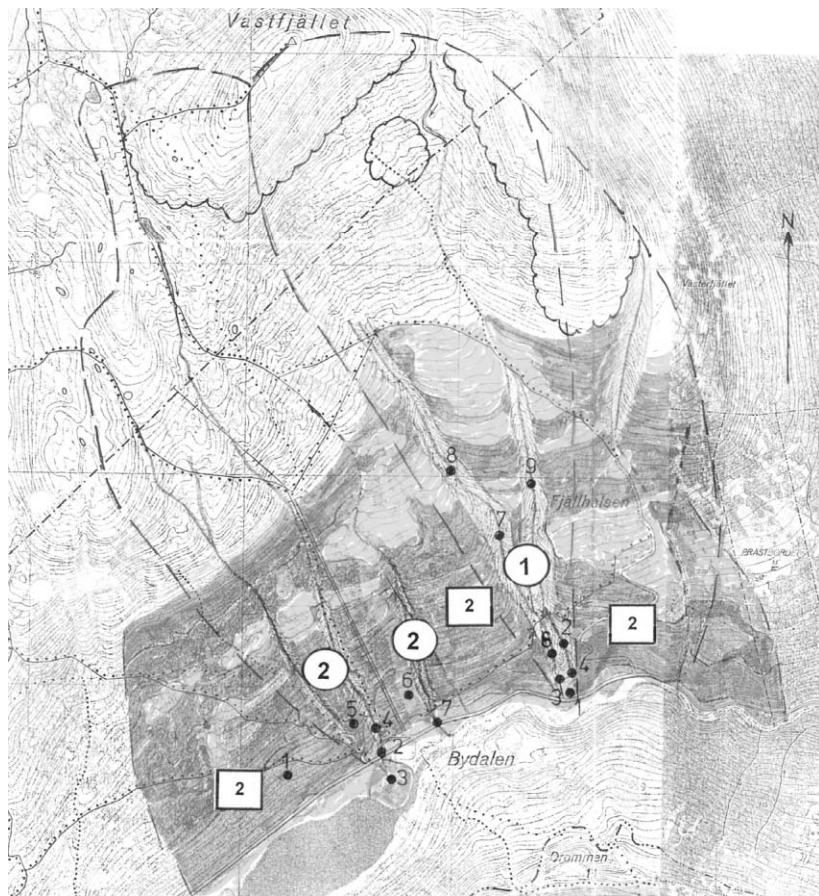
The largest gully in Fjällhalsen was classified to have an urgent need for detailed investigation. The slopes in both Fjällhalsen and Bydalen and the gullies in Bydalen were all classified to have a need for detailed investigation. The results from the investigation in Fjällhalsen and Bydalen are shown on a map in Fig 3. In Tab 3 is shown the legend used for showing the results on the map.

Fig 3. Map showing the test areas in Fjällhalsen and Bydalen, Åre. The results from the classification in step 1 are also shown.

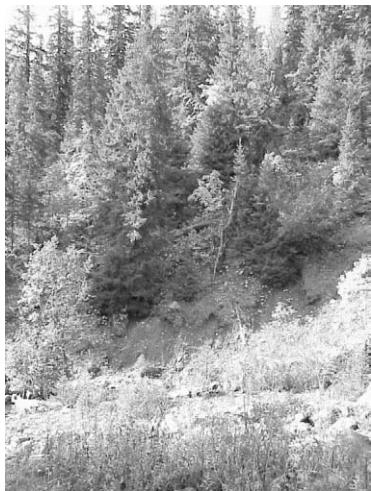
In the area of Fjällhalsen the brooks have formed two deep gullies. The largest gully in Fjällhalsen has a catchment area of around 2 km². The brook in the bottom of the gully has at some places eroded its way down to bare rock. Many levees, debris cones, inclined trees and some traces of landslides were found in this gully, see Fig 4 and Fig 5.

Fig 4. Erosion at the side slopes in the largest gully in Fjällhalsen. Photo: K., Rankka, SGI.

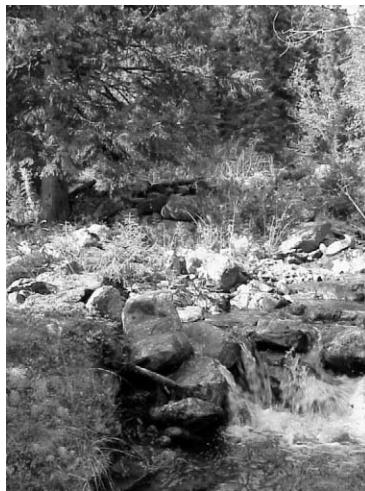
Fig 5. Old debris in the largest gully in Fjällhalsen. Photo: K., Rankka, SGI.

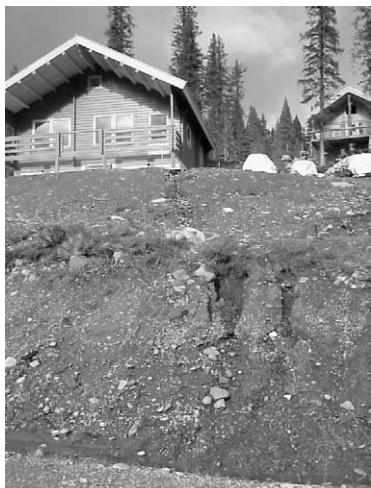
In Bydalen a ski area is situated and in the pistes erosion had occurred at some places. Some cottages were under construction in the lower part of the slope. Problems with erosion were obvious at places where the vegetation cover had been removed, see Fig 6. An old scar from a landslide was also found. The factor of safety against a planar shear surface parallel to the

Fig 6. Erosion in silty till in connection with construction of some new cottages in Fjällhalsen. Photo: K., Rankka, SGI.

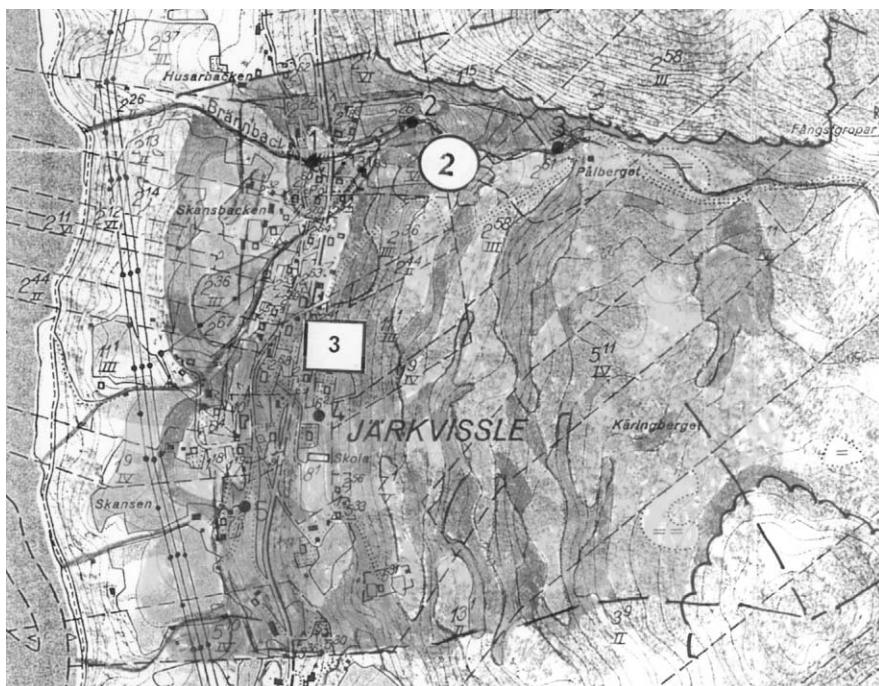
Fig 7. Map showing the test area and the results from the classification in step 1, in Järkvissle, Sundsvall. .

The area around the brook was classified to have a need for detailed investigation. The slope was classified not to have a need for detailed investigation but a need for observation. The results from the investigation in Järkvissle are shown on a map in Fig 7.

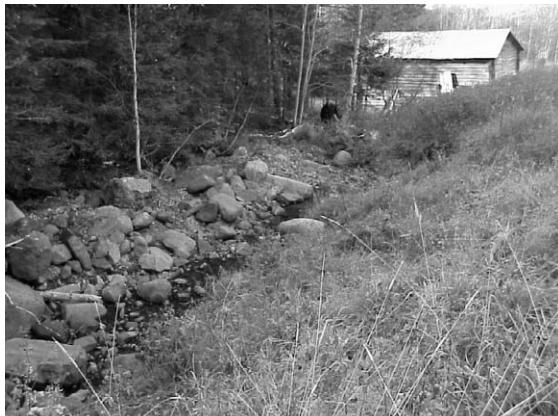
The brook has a catchment area of around 3 km². In the brook levees and debris cones from old incidents where found, see

Fig 8. The brook is lead through a culvert below the national main road connecting Sundsvall and Östersund. The risk for damming in the culvert, due to clogging by transported debris material, was estimated to be high.

Fig 8. Levees at the side of the brook in Järkvissle, Sundsvall. Photo: J., Fallsvik, SGI.
