Internationales Symposion INTERPRAEVENT 2004 – RIVA / TRIENT

THREE YEARS AFTER THE DISASTER BY DEBRIS AND MUDFLOWS IN VARGAS STATE, VENEZUELA.

Edgar Hernández¹ Ramón A. Prieto²

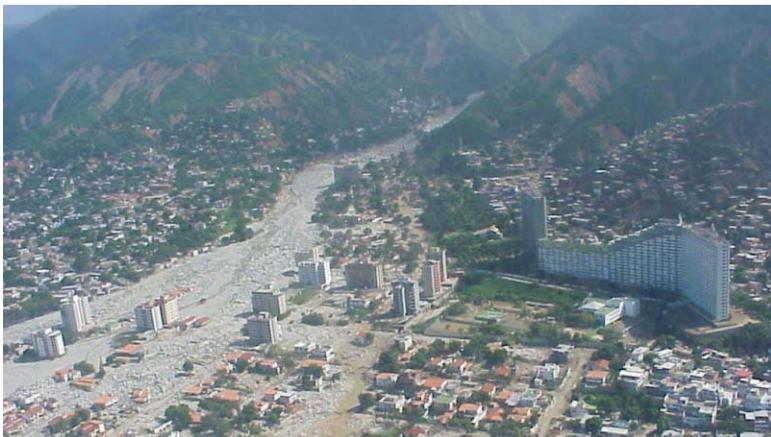
The debris cones and adjacent hills, in the majority of torrents were occupied by houses, buildings and tourist infrastructure, which were partially and totally affected by debris and mudflows (Fig 1).

Fig1: Debris cone in San Julian torrent, January 2000 (Source: UCV)

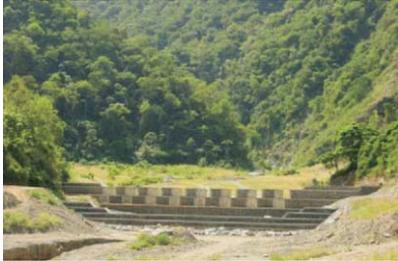
Fig2: Open dam in Piedra Azul torrent. (2003)

In torrent, Piedra Azul one open dam and two check dams with their auxiliary dams have been constructed. In addition, in the tributary Quebrada Seca two open dam were built, that altogether offers a retention volume higher than 100,000 m³. In the Curucutí torrent, three dams assure retention of 67,500 m³. In the Uria torrent, the risk has been reduced to a minimum level in association with expropriation of houses.

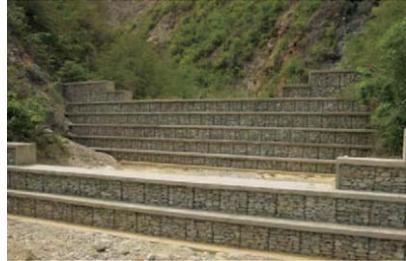
Fig3: Dams in Alcantarilla torrent. (2003)

In San Jose de Galipan there is an important work related to a long outlet channel and a check dam with low retention storage, and a significant number of houses expropriation bordering the channel. In torrents Alcantarilla and El Cojo, two check dams, each one of them with their auxiliary dams, offer a significant retention of material.

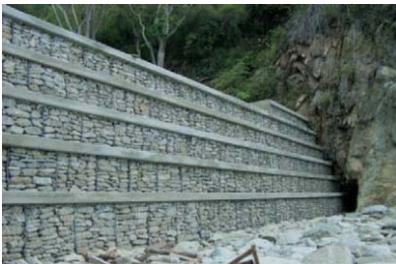
Fig4: Dam in torrent El Cojo. (2003)

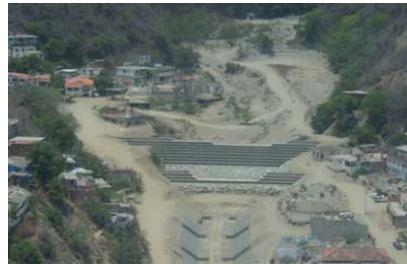
Fig5: Dam and channeling, torrent San José de Galipán. 2003. (Source: CORPOVARGAS)

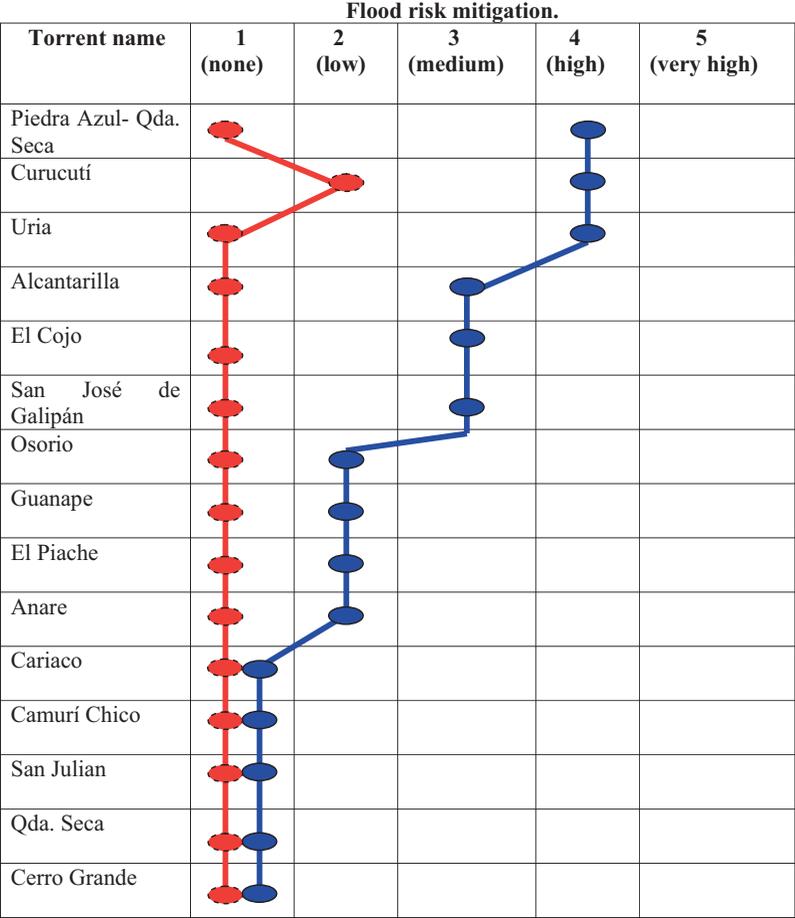
Based on the results shown in table 3, and with the scale of conversion we have developed the levels of risk mitigation, which appear in figure 1. This information allows us to classify the torrents in five groups according to the flood risk mitigation: 1) Very high reduction, 2)High, 3) Medium, 4) Low and 5) Null reduction to the risk.

Fig6: Level of flood risk mitigation (houses close to the torrents) in torrents that have been worked on in Vargas State, Venezuela. Indicators: storage volume retained by dams and level of houses expropriated.)
