# Internationales Symposium INTERPRAEVENT 2004 – RIVA / TRIENT

## CONSTRUCTION WORKS AND THEIR TECHNICAL-ECONOMIC EXPEDIENCE RIVER SAFETY MEASURES IN QUICK CLAY AREAS, THE MERÅKER PROJECT IN NORWAY

Edward Witczak<sup>1</sup> & Tharan Fergus<sup>2</sup>

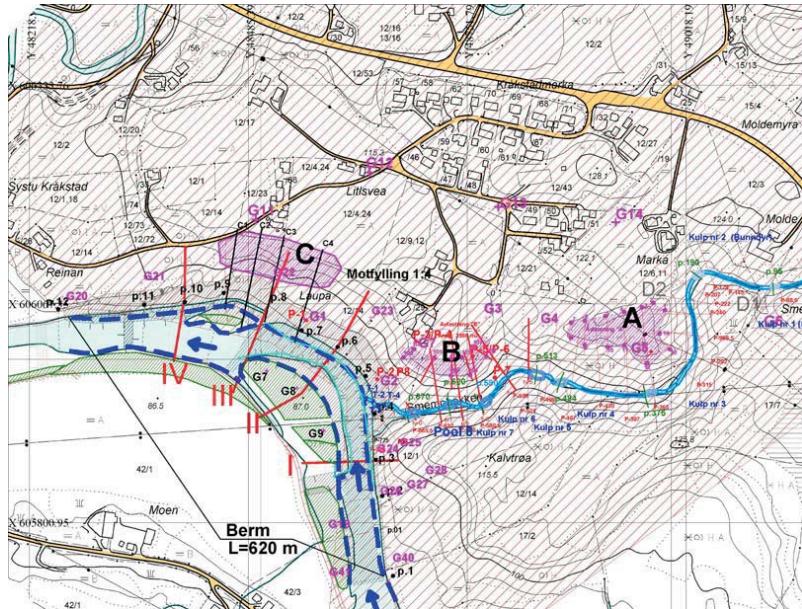
**Fig2:** Mapped quick clay deposits at Kråkstadmarka

A drilling programme to map the extent of quick clay and to plan the dimensioning of safety measures in this area was started in the autumn of 2001. This was part of the ongoing program to enhance security against clay slides initiated by NVE in 2000. The drilling exposed a much more dramatic situation than was expected from previous investigations. It was found that quick clay underlies the whole area that has been built upon and that the deposit has an incline towards the Smemobekken stream and the main river. The thickness of the quick clay layer is more than 10 m. Drill points along the river banks show that the quick clay layer lies about 1 m below the low flow level. A 4 m deep scour hole in the river bed was also uncovered during these investigations. The calculated stability towards the Smemobekken stream and the main river was alarmingly low. Geotechnical expertise deemed the situation critical in regard to the danger of initial landslides and a deeper larger landslide being triggered by further erosion. Approximately 90 people would be in danger in the event of a landslide. Figure 2 shows the Kråkstadmarka area with mapped quick clay deposits.

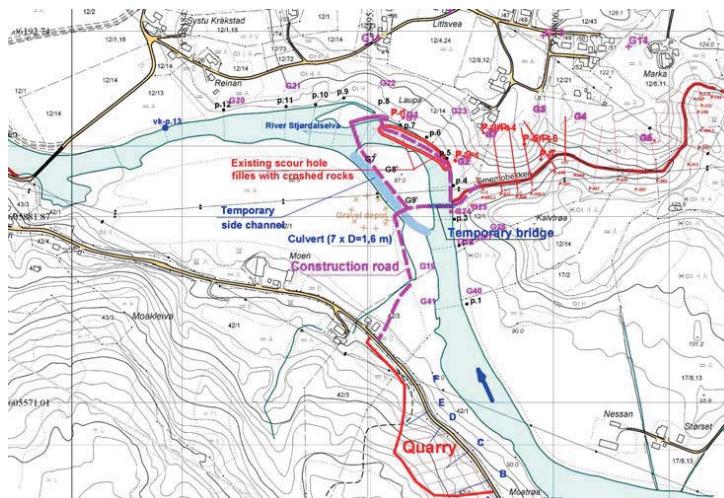
**Fig3:** Sitemap showing location of quarry, road, dam and emergency measures

A quarry was established not far from the site on the left hand side of the river (figure 3). Blasting was kept to a minimum for security reasons (due to its vicinity to the quick clay area) and vibrations were monitored on both sides of the river. The ground water level was also closely monitored during this period as this is a crucial factor in the release of an initial slide. One main reason for establishing the quarry close to the construction site was to minimise the environmental costs and the strain on local roads.

The emergency measures consisted of filling in the 4 m deep scour hole and securing the river bed by plastering it along a 130 m reach with a width. Figure 3 shows the location with quarry, road, river diversion and emergency measures. A total of 3000 m<sup>3</sup> of rock was used to secure the river bed at the scour hole. The main river was dammed 50 m downstream of the scour hole. The dam was used as a bridge to transport rock for the bed plastering. Part of the road built in the river on the right hand side will be used as part of the permanent safety measures. The flow of the river was diverted through a natural flood way that had been closed previously and a culvert using 7 turbine pipes was used to construct a bridge here. The power station kept the flow at a minimum (12 m<sup>3</sup>/s) during the construction period of 3 weeks.

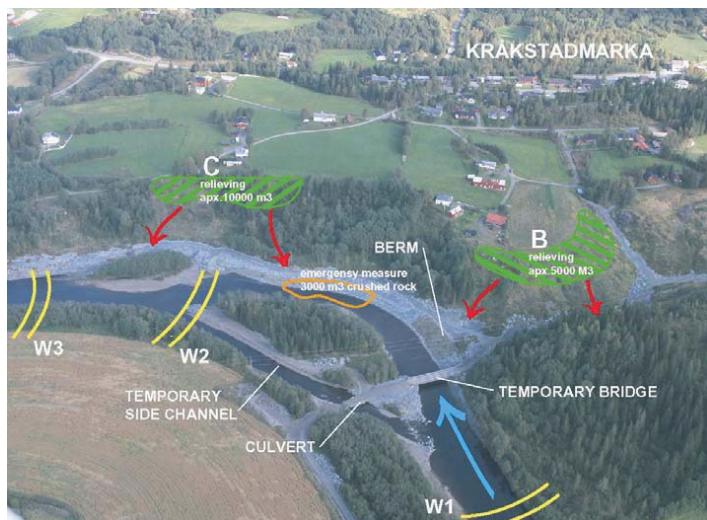
**Fig4:** Stabilisation works in main river, September 2003

Further river safety measures were deemed necessary both to hinder erosion with a risk of puncturing the quick clay layer and to stabilise slopes. This was necessary in both the main river and minor stream Smemobekken. Figure 4 shows stabilisation works in the main river in September 2003.

The stabilisation measures in the main river consist of erosion protection and berm along the right hand side of the bank and widening the river, securing the bed by plastering and building 3 weirs. The slope down to the river has also been relieved by removing mass at the top of the slope. The flood way to the left of the river that was previously closed will be reopened and this will also relieve pressure on the river bed.

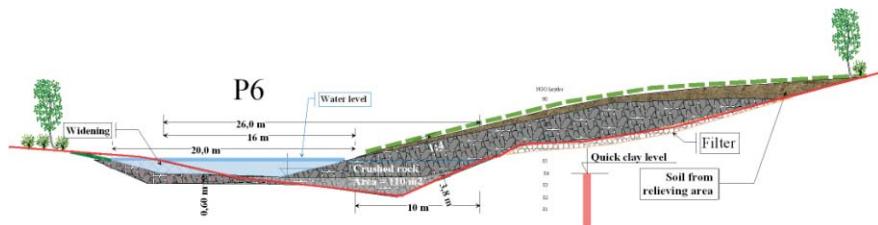
**Fig5:** Profile of main river with berm and widening at p6

The river bank has been extended into the river by 10-12 meters between p8 and p5 (figure 3 and figure 5). This was done to create a counterweight to the quick clay layer along the right bank. The extension of the bank has been compensated by removing the outer part of the vegetated bank along the left side and the river has in effect been widened. The total length of the berm is 620 m and the volume of rock used here is 50 000 m<sup>3</sup>. The total length of erosion protection along the right bank is 1100 m. The bed has been secured by plastering along a reach of 400 m and a total volume of 10 00 m<sup>3</sup> of rock has been used for this purpose.

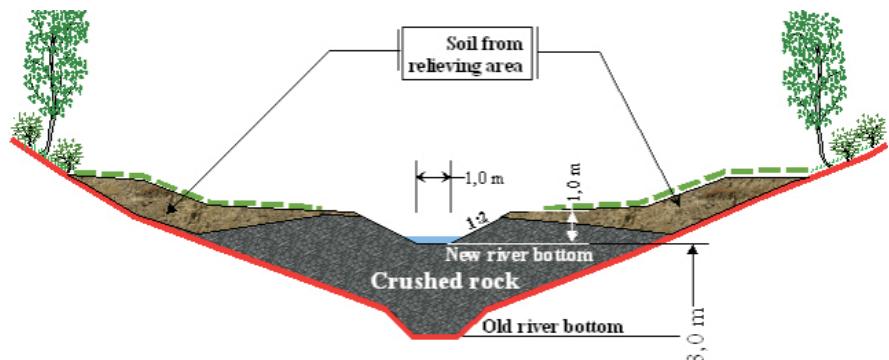
**Fig6:** Profile of stream showing raised stream and valley bed

Stabilisation and erosion protection measures in the stream consist of raising the river bed level by covering this with rock (figure 6) as well as relieving slopes. The river bed is raised 3 m from the outlet of the stream into the main river and to 550 m upstream.

The raising of the river bed will gradually be reduced from this point until 720 m from the outlet. A total volume of 30 000 m<sup>3</sup> rock will be used here.

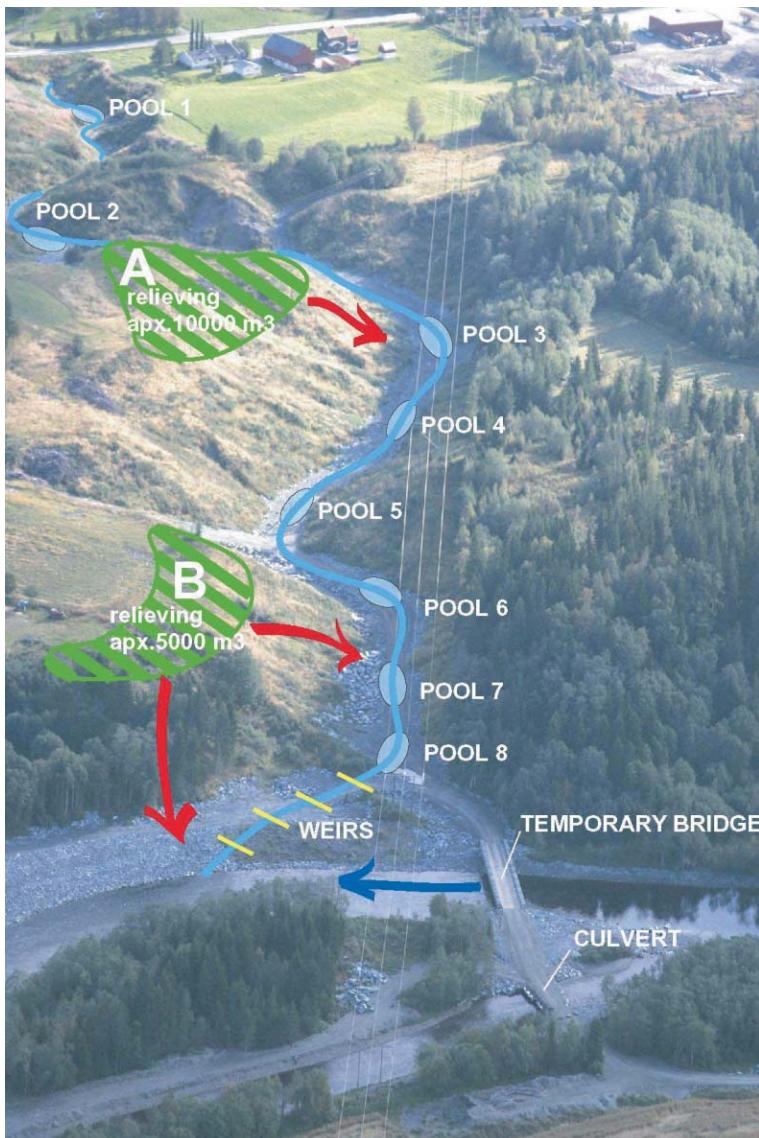
**Fig7:** Stabilisation works in stream, September 2003

A total volume of 25 000 m<sup>3</sup> of soil has been removed to relieve pressure and reduce the gradient of the slope at 3 areas along the top of the slope to the main river and stream (figure 4 and 7). This soil will be used to cover the counterweight berms along the main river and stream. The slope to the river will after removal of soil have an inclination of 1:2.5.
