Topographical Changes Due to Heavy Rainfall in the Chiu-Fen-Erh-Shan Landslide Triggered by the Chi-Chi Earthquake in Taiwan

This paper reports on topographical changes in the sediment area in the Chiu-fen-erh-shan landslide located in Nantou County, central Taiwan. This landslide was triggered by the Chi-Chi earthquake ($M_L = 7.3$) on September 21st, 1999. Field work-surveys conducted from 1999 immediately after the earthquake, to 2005. This landslide is a huge dip-slope slide, and about 1 km wide, 2 km long and 80m deep. The landslide buried several valleys on the lower slope, reaching a maximum depth of about 80m, and yielding four natural dams. The maximum depth of the water in these dams reaches about 30m. After the Chi-Chi earthquake, the heavy rainfalls accompanying the Toraji and the Nari typhoons in 2001 followed by the Mindulle and the Aere typhoons in 2004, greatly changed the topographical features of the landslide sediment area. The most dramatic changes in the sediment area mainly occurred along a main spill way which was constructed as a countermeasure against flooding. Groundsel and revetment works were severely damaged due to these changes. In particular, downstr

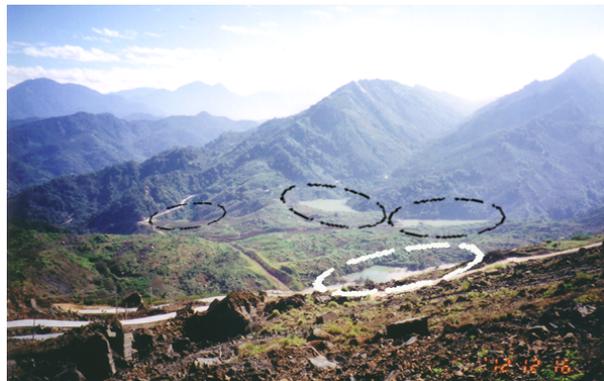
Photo. 2. Four dams produced by the landslide (taken on Dec. 16, 2000). Bottom side: Dam at toe of the landslide, Up-right side: Sezikeng Dam, Up-middle side: Chiutsaihu Dam, Up-left side: Dam in right tributary

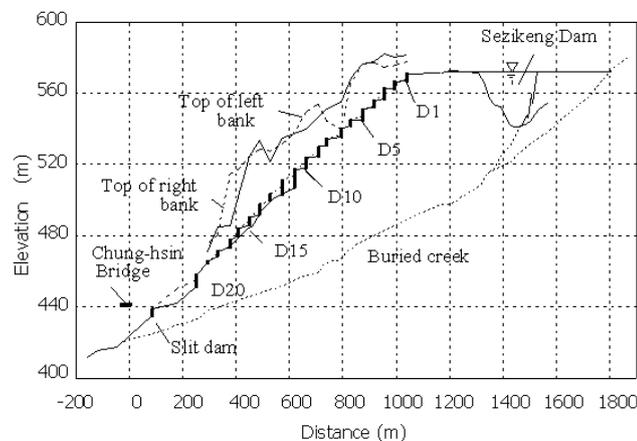
Fig. 4. Longitudinal figure of the main spill way (line A)

The longitudinal figure of the main spill way (line A) based on the survey is shown in Fig.4. The elevation in water level in the Sezikeng dam is set to 572 m and an origin of horizontal distance is set at the Chung-hsin bridge. Broken lines directly above the river bed lines indicate the intended river bed lines which would comply with the structure of the groundsel works. This figure also shows the river bed of the buried creek as a broken line. Longitudinal figures shown later are also arranged in the same way. The maximum thickness of the sediment is around 75 m at the D1 section and the maximum depth of the Sezikeng dam reached 30m. The figure of line B that is a section along the buried Chiutsaihu creek is shown in Fig.5. The figure for downstream from the D1 section is omitted because of overlapping with line A. Sediment along line B is about 80 m deep. The altitude of the water level of the Chiutsaihu dam at 20 m deep is higher than that of the Sezikeng dam at 7 m. Fig.6 shows the figure of the line C that covers from the left spill way to the slope of the main landslide. The depth of the sediment at point E is about 65 m.

In Fig.4, the average stream gradient having around $1/7.1$ from D1 to the Chung-hsin bridge, decreased to $1/12.0$ as influenced by 21 groundsel works. The groundsel works as countermeasure to prevent degradation are composed of concrete piles 1 m in diameter staggered in arrangements of 3 rows on concrete footings 1.8 m thick and 7 m wide. The piles are driven into a foundation from the bottom of the footing to protect subsidence and to maintain bearing capacity. Clearances between the piles are filled by boulders. The dam at the downstream edge (on the right upstream of the Chung-hsin bridge) in Fig.3 has a slit type gravitational concrete structure.

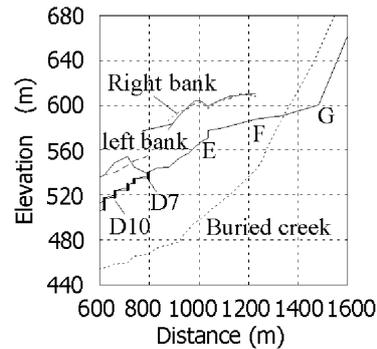
Fig. 6. Longitudinal figure of the left spill way (line C)

As mentioned previously, the natural dam, shown as a white circle in Photo 2, extending from the northeast to the southwest had been formed immediately after the occurrence of the main landslide between the points F and G in Fig.6 which are located around the foot of the main landslide. The left spill way from D7 to point F in Fig.6 has been excavated. Tributaries which had a basin consisting of the slope before the occurrence of the main landslide had jointed the Chiutsaihu creek spanning from the crest of the Sezikeng dam to D7. Due to the occurrence of the main landslide, outlet of the basins of these tributaries have moved, flowing into the left spill way. The left spill way has jointed the main spill way to the D7. The natural dam, shown as white line in Photo 2 located at the foot of the main landslide, disappeared due to flowing down of residual soil on the main landslide slope.

Knick point can be seen at point E in Fig.6. The gradient of the lower reaches from the point E reveals a steep stream with a gradient of about $1/6$. The upper reaches from point E reveals a gentle stream with a gradient of about $1/19$.

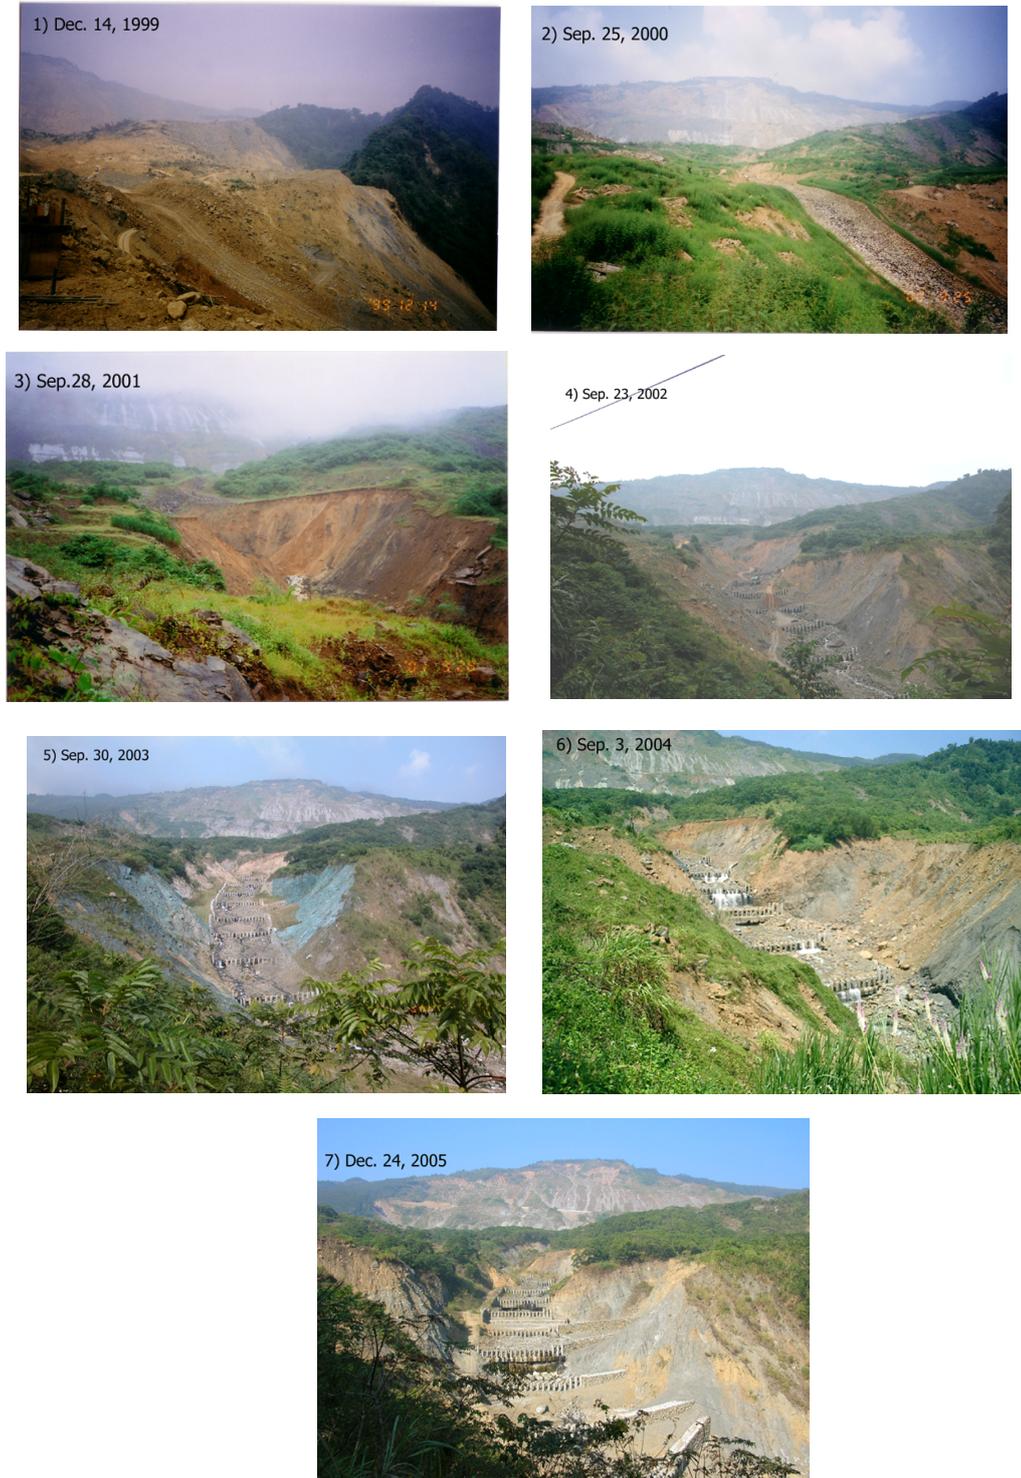
The greatest topographical changes have been generated in the sediment area. Photo 3 shows the degradation along the spill way from December, 1999 after the earthquake to December, 2005. The positions and the directions of photographs are marked in Fig.1. Photo 3 in 1999 shows the spill way excavated without timbering by the Soil and Water Conservation Bureau to deal with floods from the Sezikeng dam. Photo 3 in 2000 shows that the main spill way having 20 m wide and 2 m deep, was protected by dry pitching work, using coarse stones (Hayashi *et al.*, 2003).

However, as shown in Photo 3 taken in September, 2001, the main spill way suffered greatly from river bed degradation caused by heavy rainfall mainly accompanying the Toraji typhoon which struck in July, 2001. To prevent further degradation, groundsel work had been carrying out in steps in our investigation done in

September, 2002. As indicated by Photo 3 taken in September, 2003, 20 groundsel works in steps were near completion and wet masonry work using coarse stones between the groundsel works and slope vegetation had been under construction.

In spite of these works, as shown in Photo 3, taken in September, 2004, the foundations of the groundsel works were greatly scored by torrents and landslides which occurred at the slopes along the main spill way following the Aere and Mindulle typhoons, striking one after the other in July then in August in 2004. These situations will be further described later.

Though countermeasures against damage to the groundsel foundation had been performed, as indicated in Photo 3, taken in December, 2005, other groundsel works had been scored. Not reported in photographs in this paper, sediment control dams were erected downstream of the Chung-hsin bridge at the edge of the spill way to control reflowing of sediment that was flowing down from upstream caused by the heavy rainfalls of 2004.

In 1) and 2) of Photo 3 taken before the disaster after the earthquake, the relative height between the sediment surface and the river bed of the main spill way must have been small. By contrast, in Fig.4, the

relative height between the tops of the slope on both sides of the main spill way and the crowns of flood way of groundsel, are range from 20 m to 30 m. This is presumed to be resulted by the degradation due to the heavy rainfalls in 2001.

Photo. 3. Degradation of the main spill way (The slope behind the main spill way is the main landslide)

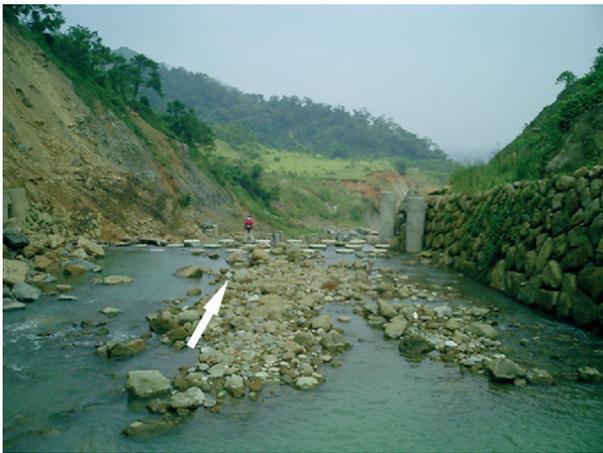
Photo. 4. Comparatively stable main spill way at D2 Downstream direction taken from D2 (Sep. 4, 2004)

On the contrary, the upper reaches from D1 to D7, that is the upstream section of the confluence with the left spill way have been maintaining a stable situation as shown in Photo 4, though the occurrence of some small landslides on the slope along the main spill way and somewhat scoring of the foundation of the groundsel works can be seen. The natural basin produces floods with little sediment, and the two natural dams interrupt sediment runoff if it does occur. Under these conditions, the reaches from D1 to D7 are maintaining a relatively stable situation when compared to the area downstream of the main spill way, as mention below.

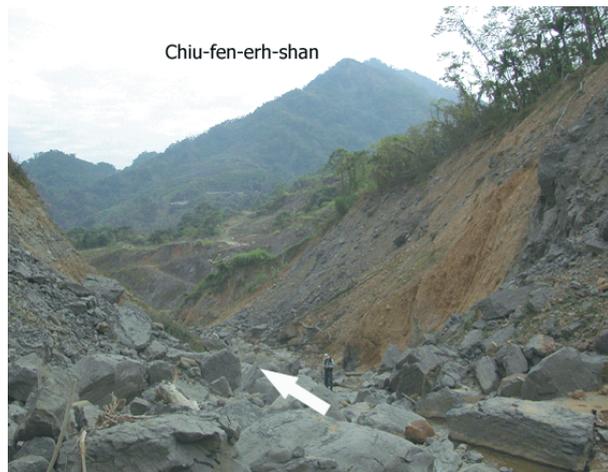
Photo. 5. Downstream of knick point E taken on Dec. 27, 2004

In the left spill way, no countermeasure to prevent scoring of the river bed have been employed. In Fig.6, the river bed from D7 to E (knick point), where the gradient is steeper ($i = 1/6.0$) than that of the main spill way, has greatly suffered from scoring, as shown in Photo 5. At the knick point E, there is a group of big rocks as shown in Photo 6 that had existed and transported within the body of the main landslide. The group of rocks is protecting a degradation in the upstream of point E in which gradient of the river bed is relatively

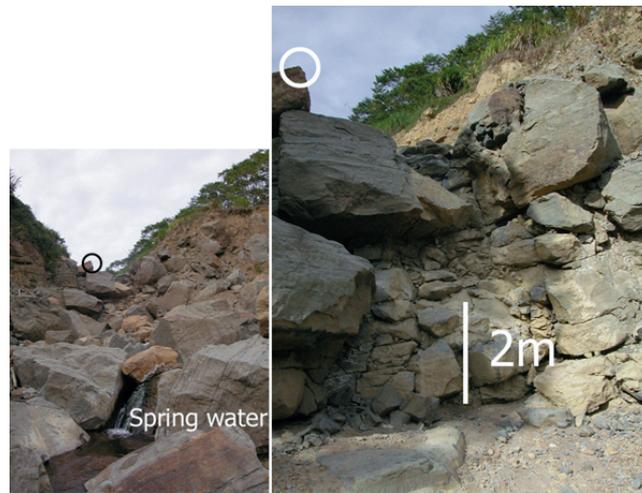
Photo. 6. Group of rocks at the knick point E (Spring water can be seen, taken on Dec. 27, 2004)

gentle ($i = 1/19$). However, spring water can be observed at downstream of point E. Erosion or collapse of this group of rocks will increase the probability that enormous sediment in the upstream, as shown in Photo 7, would run off downstream.

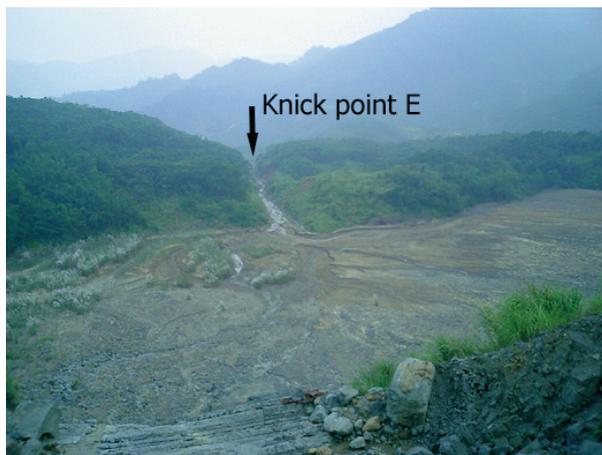
Photo. 7. Sediment upstream of the knick point E (Direction to left spill way from on the landslide slope taken on Dec. 27, 2004)

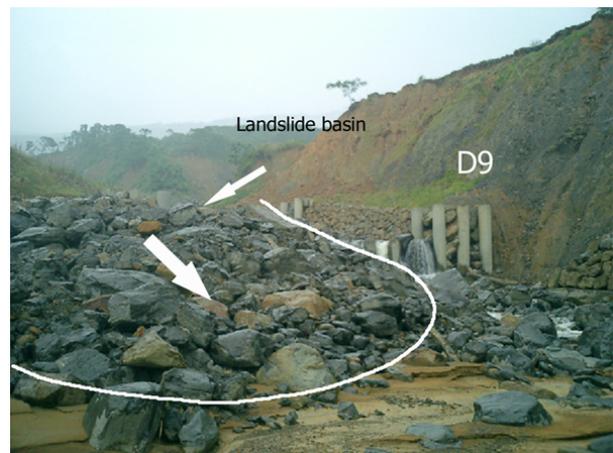
Photo. 8. Sedimentation from the left spill way taken on Sep. 4, 2004

Photo 8 shows the situation of a section in the main spill way just downstream of the confluence involving the left spill way. Enormous soil from the landslide basin through the left spill way is deposited. Erosion, scoring and sediment runoff in the downstream reaches of the left spill way have become increasingly prevalent (see Photo 5). The piles of the groundsel works were worn away and partially damaged by the flood which carried much stone and rock.

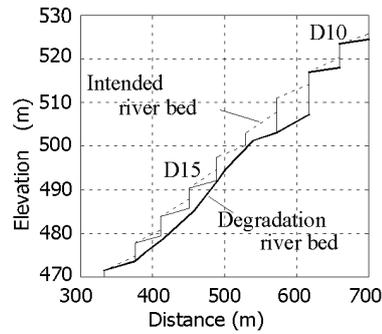
Fig. 8. Longitudinal figure from D10 to D17 of the main spill way

Fig.8 is an expanded figure of the longitudinal figure from D10 to D17 in Fig.4. In this figure, vertical lines indicate the groundsel works and the broken line indicates the intended river bed. The solid line below indicates the lowest section of river bed running behind the wing of the groundsel. Its location is shown in Fig.3 from D12 to D17 in the left bank of the main spill way. Fig.8 shows that a section of river bed from D10 to D17 suffered a lot of scoring. The level of the foundation of D11, as shown in Photo 9, was degraded up to 10 m from the intended river bed. This groundsel has controlled the height of the upstream river bed of the main spill way. If it becomes damaged, the possibility of further degradation of the river bed increases

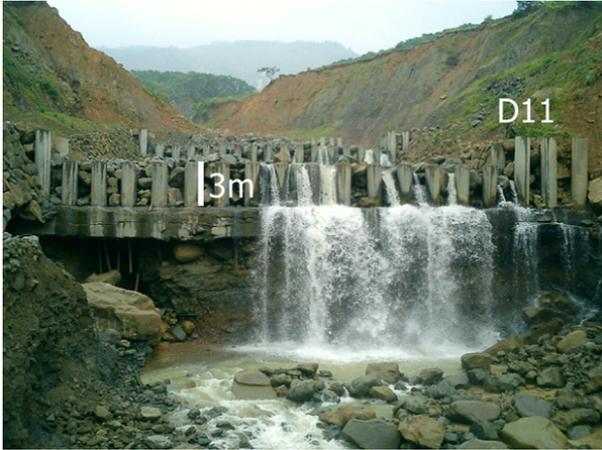
Photo. 9. River bed degradation of apron of groundsel taken on Sep. 4, 2004

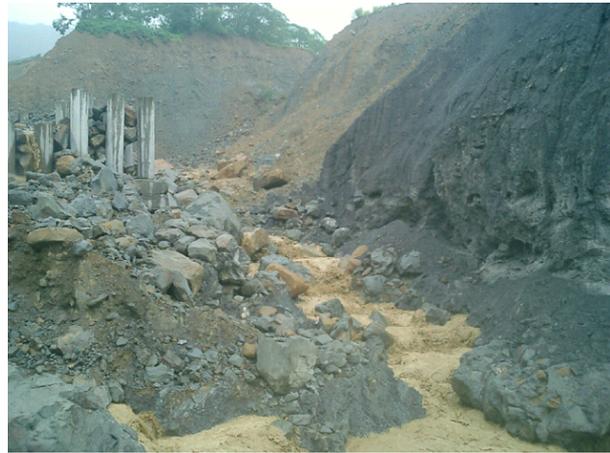
Photo. 10. New water way in the left of D12 taken on Sep. 4, 2004

upstream. The lowering of the river bed generates a new water way behind the wing of the groundsel as shown in Photo 10. Generating a new water way promotes degradation of the river bed because of weaknesses in the sediment soil. Therefore, one of integral causal factors promoting degradation of the river bed is certain to be a formidable landslide (Ls. II) in the slope along the main spill way, as will be mention later.

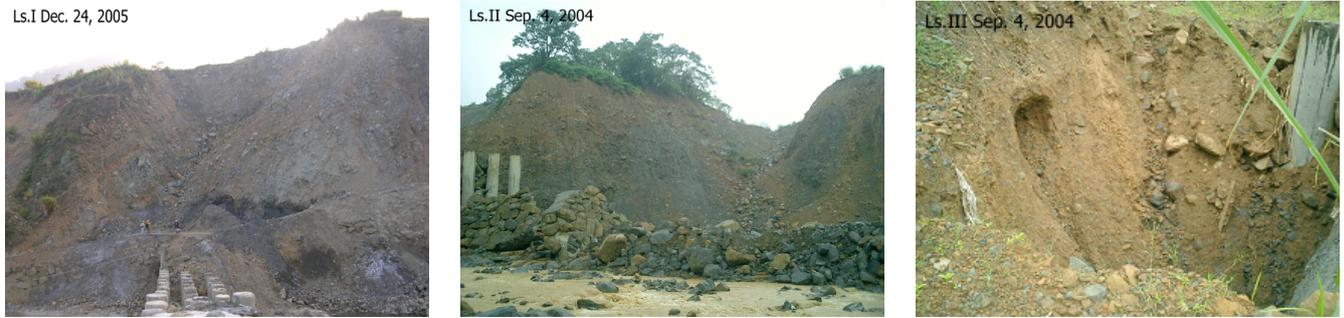
The slope under this situation suffered two big landslides and one small one as shown in Fig.3 caused by heavy rainfall which accompanied two typhoons in 2004. These landslides are hereafter called Ls. I, Ls. II and Ls. III in ascending order. The shapes of the landslides in Fig.3 are based on conducted surveys. These landslides occurred along the main spill way downstream of the confluence with the left spill way as shown in Fig.3. The situations of each landslide are shown in Photo 11. In Ls. I, spring water from the slope could be seen from our investigations done in September 4th, 2004. A wet zone at the toe of the slope could also be seen in December 24th, 2005. Traces of spring water in Ls. III were recognized in our investigation done in September 4th, 2004. Ls. II having a large scale valley configuration had caused the degradation of the river bed, as shown in Photo 9 and Photo 10. Fig.9 shows the longitudinal figures for Ls. I and Ls. II. Ls. I has a steep slope of about 35 degrees in inclination. Ls. II dissected comparatively, has a gentle slope of about 25 degrees.

Ls. I and Ls. II occurred in the region where the buried creeks meet with the main spill way. There are sunken grounds in the upper part of the slopes behind the landslides indicated by the circle marks in Fig.3. Small natural dam, indicated in the upper left in Photo 2, was generated in the slope behind Ls. I. Though

Photo. 11. Landslides along the main spill way
