Characteristics of Slope Failure Induced by the Mid Niigata Prefecture Earthquake and the Snow Melting after the Snow Term

Kazuya Akiyama,¹⁾ Jun-ichi Kurihara²⁾ and Kiichiro Ogawa³⁾

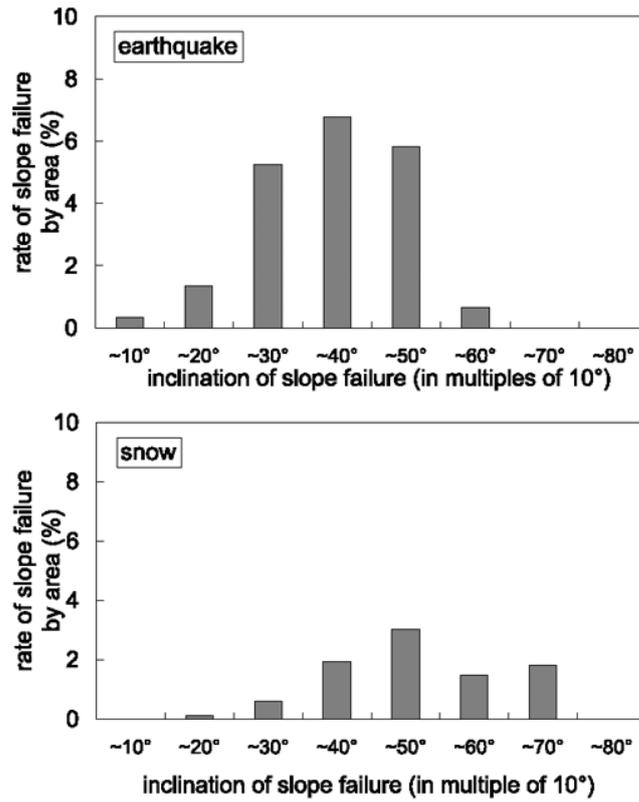
Fig. 4. Rate of slope failure by area in the Imo River basin

The inclination of slopes in the river basin area was analyzed by calculating the number of 5 m meshes in each inclination category (in multiples of 10°) and multiplying this by the lattice area to determine the relative proportion of each category within the river basin as a whole. The same approach was used to calculate the respective proportions of slope failures caused by earthquake and snow within each inclination category. The inclination of a slope failure region after earthquake was defined as the angle between the horizontal plane and a straight line drawn between the highest and lowest points within the region. Figures 3 and 4 show the results. Most slopes in the Imo river basin have an inclination of between 10° and 40°. Within slope failure regions, failures caused by earthquake were most common at slope inclinations in the range 30°–50°, which is virtually equivalent to the inclination most vulnerable to earthquake (as shown in Table 1). However, earthquake slope failures also occurred in locations with lower inclination in the range lower than 30°. Failures caused by snow were most common at slope inclinations in the range 40°–50°. Thus, inclination of slope failure caused by snow is higher than by rainfall (as shown in Table 1), and overlaps the range for earthquake, suggesting that the earthquake has had an effect on the slope failures due to snow.

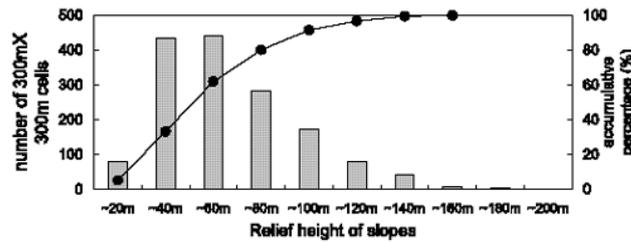
Fig. 5. Distribution of slope relief in the Imo River basin

In the Imo River basin, the height of the highest point or knick line (concave) relative to the river bed or knick line (convex) is defined as the relief height. In terms of frequency, around 90% is 100 m or less, while 20–60 m accounts for around 60% (see Figure 5).

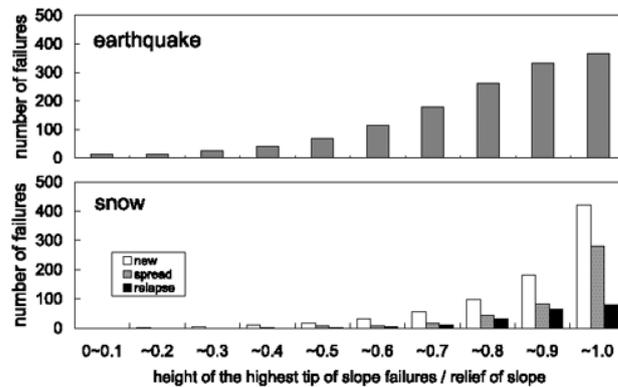
Fig. 6. Relative height of slope failures by the earthquake and snow

Figure 6 shows the relative height of the highest tip of a slope failure in relation to the height of the slope where the failure occurred. Many earthquake slope failures originate at the top of the slope, generally in ridge-type and parallel-type slopes. Post-melt slope failures also tend to originate at the top of the slope. However, new failures were found on valley-type slopes that were unaffected by the earthquake, as in the case of ridge-type and parallel-type slopes. Spreading slope failures was identified mainly at the head part of earthquake slope failures but also in the side part, while relapse of slope failures that occurred during earthquake was commonly found in the top to middle parts.

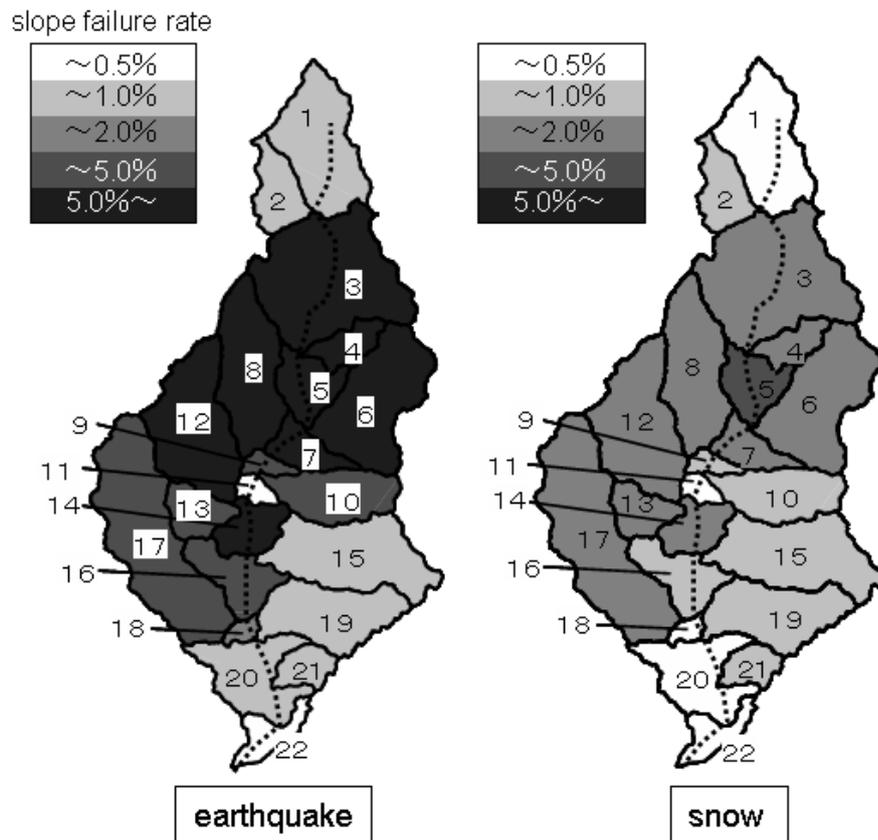
Fig. 7. Distribution of slope failure rates in each unit basin

Table 4 shows the slope failure rate by area caused by earthquake and snow for each unit river basin within the Imo river basin area. Figure 7 shows the distribution of slope failure rates in each unit river basin.

failure rate for earthquake was likely to have a high slope failure rate for snow too. Units 3–10, 12–14, 16 and 17 had a high slope failure rate for earthquake, while units 3–8, 12–14 and 17 had a high slope failure rate for snow. These units are all adjoining the middle reaches of the Imo River basin. Slope failures caused by the earthquake accounted for 3.9% of the total land area of the Imo River basin, while slope failures caused by snow accounted for 1.2%. The slope failure rate by area for snow is around one-third of that for the earthquake. The total slope failure rate by area for earthquake and snow combined was 4.9%, taking into account that relapse collapses caused by snow involved little increase in area.

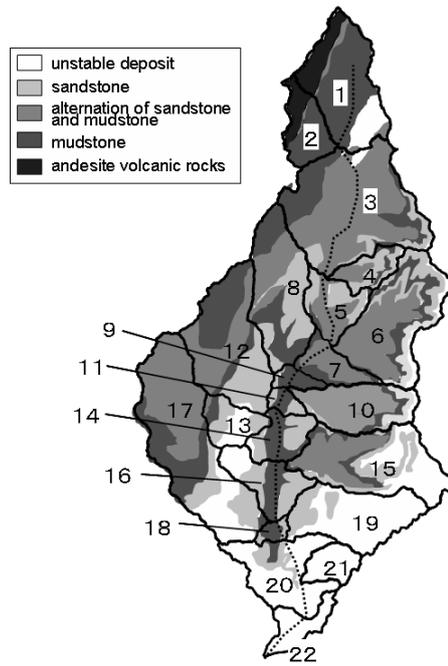
Fig. 8. Geology and unit basins in the Imo River

Figure 8 shows the five main types of geology found in the unit river basins. The slope failure rate is higher in sandy and muddy soils, particularly those consisting of sandstone or sandstone alternating with mudstone. The slope failure rate tended to be lower in regions with less of this type of geology. To examine the relationship between geology and slope failure in the river basin more closely, a more in-depth comparison was conducted in which the geological categories were sub-divided in accordance with the numerical geological maps described above.

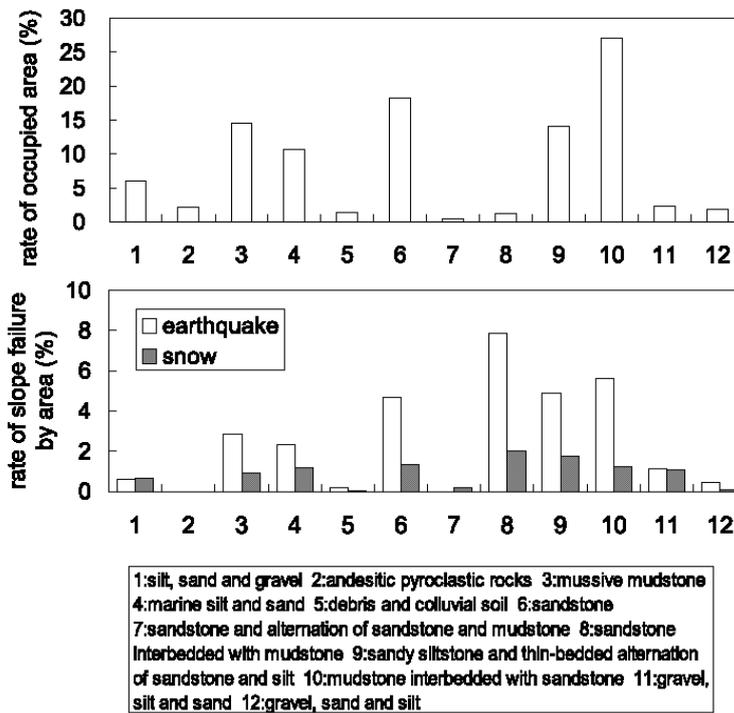
Fig. 9. Rate of occupied area and slope failure with detail geological categories

Figure 9 shows the area of each geological category as a proportion of the total for the river basin, and the slope failure rate by area in each category.

Slope failure rates were higher — both for earthquake and snow melt — in sandstone and mudstone regions, especially those featuring sandstone, sandstone alternating with mudstone, sandy siltstone or sandstone alternating with siltstone. The geology represented in (8) — predominately sandstone with alternating sandstone and mudstone — had the highest slope failure rates for both earthquake and snow melt despite accounting for only a small proportion of the river basin, indicating that this geology type is highly vulnerable to slope failure. The slope failure rate tended to be lower in unit river basins with less of this type of geology.

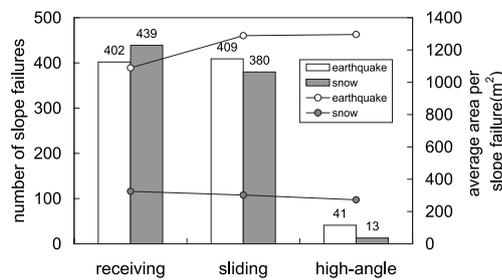
Fig. 10. Geological structure and slope failures

from 1:50,000 geological maps. Regions without defined strata (numbers 1, 2, 5, 11 and 12 in Figure 11) were excluded from the analysis. Figure 10 shows the results.

The general trends were similar for slope failures caused by earthquake and by snow. The incidence of slope failure was equally high for both sliding and receiving ground, and low for high-angle ground. When average volume per slope failure is taken into account, it can be seen that slope failures caused by snow were generally smaller in area than those caused by earthquake, as noted earlier. Slope failures due to earthquake tended to be slightly larger on sliding and high-angle ground, while post-melt snow failures were the same size across all categories. There were 16 slope failures due to earthquake involving an area of more than 10,000 m², and these occurred on both sliding and receiving type ground and located in unit river basins 3–8, 10 and 12 which had high rates of slope failure.
