A FLOOD RETENTION BASIN IN AN ABANDONED STONE QUARRY - EVALUATING THE STABILITY OF A SUBMERGED ROCK SLOPE

ABSTRACT

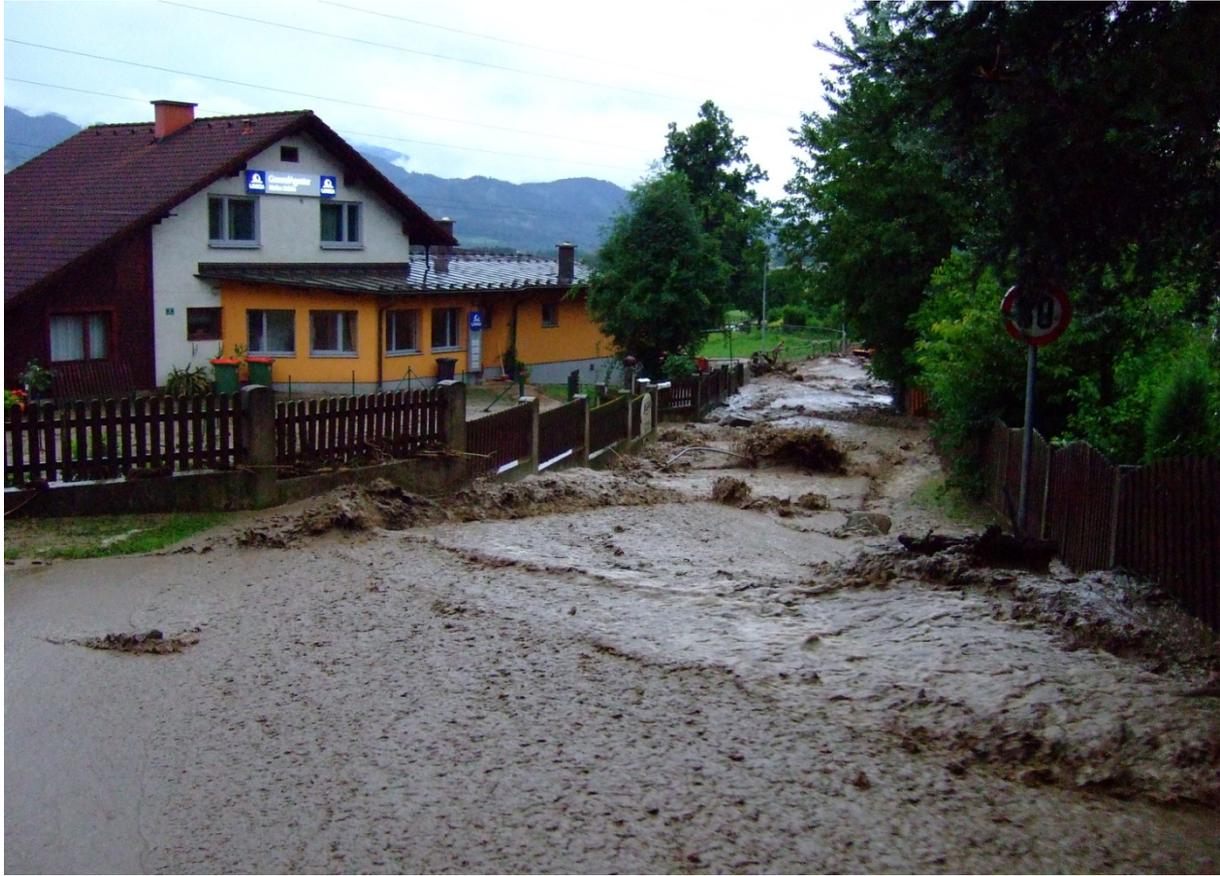
Fig.1 Lammerbach flood event July 15th, 2009

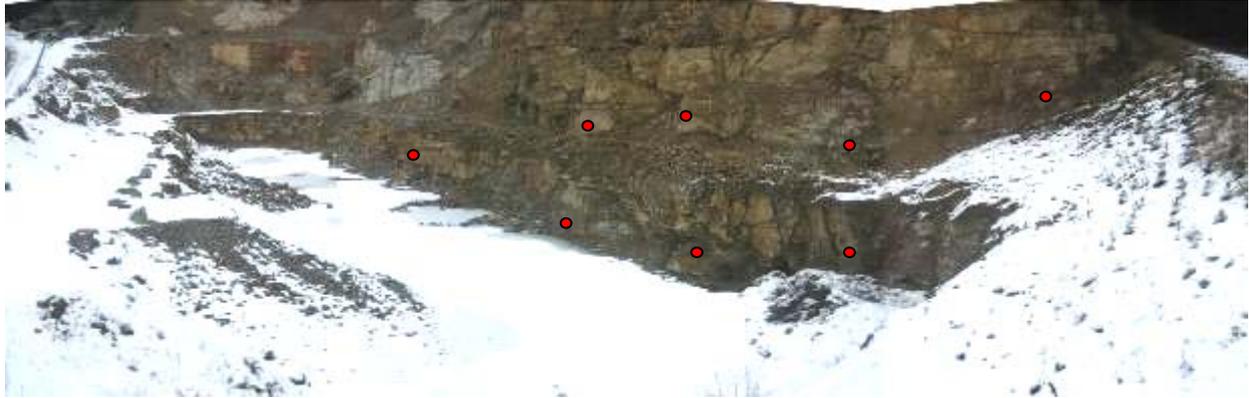
Fig.4 Location of benchmarks at the base of the rockwall

High accuracy measurements of the benchmarks were repeated periodically for 2 years, especially during thawing periods and after blasting operations in the quarry. It could be verified by these measures, that no significant deformations occurred during the monitoring-period.

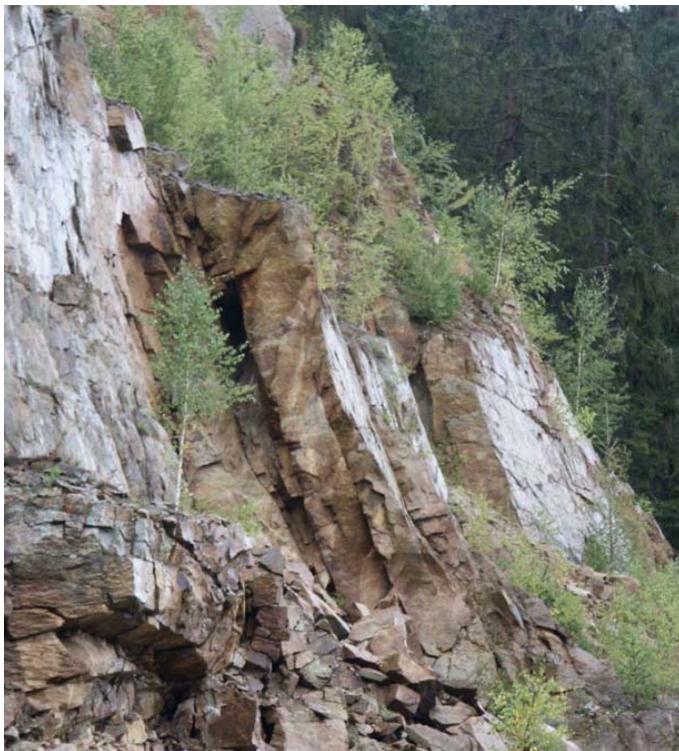
Like a ladder leant too flat against a wall, rocks with heights of 10 to 15 m and thicknesses of max. 2 m slump on faults with inclinations of 35 to 40°. The rocks are isolated from the wall by joint system 2.

Fig.6 Isolated rocks prone to slump

Failure mechanism 1 Rock slumping		
Safety class	2	No endangerment of human lifes, no serious economic consequences
Required factor of safety	1.15	
Provided factor of safety	1.16	
Proof of stability	1.16 > 1.15	Evidence provided ✓

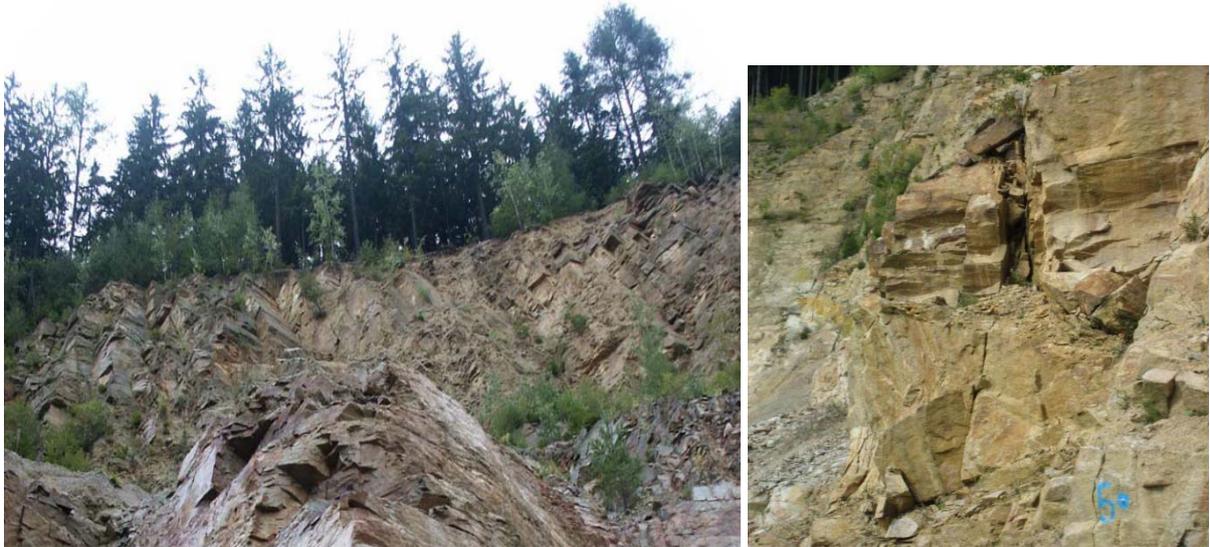
Columns are isolated from the rock wall by the two joint systems. These columns or wedges slump on steeper foliation planes sliding along the joint systems.

Fig.7 (left) Missing (already slumped) wedges in the upper part of the rock slope
Fig.8 (right) Isolated wedge

Failure mechanism 2 Wedge slumping		
Safety class	2	No endangerment of human lifes, no serious economic consequences
Required factor of safety	1.15	
Provided factor of safety	1.04	
Proof of stability	1.04 < 1.15	✗ Evidence not provided → Wedges prone to sliding must be removed

- Reduction of the slope angle of the sidewall from 60° to 40° .
- Removal of small scale rock wedges prone to sliding (especially below maximum water level, but also above).
- The draw down velocity has to be controlled in order to keep the difference between the reservoir water level and the ground water to a maximum of 2 m.
- Continuation of the geodetic monitoring of the sidewall (differential survey).

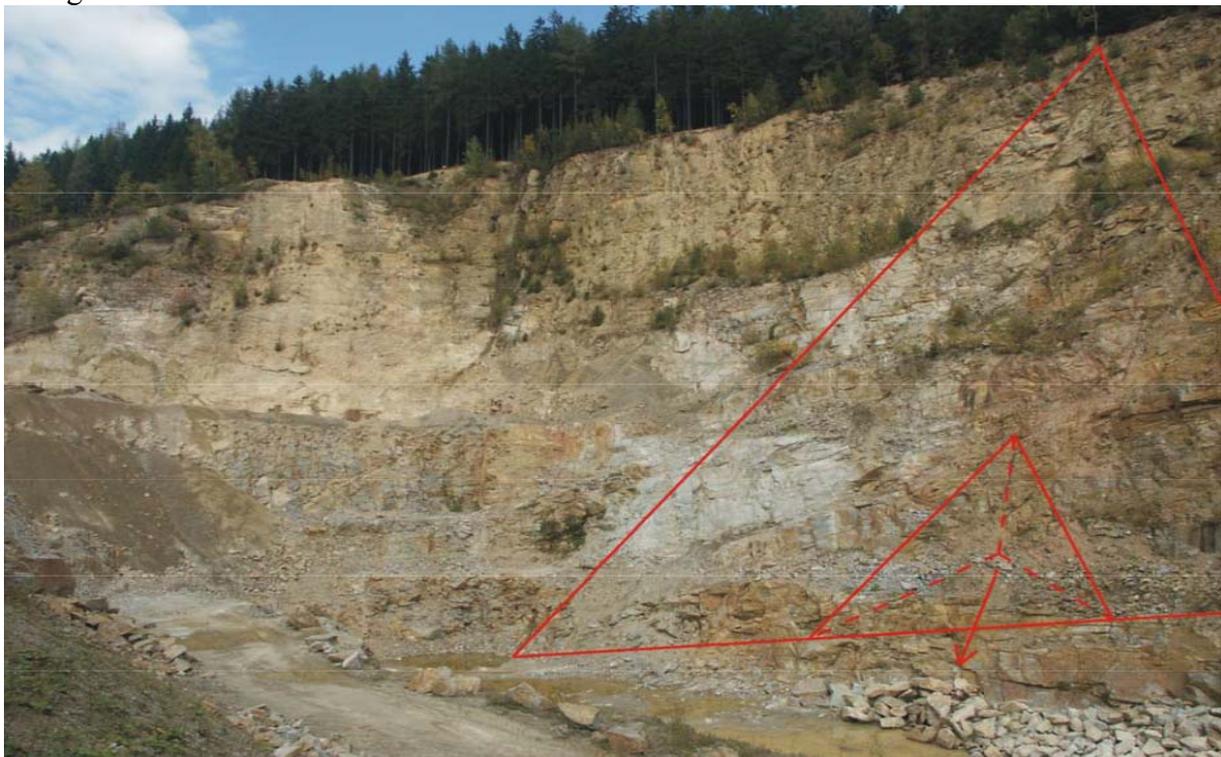
Large rock blocks, isolated by the two joint sets, slide on foliation planes with clayey-sandy fillings.

Fig.9 Schematic picture of large blocks isolated by joint systems sliding on foliation planes

Failure mechanism 3 Large block sliding on foliation planes		
Safety class	3	Endangerment of numerous human lives, serious economic consequences
Required factor of safety	1.3	
Provided factor of safety	1.307	
Proof of stability	1.307 > 1.3	Evidence provided ✓

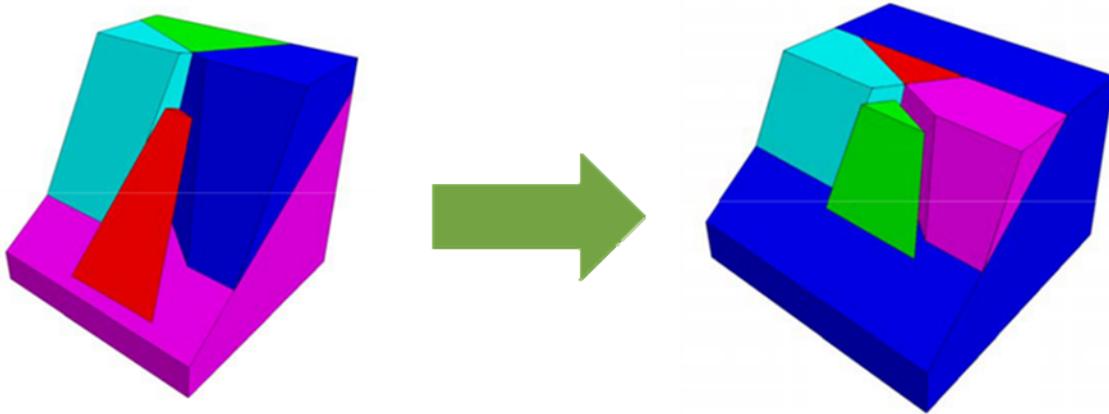
Due to the planned reduction of the height of the berms of the new design-slope this failure mechanism would change from slumping to sliding.

Fig.10 The planned reduction of berms to heights of 6 m would cause large rock blocks to slide instead of slumping

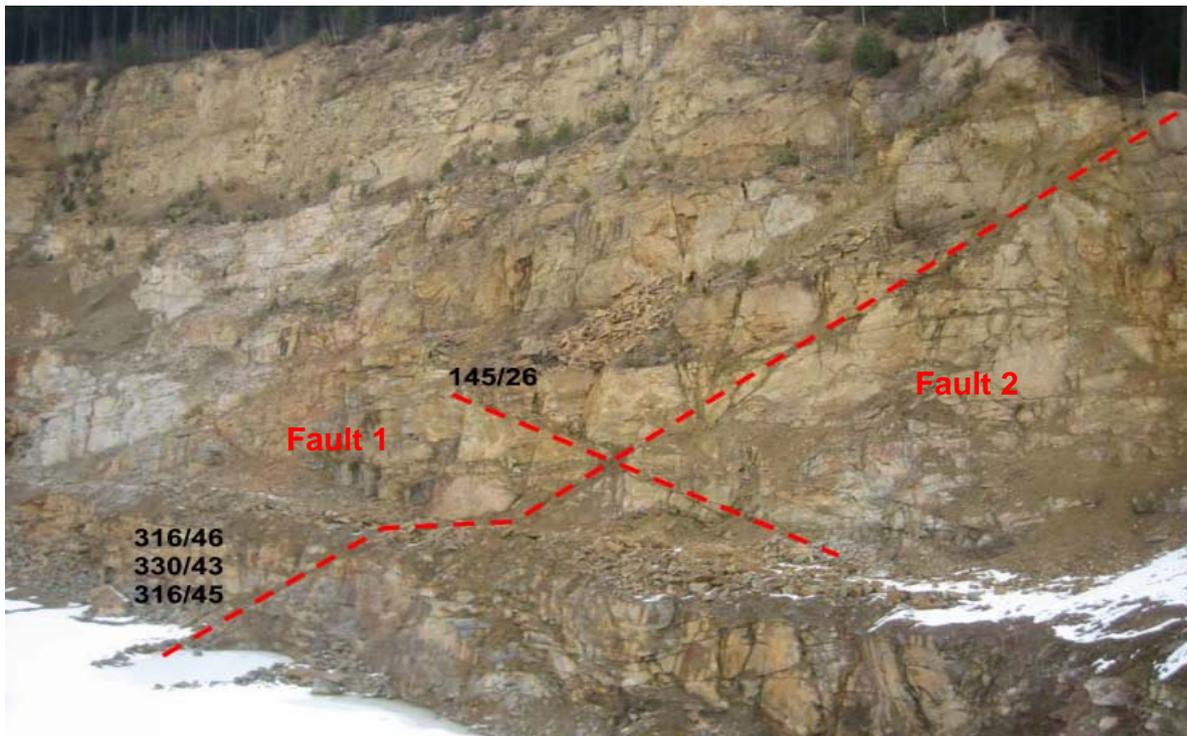
A wedge-shaped joint-bordered rock block slides on fault 1 and 2.

Fig.11 Two large faults serving as sliding planes for joint-bordered rock blocks

Failure mechanism 4 Large, joint-bordered rock blocks sliding on faults		
Safety class	3	Endangerment of numerous human lives, serious economic consequences
Required factor of safety	1.3	
Provided factor of safety	>> 1.3	
Proof of stability		Evidence provided ✓ Failure mechanism not relevant
