THE DÜRNSTEIN ROCKSLIDE (WACHAU, LOWER AUSTRIA)

IMPLEMENTATION OF PROTECTIVE MEASURES WHILE MAINTAINING PUBLIC TRANSPORTATION – A CASE STUDY

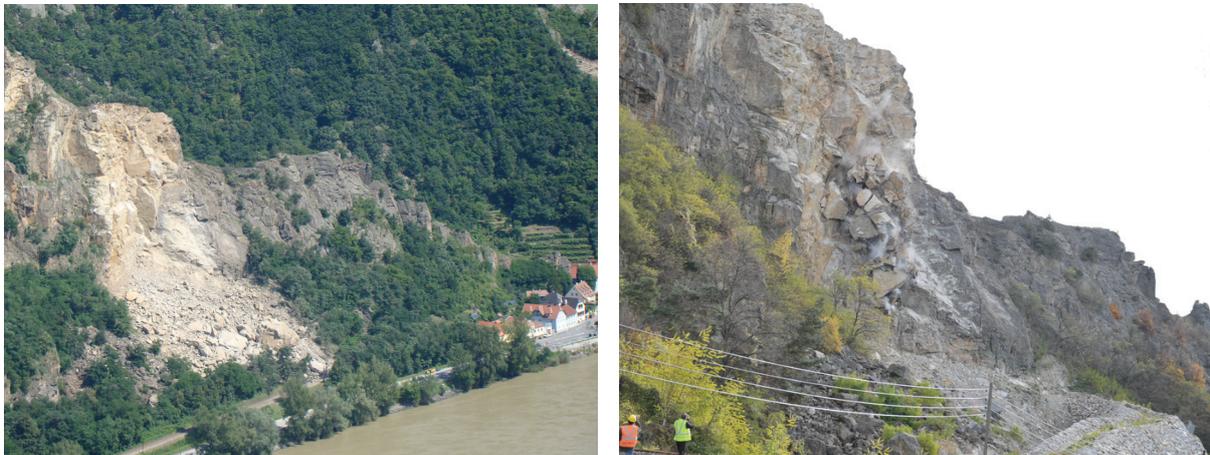
Immediate rock mechanical failure analysis clearly showed that block sliding along failure planes dipping out of the slope was the main failure mode. In that case long-term stable equilibrium are typically achieved by removing potentially unstable falls and by cutting back the rock surface extensively, which means further long-lasting traffic obstructions. As this option was politically and economically difficult to achieve and historic and nature conservation directives limited measure options, a detailed slope stability analysis by means of a joint monitoring system was implemented first to optimize location, design and morphologic impact of slope stabilisation measures. To start restoration action as soon as possible, the joint monitoring system was combined with a warning system. The system consisted of seven fissurometers, measuring the opening width of cracks, 17 3-D prism targets for measurement of surface movement and two geophones. Additionally, a pluviometer was installed to check for periods of heavy rain as a triggering mechanism.

Approximately half a year later a fissurometer logged rock wedge movement of approx. 700 m³. As joint opening rate increased after each rainfall, it was necessary to remove these unstable rock masses immediately. Security blasting and removal of loose stones were carried out safely behind the dam without lengthy traffic interruption. The energy-absorbing capacity of the dam is limited to an impact of approximately 10.000 kJ. Major rockslides could easily exceed this capacity. Therefore a long-term remedial concept was designed, cutting back all unstable parts of the rock face by blasting. The projected slope design considered the fact that slope geometry is strongly influenced by geological settings, whereby discontinuity properties have the greatest control on slope stability. The overall slope angle is reduced by the inclusion of seven benches. These measures will be finished in summer 2011 with a total cutting volume of 4.500 m³. The material will be deposited at stockpiles on site. During measure implementation the warning system will ensure safety during construction works.

Fig. 1 The 2009 rockslide at Dürnstein (left) and blasting of an unstable rock wedge after dam construction completion (right)

rockfall protection kits were installed. As the dam consisted of deposited rockfall material no construction material had to be transported to or from the site. By creating this absorption bench parallel to the railway line at the foot of the rock face, the endangered runout zone was considerably reduced. During dam construction all construction machines working in the danger-zone were equipped with hazard lights, which were connected to the alarm system, enabling in time evacuation. At the same time restoration of the railway track started and the first train passed the danger-zone three months after the rockfall event took place.
