DURABILITY OF TIMBER STRUCTURES IN TORRENT CONTROL

Christian Rickli¹ and Frank Graf²

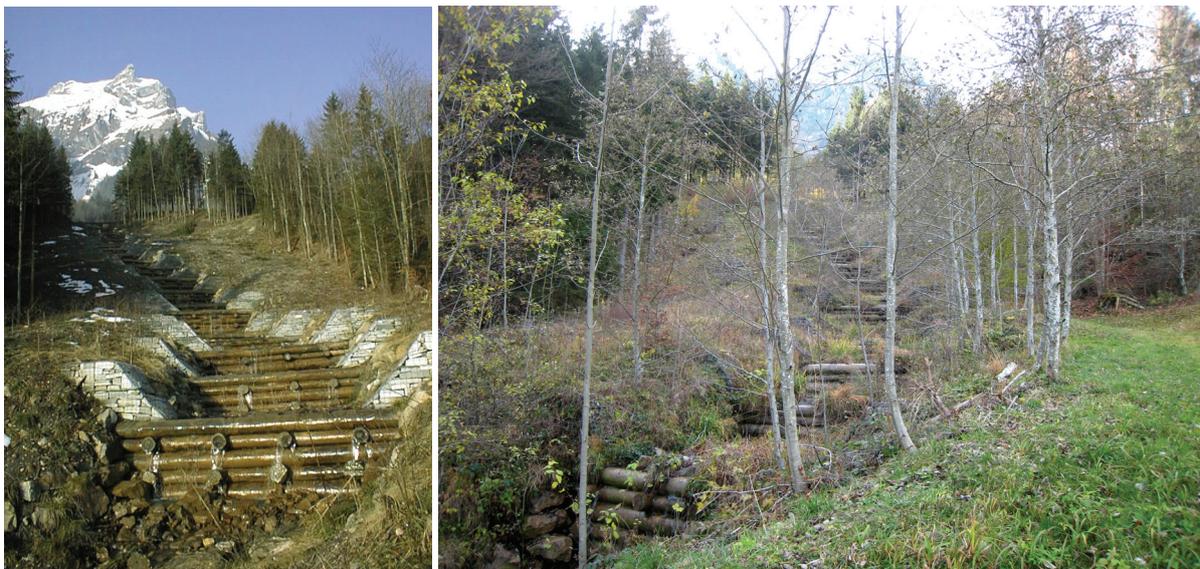
Fig. 1 Series of investigated timber check dams near Hergiswil, Switzerland. Situation in 2001 (left) and in November 2010 (right).

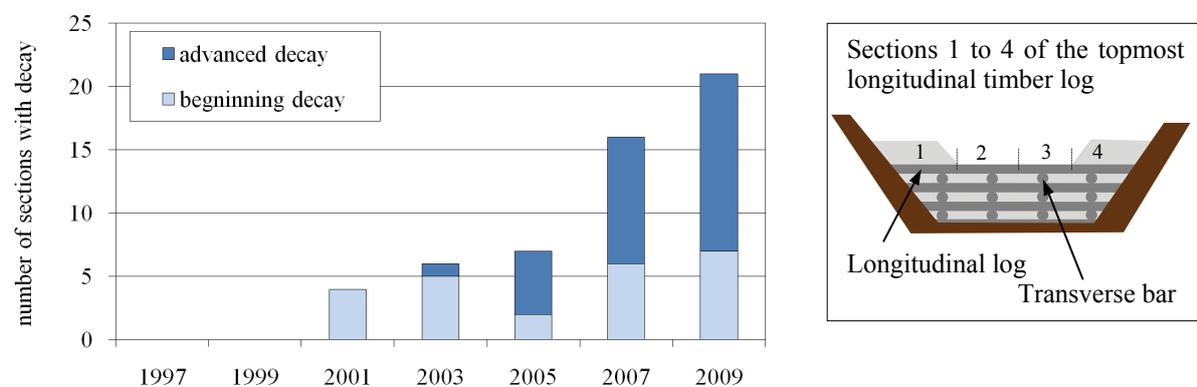
Simple strength tests showed first patches with evidence of timber decay in 2001 (Fig. 2). Thereafter decomposition increased with time. In 2009 decay was detected on 11 of the 15 check dams, representing totally 21 sections with beginning or advanced decay. The sections 2 and 3 with permanently high water saturation were less affected than the occasionally dry sections 1 and 4 (Fig. 2). So far, an obvious difference in decay progress dependent on tree species (Norway Spruce, resp. Silver Fir) and bark removal is lacking.

Fig 2. Sections with either beginning or advanced timber decay (assessment by qualitative inspection) in the topmost longitudinal log of the 15 timber check dams. Each log was divided into four sections: mostly dry left and right side (No. 1 and 4), mostly wet central parts of the check dam (No. 2 and 3).

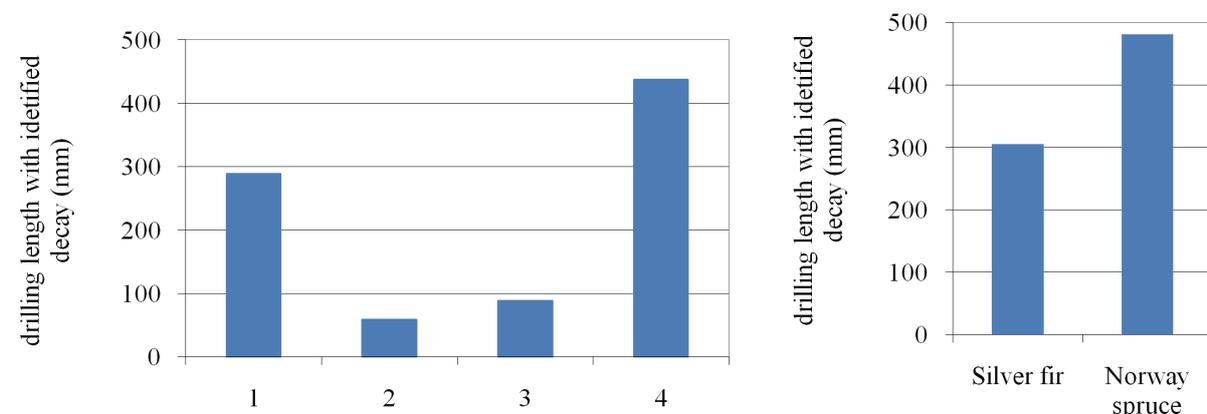
Drilling resistance measurement: In 2010, wood decay was detected by resistography in 11 of the 15 timber check dams confirming the above described results of the qualitative assessment in 2009. Again, wood quality was markedly worse in the occasionally dry sections 1 and 4 (Fig. 3, left). The drilling resistance measurements showed more decay in Norway Spruce compared to Silver Fir (Fig. 3 right) but no consistent results concerning the influence of bark removal. Future investigations and statistical analyses are needed to confirm the observed trends.

Fig 3. Drilling length (sum of all 15 timber check dams) with identified wood decay in sections 1 to 4 of the topmost longitudinal log measured 14 years after construction (left) and corresponding difference between Silver Fir and Norway spruce (right).
