REHABILITATION MEASURES OF A ROCK-FALL GALLERY

“GALLENSCHROFEN”, DISTRICT INNSBRUCK LAND, AUSTRIA

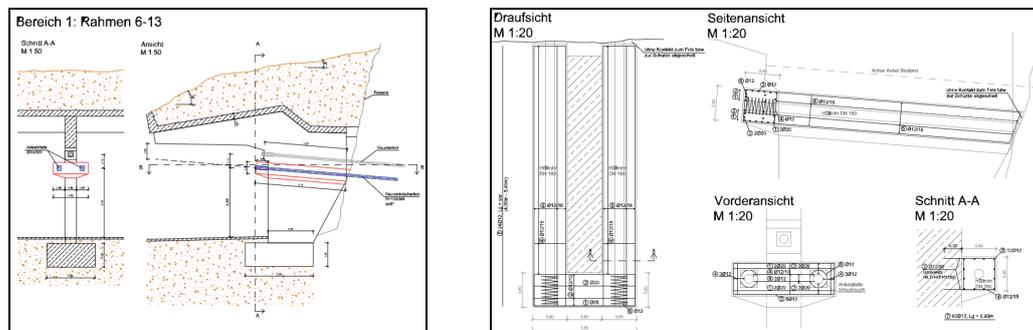
Fig. 1 Stabilization of the projecting slabs by 9 anchored and pre-loaded concrete tie beams

Therefore, the most reasonable and economically remedial measure was to reinforce the existing and replace the failed anchors. By regarding the results of the investigations, the consequences of the rehabilitation measurements on the rock-fall gallery were to stabilize the projecting slabs by nine anchored and pre-loaded concrete tie beams. These stabilization measurements were necessary to absorb the static equivalent load of 985 kN and 634 kN respectively for two different slope sections derived from rock-fall simulation. The calculation of the static equivalent load from the kinetic energy was conducted using the Swiss approach described in BAS (2008). In addition, the surface run-off being collected on the top of the gallery as well as water arriving from subsurface are now harmlessly discharged by a new drainage-system.
