## LONG-TERM STABILIZATION OF A COLLAPSED SKI SLOPE IN SAN VIGILIO DI MAREBBE, SUD TIROLO, ITALY

Paolo Simonini<sup>1</sup>, Alfred Psenner<sup>2</sup>, Simonetta Cola<sup>3</sup>, Maurizio Schiavo<sup>4</sup> and Zeno Kastlunger<sup>5</sup>

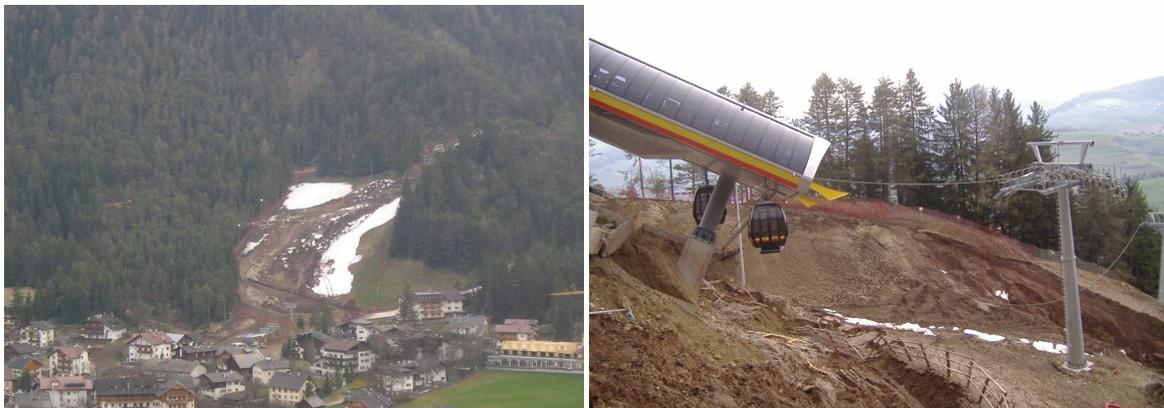
The April, 22<sup>th</sup>, 2006, early afternoon, a snow-capped ski slope, located just above the village in the famous skiing area in San Vigilio di Marebbe, Sud Tirolo, Italy, collapsed and moved downwards for approximately ten hours. Due to the landslide, the uphill station and upper pier of a new cableway crossing the ski slope tilted and moved tens of meters down the slope scaring the people of the village and the authorities. The moving mass stopped very close to the lower station of the cableway, partially submerging the station and an adjacent garage. Figure 1 shows the mass flow area on the ski slope.

The destabilised volume consisted of a mixture of sandstone boulders and remoulded soil derived from strongly decomposed sandstone rocks with an exceptionally high percentage of water.

The visual inspection of the slope a few hours after the event showed that a pipe of the snow-making system crossing the crest of the landslide at small depth had been cut off.

The catastrophic event has been caused by an unfavourable combination of different factors. More particularly, it seemed that probably some small movements on pre-existing structural weaknesses (Clayey layers - Figure 2) in the upper part of the ski slope damaged the pipe system supplying water at very high pressure to the snow guns in the area. This led to a water seepage, which increased the

**Fig. 1** View of the collapsed ski-slope.

water pressure and weight of the slope hereby reducing the frictional resistance of the future gliding surfaces and increasing the downhill stress component finally exceeding the shear strength of the surfaces. With the sliding started, the water saturated volume partially liquefied and flowed down the slope.

Short-term stabilization/protection interventions consisting of an earth wall at the base of the slope and a shallow drainage network on the slope were rapidly carried out by the Authority for the Mountain Protection to reduce the risk and avoid possible additional damages.

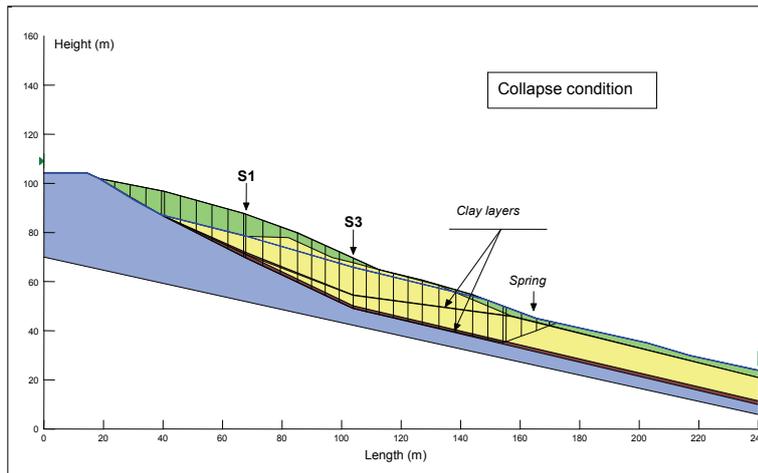
**Fig. 2** Localization of failure surface in the slope

The flow slide involved the detrital cover and the fractured and altered sandstone, sliding on thin layers of non-plastic clayey-silty material down to depths of 15-20 m.

Laboratory measurements of the shear strength of these layers provided a residual friction angle of around  $30^\circ$  and no cohesion. Back analysis of the mass flow showed that the rise of the piezometric surface above the clayey-silty layers was responsible for the flow slide.

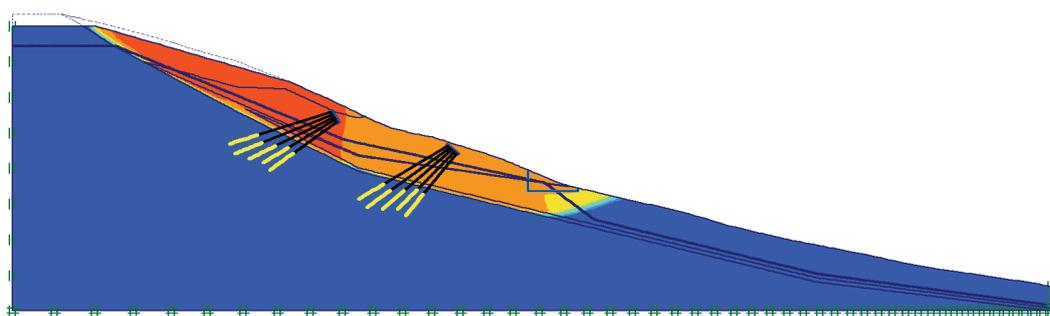
**Fig. 3** Localization of displacements in the slope after stabilization from the finite element analysis

In order to avoid the reoccurrence of the slope failure allowing for the reconstruction of the ski slope, three types of stabilization measures, namely a slope re-profiling, a shallow and deep drainage system and a deep soil nailing were selected (Figure 3).

The gained increase of the safety factor FS was proportional to the effects of the three different measures, namely  $FS=1.02$  for slope re-profiling,  $FS=1.12$  including the drainage system and  $FS=1.20$  including also soil nailing. The selected value of 1.20 seemed a reasonable and justifiable compromise between the required reduction of risk level and economical costs of the whole intervention.
