# Landslide Dam Outburst Flood in Way Ela River, Ambon Island, Indonesia

**Key words:** landslide dam, outburst flood, longitudinal profile, grain size distribution

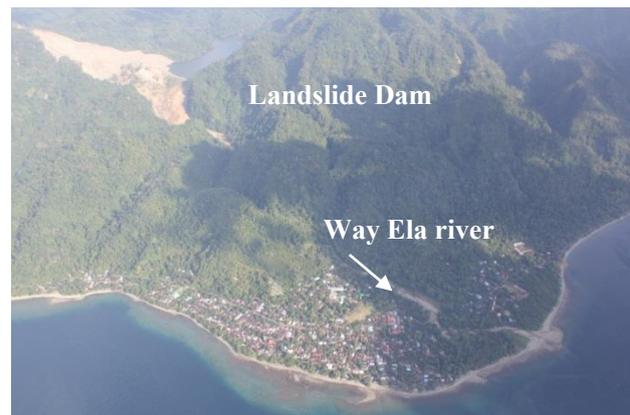
Ambon Island is located at latitude 3 degrees south and longitude 130 degrees east, about 2,500km from Jakarta toward east-northeast (Fig.1). On 13th July, 2012, a slope on the right-side bank of the river failed and formed the large-scale landslide dam three kilometers upstream from the sea. One kilometer upstream from the sea along the river is classified into alluvial fan. A village with the population of 5,300 is located on the alluvial fan (Fig.2). Outline of the landslide dam is summarized as shown Table 1. These figures are calculated based on satellite DEM data and ground survey data is also applied.

The landslide is a large scale of about 500 m in width and about 100 m in depth. As the geological factor for the landslide, aggravation of weathering in deep layer, existence of fault along a scarp and less permeable bedrock could be considered.

Fig.2 Overview of the landslide dam

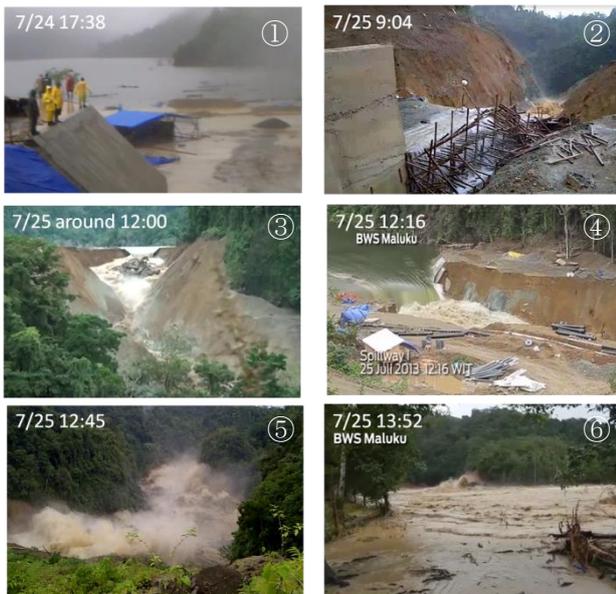
channel in the early morning on 25th July (①, ② in Fig.3). Erosion of downstream slope of the dam continued and it reached to the top of the dam. Then structures on the dam started to be broken due to the erosion around 12:00 (③, ④).

Rapid erosion started soon after the structures were broken down, and then huge scale outburst flood emerged around 12:30 pm (⑤). It continued until around 2:00 pm (⑥) and then surge flow disappeared. Flood spreads over the alluvial fan and two third of houses and buildings in the village were washed away by the flood (Fig.4).

Fig.3 Chronology of the outburst flood

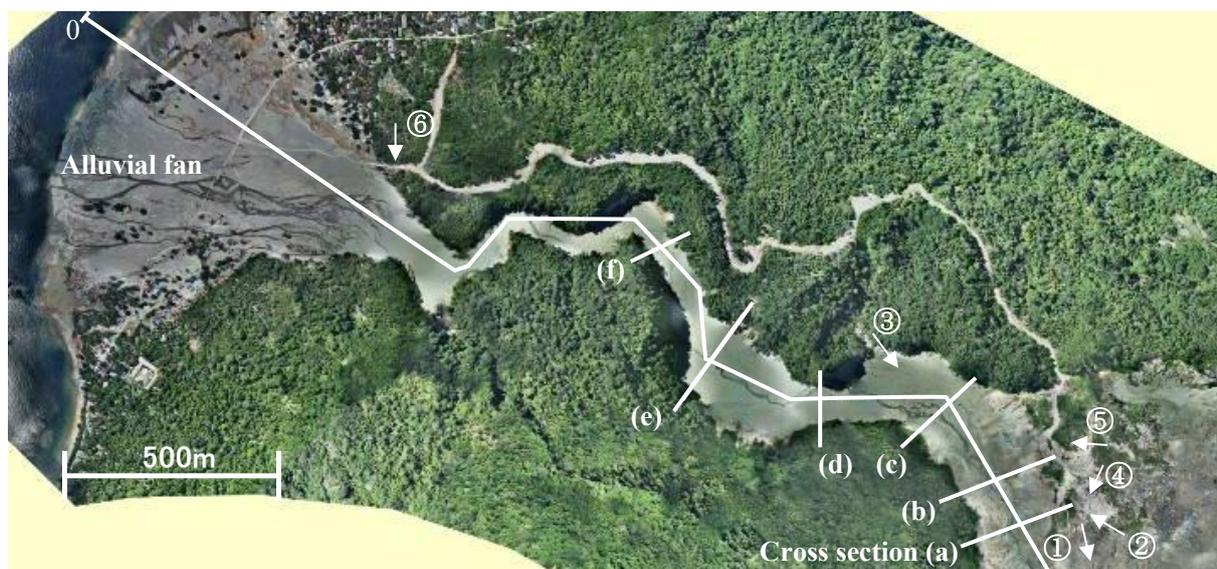
Fig.4 Way Ela River after the flood  
(①-⑥ show the location and direction of the photos in Fig. 3)

present riverbed for the right bank and 10 m higher for the left bank. The down part from this section, the flood traveled down in relatively narrow and winding stream channel (Fig.4).

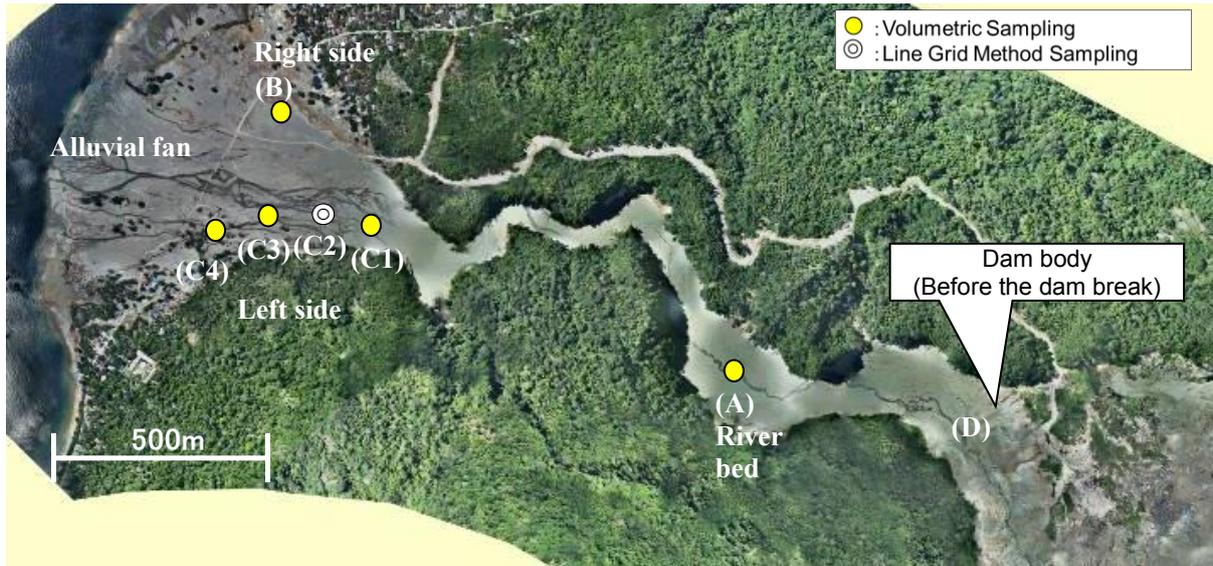
#### 3.2 Grain size analysis

**Fig.5 Location of the sampling points for grain size analysis**

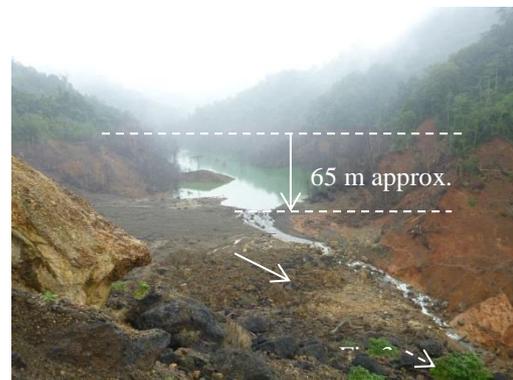
After the failure of the dam, the water level is approximately 65 m below the previous highest water level (Fig.6). The water flows over the present top of the dam. Part of the downstream slope of the remained dam is covered with big boulders and erosion of the dam body is not observed. Photos of 6 sections of the landslide dam and the downstream river is shown as Fig.7. The location of each sections is shown in Fig. 4.

**Fig.6 Remained landslide dam after the outburst flood**

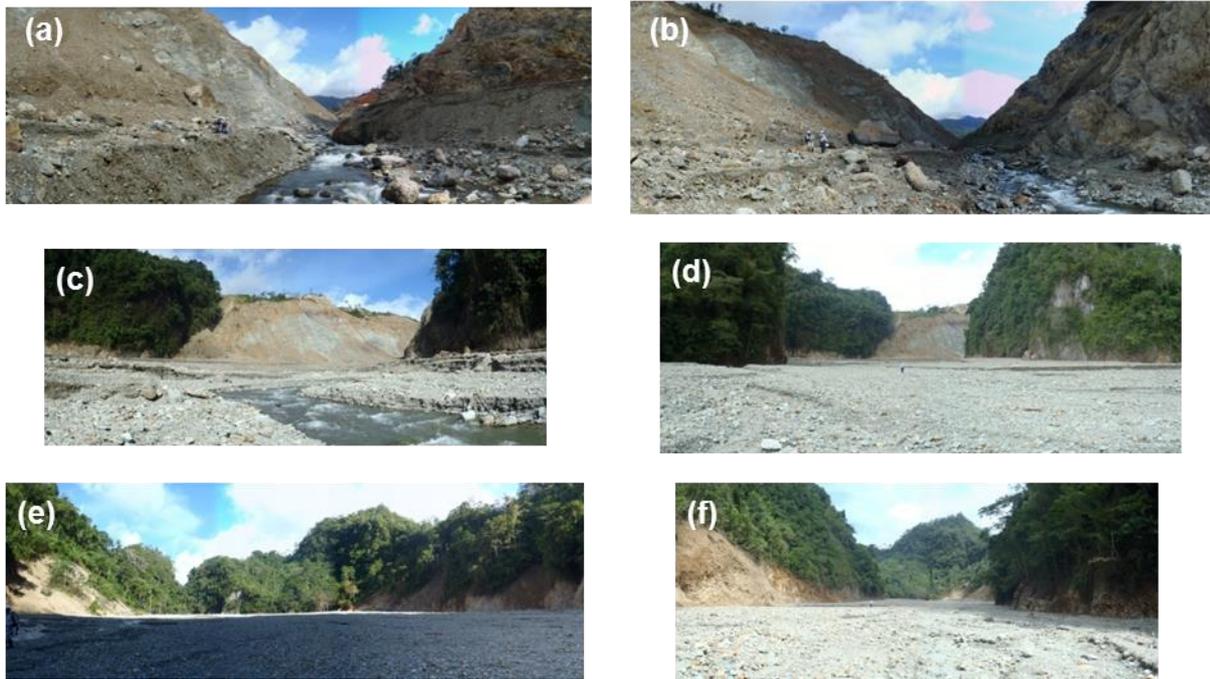
Section (a) and (b) are near the previous highest point on the landslide dam. Very steep water channel is formed after the overtopping and erosion. The width of the upper part of the water channel is approximately 250 m and the depth of erosion is about 70-90 m in this section. The slope gradient is about 30 degree for the right-side bank and about 50 degree for the left-side bank.

Section (c) is 300 m upper from the previous downstream end of the landslide dam; section (d). Both sides of the section (d) are upstanding rock wall and the width of the channel becomes narrowed. The deposit of sediment in this section after the dam break is about 30 m deep according to the difference between the two periods of DEM data before and after dam failure.

Similarly, the depth of the deposit in the section (e) and (f) is about 25-35 m. The width of the river channel in the section (e) is about 160 m and it is wider than upper part and down part of this section. The river channel width in the section (f) is about 70 m and the flood marks is 30 m higher than the

Fig.7 Photos of the landslide dam and the downstream river (View from downstream)

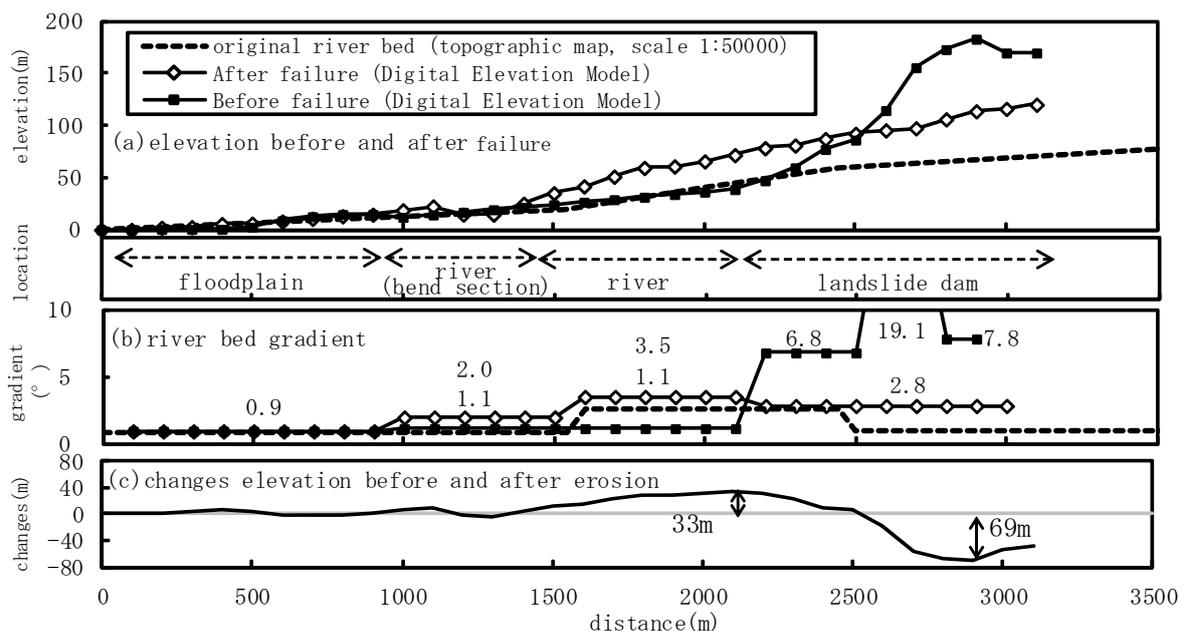
The longitudinal profile and riverbed gradient are shown as Fig.8. The erosion due to the landslide dam outburst flood occurred, but the original riverbed is not eroded shown as Fig.8 (a). It is noted that the sediment deposited in the area 1km downstream of the landslide dam (Fig.7 (c)). The

slope gradient is 0.9 degree at each point of the alluvial fan before and after the dam failure. The slope gradient in the landslide dam section changed from 6.8 – 19.1 degree to 2.8 degree . The channel located in the upper part of the alluvial fan was formed by curved and narrow part, so the sediment cannot flow smoothly and the sediment deposition progressed. Hence, the slope gradient of this section changes from 1.1 degree to 2.0 – 3.5 degree and becomes steeper than the value before the dam failure.

Fig.8 Changes of longitudinal profile and riverbed gradient

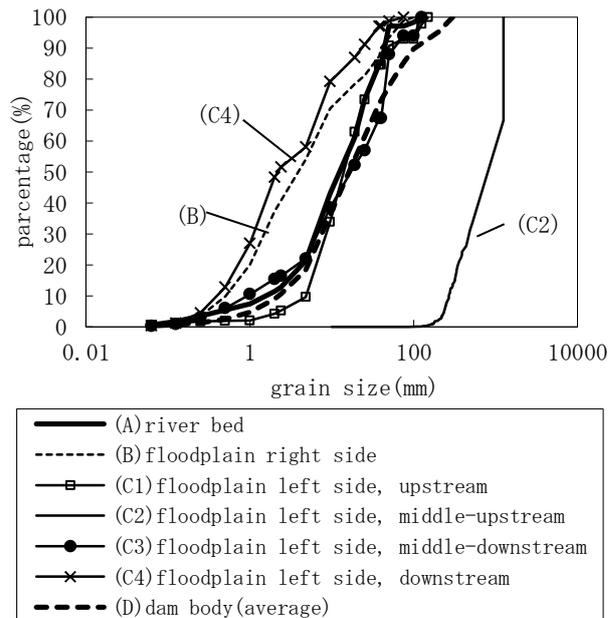
According to the previous reports and examination results, large gravels tend to deposit around the forefront of the debris lobes in an alluvial fan or edges of a deposited area [Takahashi, 1980]. In this study, the particle size distribution at the site on the left side of the lower part of the alluvial fan (C4), and on the right side of the alluvial fan (B) indicates that size of the sediment is smaller than the other site. The particle size distribution at the site on the middle part of the left side of the alluvial fan (C2) indicates that larger size of the sediment exists (Fig.9).

Fig.9 Grain size distribution

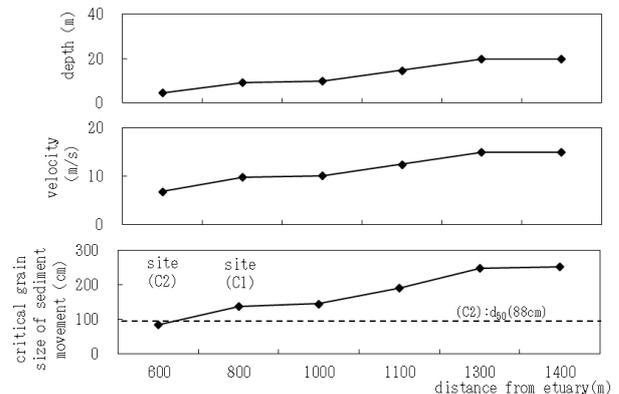
Using the height of flood marks, topographic data, Manning formula and Iwagaki's formula, we calculated the threshold of particle size of incipient motion at the site C1 where the river channel curves and at the site C2 where boulders deposited. In the calculation of Manning formula, the value of 0.05 was used for coefficient of roughness ( $n$ ). Fig.10 shows the threshold of particle size of incipient motion at C1 and C2. According to the figure, the threshold of particle size of incipient motion at C2 is smaller than the value at C1 and also than the value of  $d_{50}$  obtained at C2; 88 cm. Hence, it is estimated that the forefront of the debris flow containing boulders stopped and the sediment deposited at C2. The river channel in upper stream of the apex of the alluvial fan is curved rightward. It could be considered that debris flow with boulders traveled down along the excurvation and reached around the leftward area including C2. Given the fact that smaller particles deposited around the site B and C4, the subsequent flow containing smaller particles after the forefront of the debris flow travelled down bypassing or overtopping the deposited boulders around the site C2.

Fig.10 Longitudinal profile of hydraulic properties
