Clarifying Hydrogeological Structure of Deep Catastrophic Landslide Using Airborne Electromagnetic Survey, Spatial Patterns of Stream Flow and Drilling Investigation

Hiromitsu ISSHIKI^{1*}, Atsuhiko KINOSHITA¹, Teruyoshi TAKAHARA¹,
Tadanori ISHIZUKA¹, Ken'ichirou KOSUGI², Ryo SAKAI³, Makoto OYAMA⁴,
Shinji KOMATSU⁵, Yuji UEHARA⁵, Masami ITOU⁵, Makoto YAMANE⁵,
Katsushi KAWATO⁶ and Minoru OKUMURA⁶

¹ Public Works Research Institute (1-6 Minamihara, Tsukuba-shi, Ibaraki 3058516, Japan)

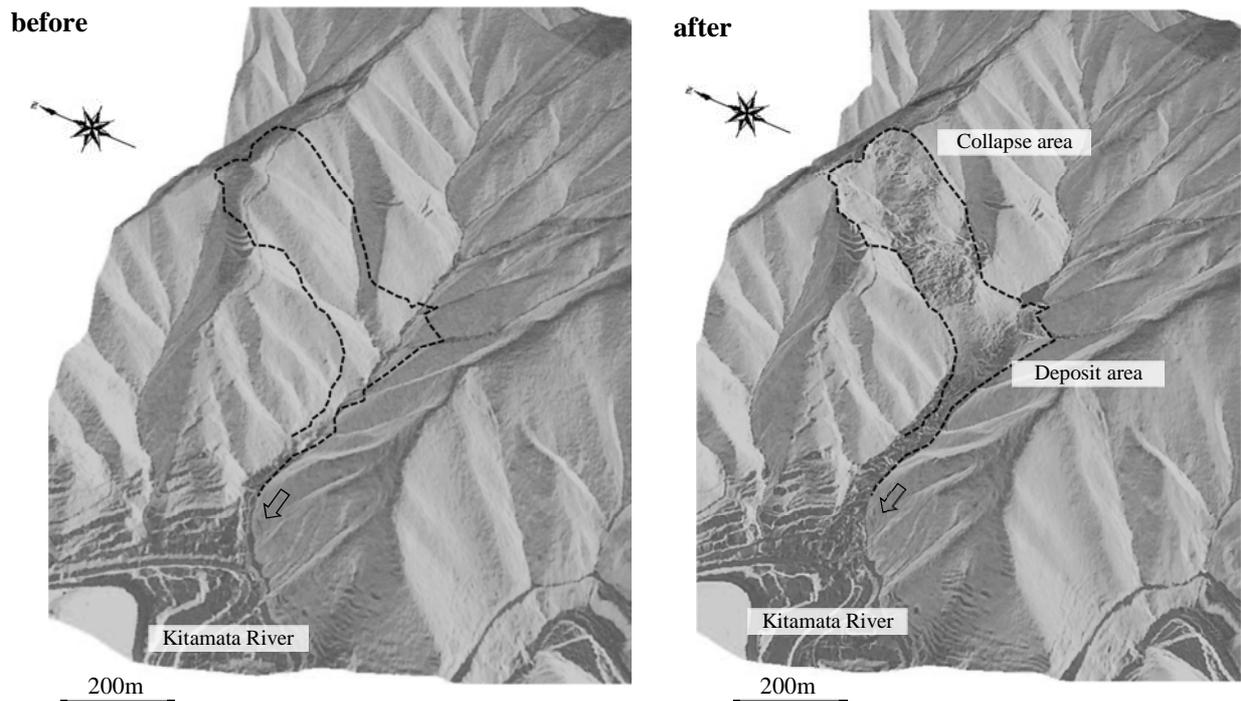
Fig.2 Bird's-eye view of before and after the collapse

4 houses. **Fig. 2** shows the gradient map based on the DEM data before and after the collapse. The collapse was generated involving flat surface of a ridge, according to the inclined view before the collapse. DCL has occurred in the convex slope above the two small tributaries and the catchment area is almost same as the collapsed area. According to the LiDAR topographic map and aerial photographs before the collapse, clear linear depressions are seen in the summit area and creep terrains are seen on the slope. We can guess that the slope had been gradually deformed by gravity.

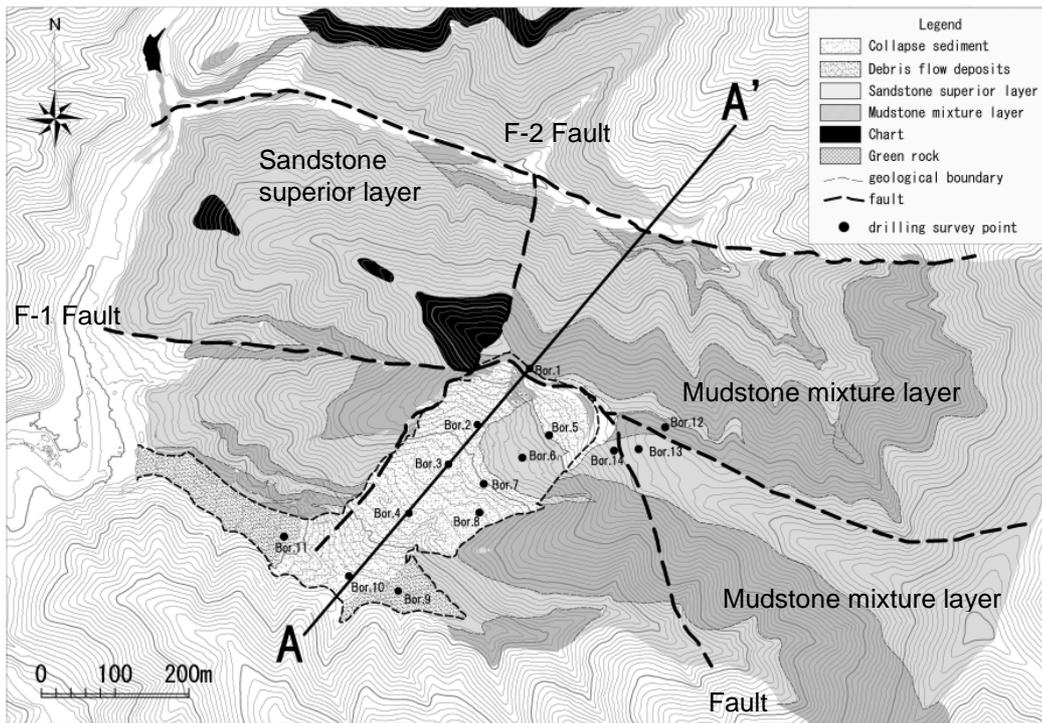
Fig.3 Geological map

A geological map of area near collapse is shown in **Fig. 3** and an estimated geological cross-section in **Fig. 6**. Slope inclination before the collapse is around 35° and gentler than other DCLs that occurred by Typhoon Talas at the same period. For example, the slope of the Nagatono district and Akadani district shows 40°. DCL has occurred along the ridge in the east-southeast to west-northwest direction where F-1 fault with south-facing scarp is distributed and head scarp of the DCL was formed there. It is very loose around the F-1 fault and mineral veins are developed. In addition, F-2 fault is distributed on the west side of the collapse in the north-south direction.

As shown in **Fig. 3**, catchment area including the DCL is only slightly larger than the area of the collapse. But, spring water is frequently observed immediately after the collapse from the steep cliff which is formed by DCL. It was assumed that occurrence of inflow of groundwater from outside the basin. According to geological survey, sandstone layers are found along the ridge. It is about 30 degree north slope, and it forms infacing dip. And the layers are cut by F-1 fault in the south slope and distributed in wedge-shaped, cut by F-1 fault in the south slope (**Fig. 4**). This wedge shaped sandstone is distributed continuously along the ridge and it make easy that the groundwater from the high- altitude area flows into the DCL site (**Fig. 6**).

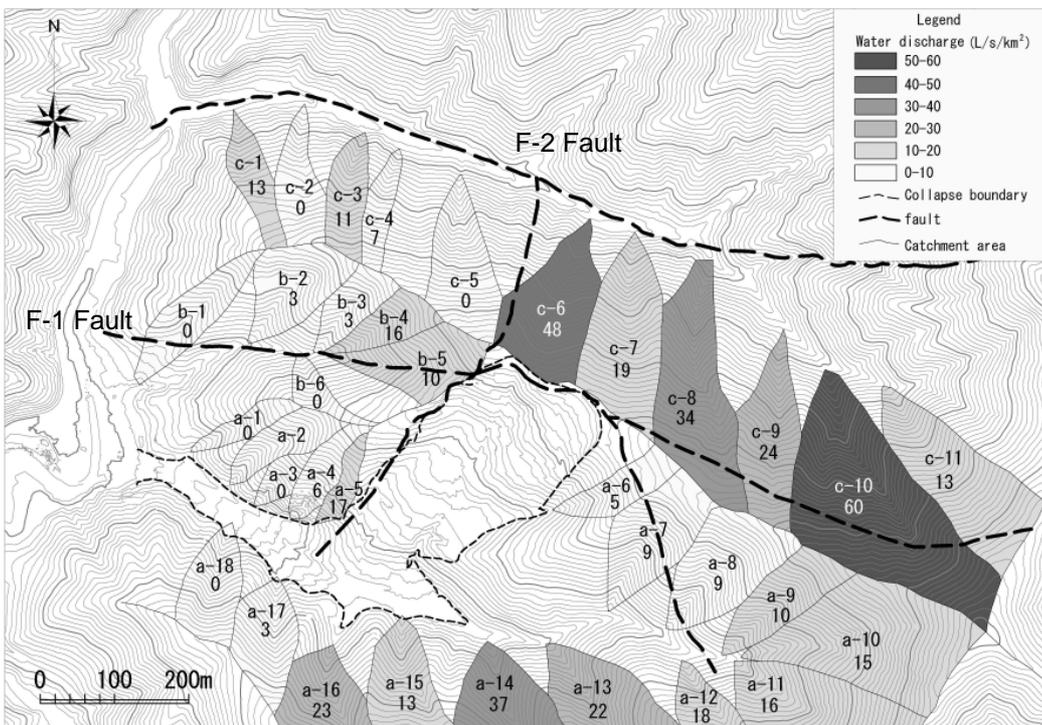
Fig.4 Specific discharge distribution map (Measured on December, 2012)

The ridge extends in the northwest to southeast direction above the head scarp of the DCL. In the northeast side of the ridge, the specific flow rate is high. On a contrary, the specific flow rate is low in the southwest side of the ridge. Specific discharge of catchment area c-8 and c-9 larger than that of catchment area a-6, a-7 and a-8. In addition, the flow rate in the northeastern side of the ridge that extends southwest from the head of the landslide is larger than the values in southwest side (c-6 larger than c-5).

discharge distribution map, a large difference can be seen in the specific water discharge in the upstream and downstream across the fault in the basin which is adjacent to the fault in the east-west direction and the fault in the north-south direction. The presence of a fault is considered to have an impact on the hydrogeological structure directly or indirectly. Accurate measurement of the flow rate is not performed in the collapsed slope because river water flows under the ground. However, there are paddy fields and traces in the area, so the flow rate is considered to be high.

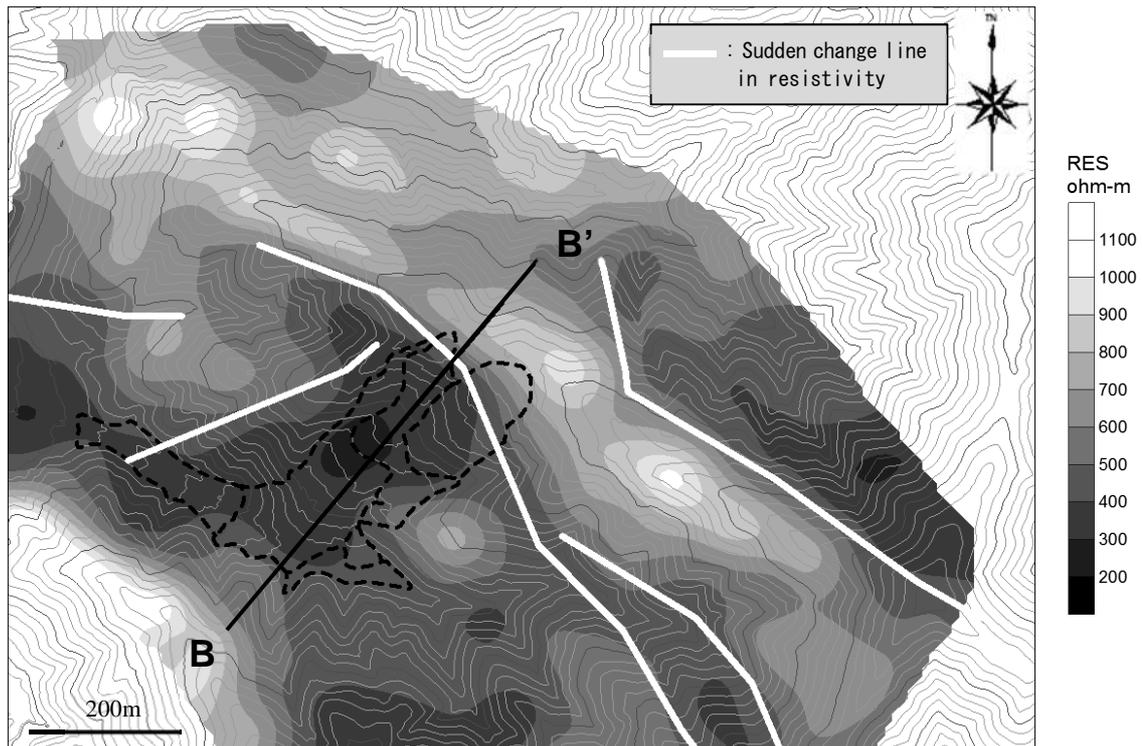
Fig.5 Resistivity distribution map view of the surface by airborne electromagnetic survey

The plan view of the surface portion of the resistivity by the airborne electromagnetic survey is shown in **Fig. 5** and the cross-sectional view in **Fig. 6**. Low resistivity zone distributed inside the landslide corresponds to the point of deposited sediment induced due to collapse. It is considered to represent condition of higher soil saturation. Since resistivity in the northeast side slope without collapse is relatively high in compared to the southwest side slope where the DCL occurred and the value becomes higher according to the depth

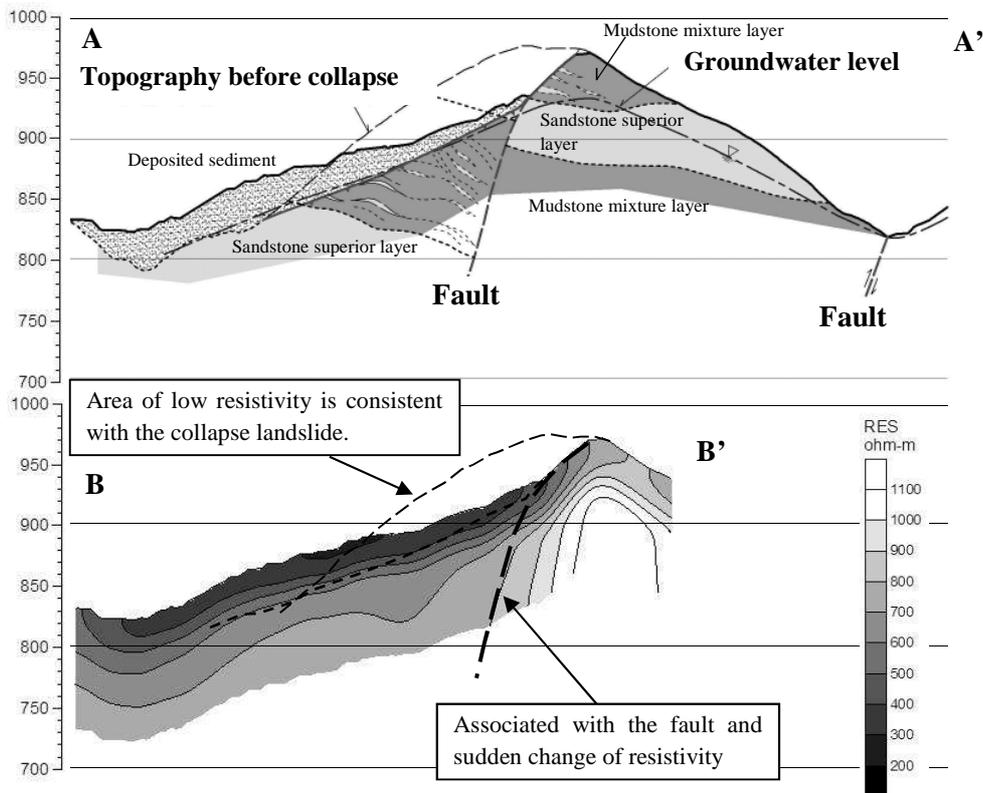
Fig.6 Geological cross-section of the landslide (upper) and resistivity cross-section

The bedrock geology of the landslide indicates that the predominant sandstone layer and mud mixed layer corresponding to Shimanto Belt Yukawa layer is distributed in alternate layers. Schistosity plane and bedding planes of these are repeatedly folded slightly along the fold axis of $N20^{\circ} \sim 30^{\circ} W$ in general and it shows structure of outfacing dip locally. However, the angle between collapsed surface and boundary layer of sandstone dominant and pelitic mixed rock is 20° to 40° . It is said that DCL occurred on the infacing dip in macro

scale shown as the cross section in **Fig. 6**. It is contemplated that strongly weathered bed rock has remained, which could have lost by outcrop of surface material such as shallow slope failure in case it would be dip slope. It is estimated that the DCL in Kitamata district has been regulated by the geological structure predisposition mentioned above and as following.

It is considered that the resistivity pattern represents the condition of the unweathered foundation rock. Sudden change in resistivity is found at the boundary between southwest slope where the collapse occurred and the northeast slope where the collapse did not occurred.

Similarly, the sudden change in resistivity is observed between the both sides of the ridge extending southeast to northwest of landslide. Sudden change of the specific resistivity is consistent with the position of the faults; F-1 fault in west-northwest to east-southeast direction faces along the head scarp of the collapse, and F-2 fault in the north-south direction that borders the west side of the collapse. It suggests that the existence of those faults is related to the sudden change of the resistivity.
