# Investigation and Studies of the Slopes along Chen-Yu-Lan River Watershed after Typhoon Morakot

Sung-Chi Hsu<sup>1,\*</sup>, Ming-Hung Liu<sup>2</sup>, Ji-Yuan Lin<sup>3</sup>, and Ming-Der Yang<sup>4</sup>

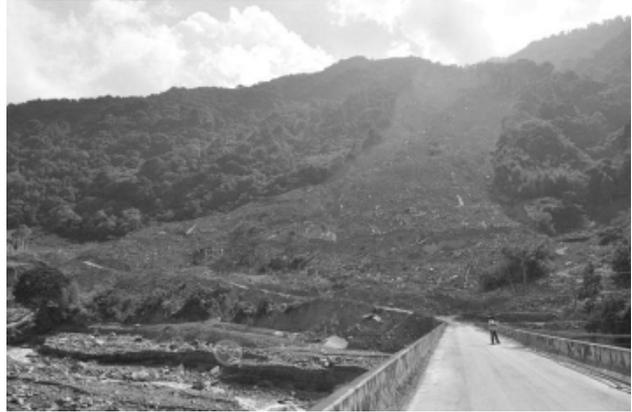
There are 24 landslides related to the failure from the upslope of the road. The cause of the slope failure is mainly due to the infiltration of extreme rainfall within two to three days and rise of groundwater level. An example of a large landslide is shown in **Fig. 2**. The height and length of the landslide are around 450m and 950m, respectively. About the failure at the downslope of the road, the major cause of the slope failure could be due to the scouring by the flood or the attack by debris flow from elsewhere, e.g. from the opposite site of the river. An example of constructing temporary pass using cargo containers is shown in **Fig. 3**. A huge landslide had originated from the upslope due to the heavy rainfall, and caused the failure surface to extend below the road.

**Fig. 2** A large landslide initiated from the upslope

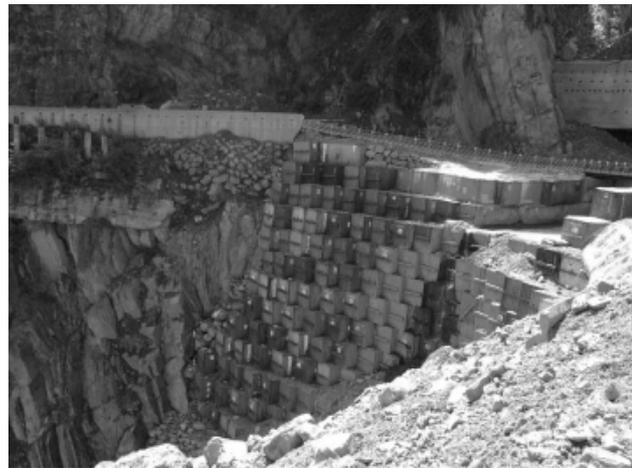
**Fig. 3** A temporary pass using containers is constructed after a large slope failure (Provided by Directorate General of Highways, Taiwan)
