# Monitoring a rockslide in development

Ingrid Skrede<sup>1</sup>; Lars Harald Blikra<sup>1</sup>; Lene Kristensen<sup>1</sup>

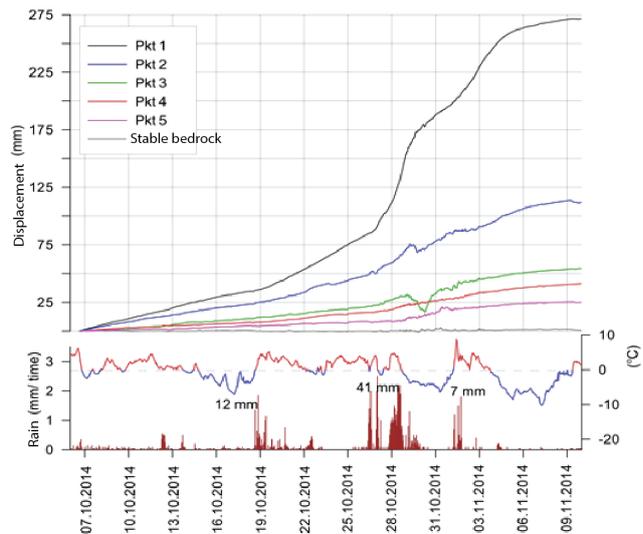
The data showed that part of the rock slope moved 45 mm during the eight days of measurement. The moving area was 6000 m<sup>2</sup> which is only a small fraction of the defined scenarios of Mannen, and for this reason it was named „Veslemannen“ (The small man“). During a heavy rainfall the 21 th of September 2014 displacements rates increased dramatically, giving displacement rates that were five to ten times greater than the initial speed. In

landslide monitoring acceleration is used to predict when a failure is likely to occur. Due to the increased and rapid displacement rates the radar was reinstalled the 6th of September 2014 and measurements have continued ever since. In the time that followed the displacement rates increased several times and several acceleration phases were registered. The acceleration was at its greatest after a heavy rainfall the 28th of September 2014 when the speed was over 80 mm/day in the fastest moving area. At this time it was expected that a failure would occur shortly. People had been

Figure 1. Registered movement between the 6th of October 2014 and the 9th of November 2014 in five points in the moving area and a reference point outside the moving area.

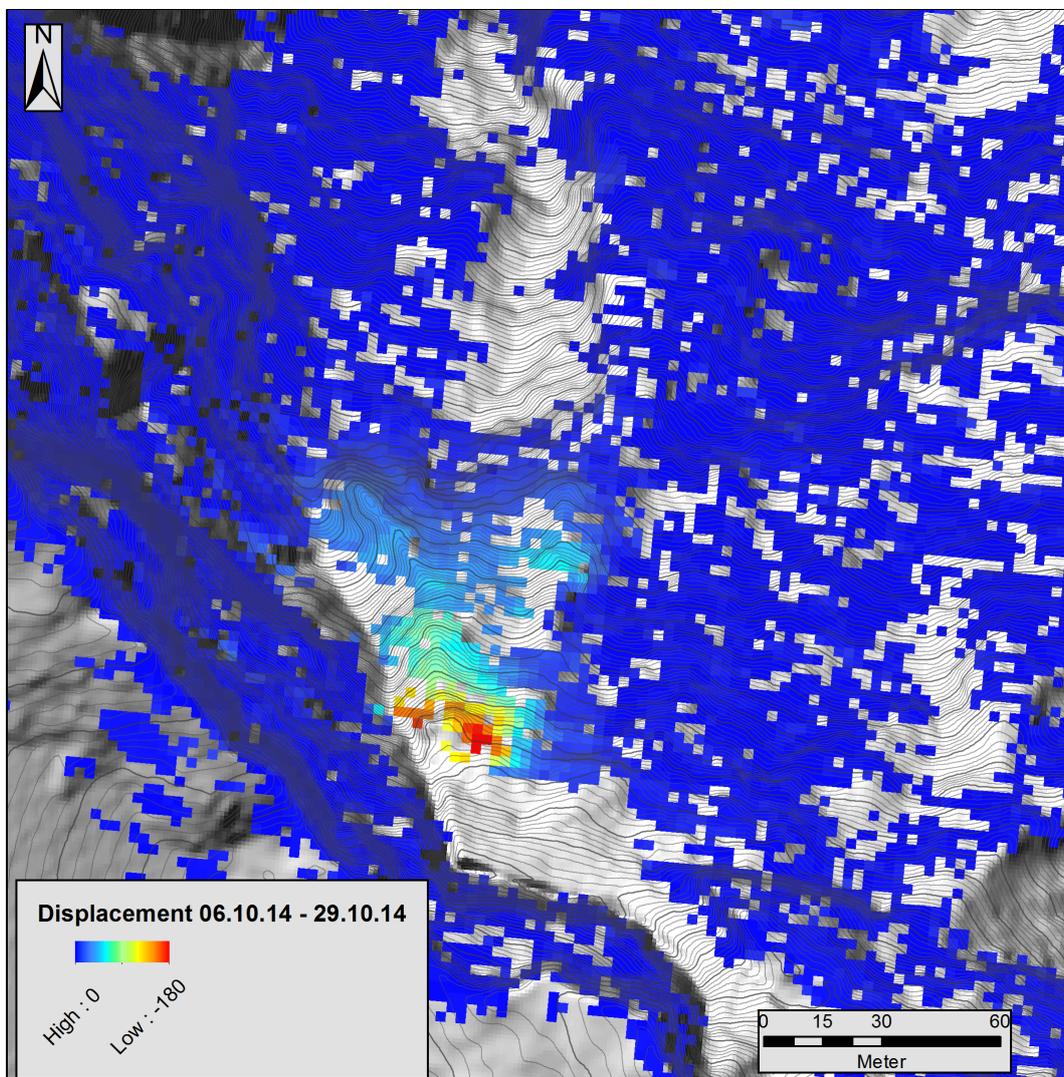
Figure 2. A georeferenced cumulated radar image from the second campaign show that the displacement is greatest in the upper part of the moving area.
