Investigation on slope disaster and failure mechanism of Yi-Shing area in Taiwan

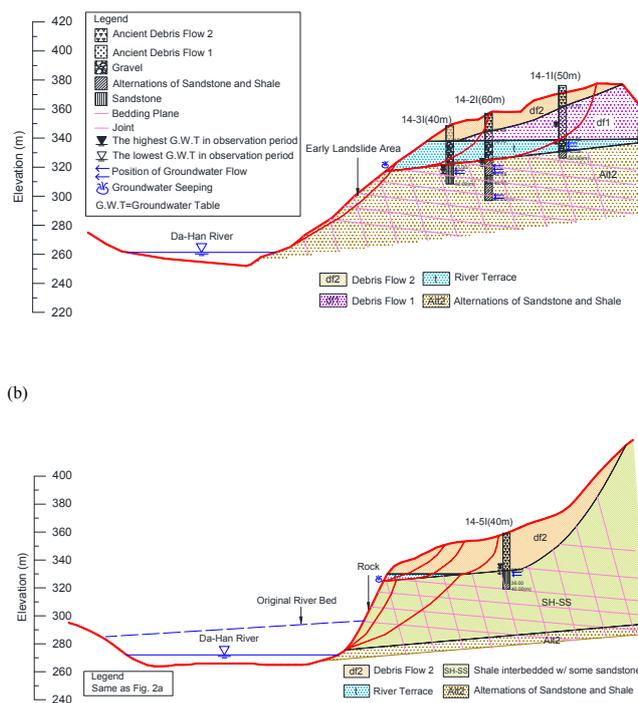
Base on the geological exploration results, Yi-Shing region was classified into two areas. (1) Area I: The region of disaster caused by Nari typhoon. The layer deposits of Yi-Shing region consisted of rock, river terrace and debris flow deposit layer based on the results of geology bore drilling. Slope landslide had been occurred here in early years mentioned above, and cliff had affected the above roads and houses. So the river terrace and debris flow deposit layer behind the cliff was easily to develop back progressive slope failure. The collapse mechanism was considered as landslide. (2) Area II: The toe of the slope erosion by river. Two existed groups of joints showed high dip angles and rock mass were crushing. The joint plane was sandwiched mud with shear crack and water leakage could be observed, and this was likely a symptom of slip-page. In addition to wedge failure or overturning failure, it is considered that the joint parallel to the slope connected together to form a sliding surface will possible trigger a large scale landslide disaster again.

Figure 1. Cross section of landslide mechanism (a) Survey Area I and (b) Survey Area II

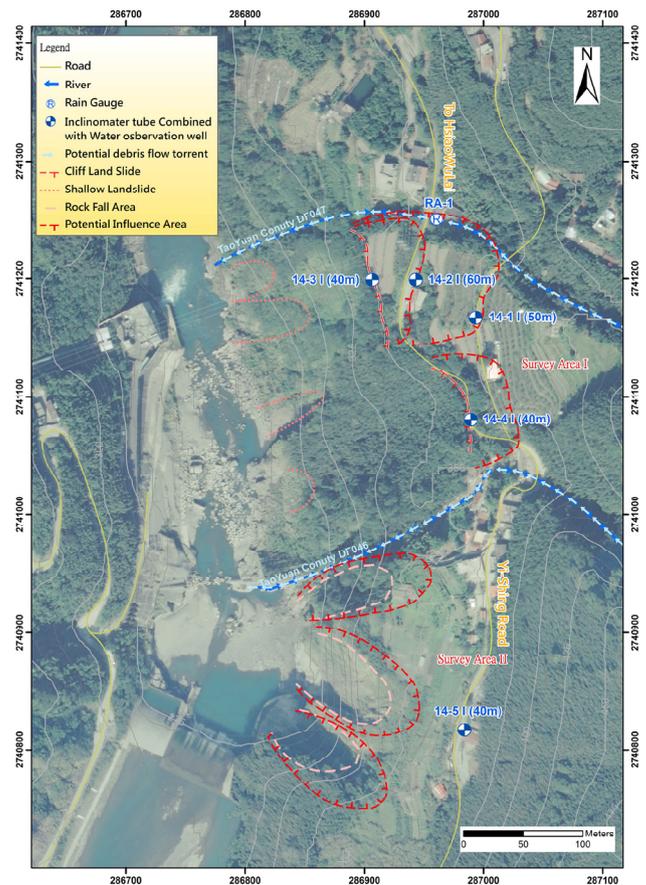
Figure 2. Plan view of the landslide range
