# Geologic and Topographic Features of Slope Failure Sites in the Aso Caldera Wall Induced by the 2016 Kumamoto Earthquake

Large-scale earthquakes can trigger slope failures. To effectively implement countermeasures to mitigate damage caused by slope failures, it is necessary to identify locations where the risk of slope failure is high. The geologic and topographic features of slope failure in the Aso Caldera wall induced by the 2016 Kumamoto earthquake were examined as a case study. The geology was roughly divided into three categories: pyroclastic flow deposits, andesite, and talus accumulation. The elevation, slope, and curvature were calculated using geographic information system (GIS) software and a digital elevation model (DEM) obtained before the earthquake; these parameters were then used as topographic indices. The analysis results showed that slope failures occurred most densely in the pyroclastic flow deposits. Within this geology, slope failure frequency increased proportionally with slope, and more slope failures occurred at sites with a positive curvature (i.e., convex slopes). There was no relationship between elevation and slope failure. We conclude that sites wit

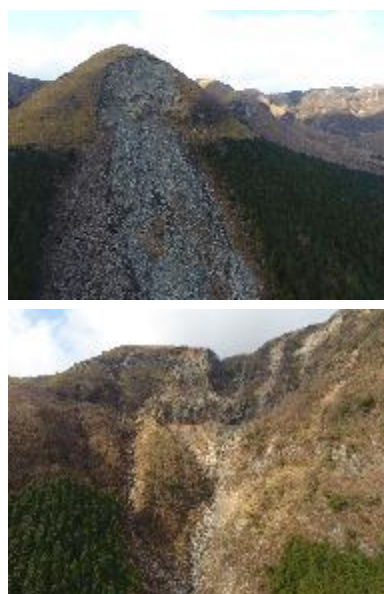
A series of earthquakes with epicenters mainly in Kumamoto Prefecture, Kyushu Region, Japan, occurred in April 2016. The main shock of the 2016 Kumamoto earthquake on April 16 had a maximum seismic intensity of 7 on the Japan Meteorological Agency (JMA) 7-stage seismic scale and a JMA magnitude of 7.3. The Aso Caldera is a large caldera in Kumamoto Prefecture that was formed by catastrophic eruptions 270,000–90,000 years ago, and which measures about 17 km in the east–west direction and about 25 km from north to south. A JMA seismic intensity of 6 lower occurred in the Aso Caldera wall, which resulted in numerous slope failures and extensive damage (**Fig. 1**).

**Fig.1** Photographs of slope failures in the Aso Caldera wall (taken by the authors, December 19–20, 2017)

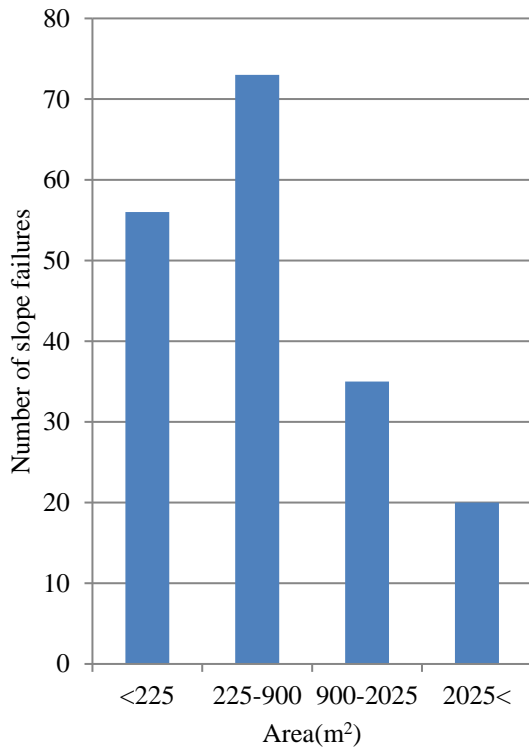
**Fig.3** Area of slope failure sites

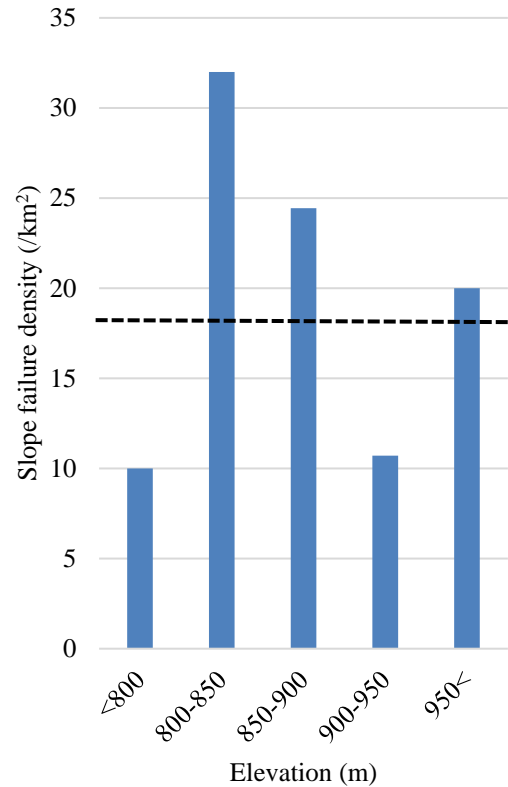
**Fig.4** Slope failure density for each elevation class within the pyroclastic flow deposits

The slope failure density for each elevation class is shown in **Fig. 4**. The average slope failure density in the pyroclastic flow deposits ( $18.4/\text{km}^2$ ) is indicated by a broken line. In the 800–900 m and  $> 950$  m classes, slope failure density was larger than  $18.4/\text{km}^2$ , indicating that slope failure occurred more frequently at these elevation ranges. Although some previous studies [e.g., *Jitousono et al.*, 1998] have suggested that slope failure density increases with increasing elevation, probably due to the amplification of seismic waves at high

elevation [Yamaguchi and Kawabe, 1982], the current study detected no such tendency. We concluded that there was no relationship between elevation and slope failure.

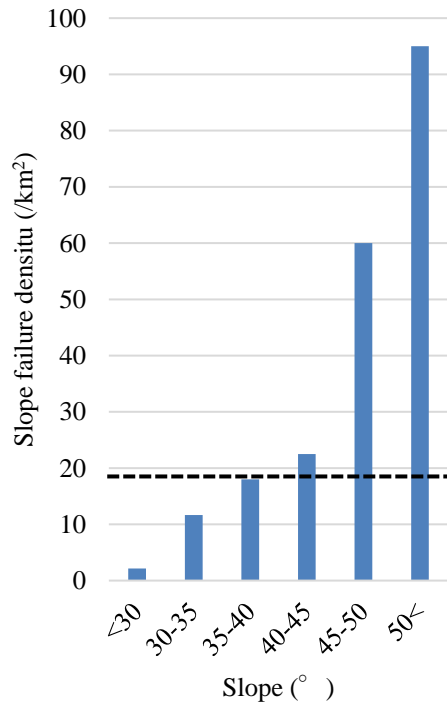
**Fig.5** Slope failure density for each slope class within the pyroclastic flow deposits

The slope failure density for each slope class is shown in **Fig. 5**. Slope failure density clearly increased with increasing slope, and the average slope failure density ( $18.4/\text{km}^2$ ) was exceeded in slope classes  $> 40^\circ$ . Therefore, slope was found to influence slope failure, with steeper slopes being more prone to failure, probably because downward force on an inclined soil mass increases as slope increases, as has been reported in many previous studies [e.g., Okimura et al., 1997].

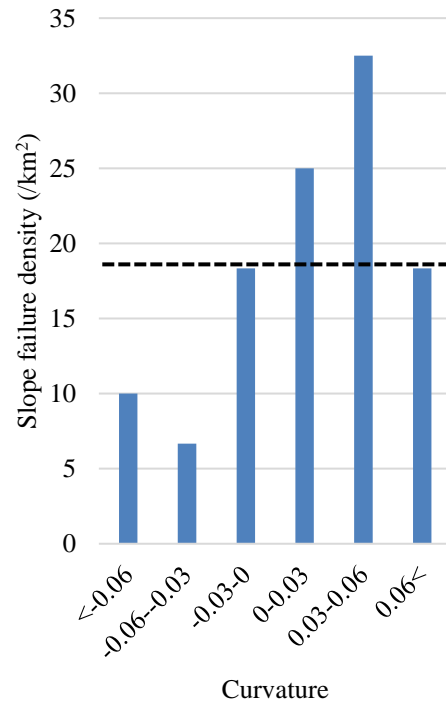
**Fig.6** Slope failure density for each curvature class within the pyroclastic flow deposits

The slope failure density for each curvature class is shown in **Fig. 6**, which demonstrates that the average slope failure density was exceeded for curvatures between 0 and 0.06. This finding suggests that a convex slope is more prone to slope failure, likely because seismic waves are amplified at convex slopes [Yasuda et al., 2006; Nishida et
