Effect of Emergency Measures to Minimize Debris Flow Disaster after the Pyroclastic Material Deposition in Gendol River due to the 2010 Eruption of Mt. Merapi, Indonesia

Naryo Widodo, ST., MT¹, Suyanto, ST., M.Tech², Ir. Tri Bayu Adji, MA²
and Masaharu MIZOGUCHI^{3*}

¹ Mt. Merapi Lahar Control Office, Ministry of Public Works and Housing
(Jl. Magelang Km.4, Yogyakarta 55244, Indonesia)

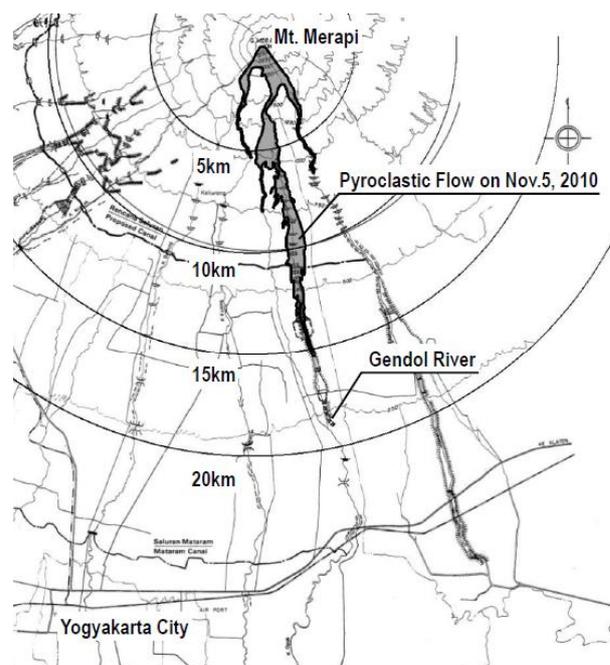
Fig. 2 Pyroclastic flow occurred on Nov. 5, 2010

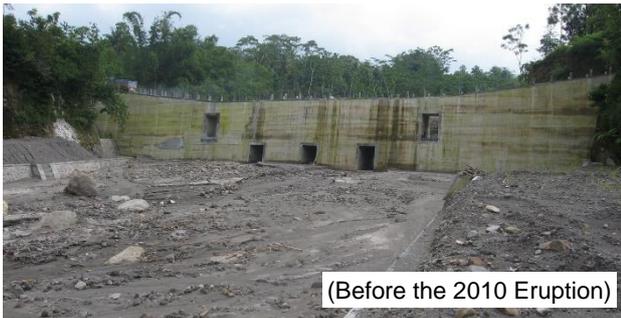
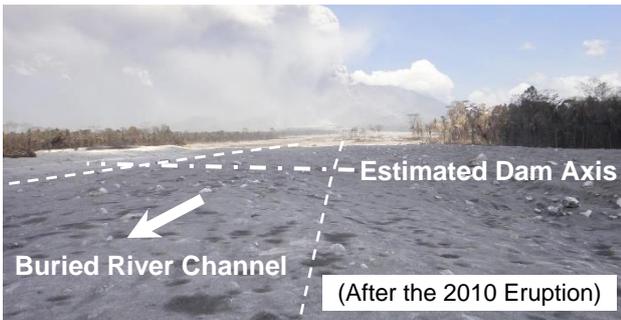
Fig. 3 Riverbed aggradation due to the pyroclastic flow deposition at sabo dam GE-C13, 11 km from the summit

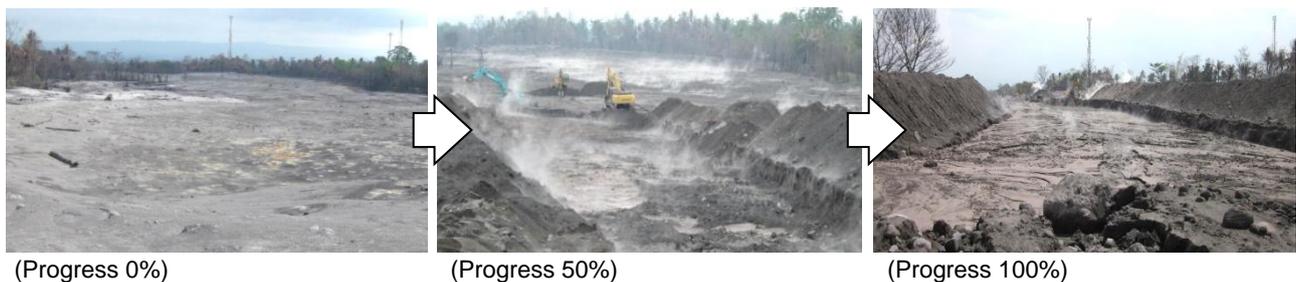
Fig. 6 Situation of the construction work

The heavy equipment used for this construction work was a backhoe and a bulldozer for general construction work (see Fig. 6). Although the construction period was in the rainy season, the construction work could be proceeded during a sunny time because of a simple construction work. Since the construction work had to be interrupted when heavy rain came or debris flow occurred, it was carried out not only on weekdays but also on Saturdays and Sundays. Because debris flow often occurred during the construction period, deposited debris flow material also needed to be removed as mentioned in (b) above. As a result, total 1.3 million m³ of pyroclastic flow and debris flow deposits could be excavated during the construction period of

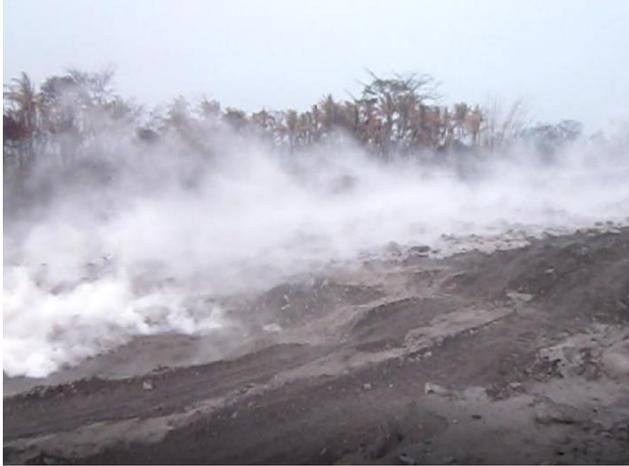
Fig. 7 Debris flow flowing in the guide channel under construction (December 30, 2010)

As a result, this simple guide channel was effective enough to prevent flooding of debris flow by guiding it to downstream. **Fig. 7** shows that the debris flow flowing in the guide channel under

construction. Despite the high frequency of debris flow occurrence, flooding of debris flow did not occur in the section where the guide channel was constructed. After the occurrence of debris flow, debris flow sediment accumulated on the channel and raised the riverbed maximum 2 m. On the other hand, debris flow often caused maximum 2 meter wide lateral erosion on the foot of the embankment. Maintenance work to remove the accumulated sediment and to fix the partially eroded embankment were required after the occurrence of major debris flow.

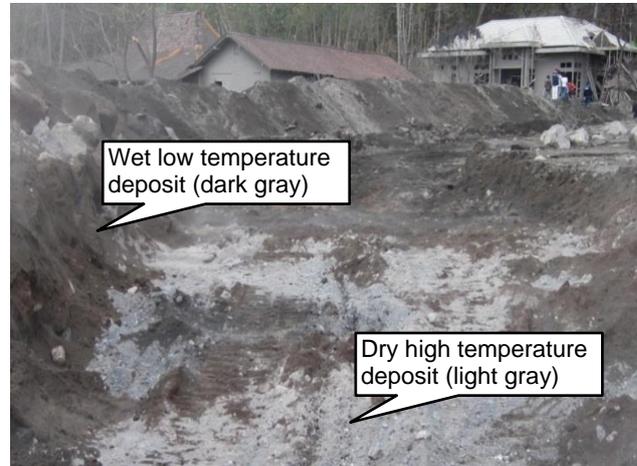
Fig. 8 Difference in color of pyroclastic flow deposit by temperature

Because it rained frequently, the surface of the pyroclastic flow deposit was wet and relatively low temperature, while the interior of the deposit, 30 cm deep or more from the surface, were dry at high temperature of 90 degrees centigrade or more. However, we had no choice but to use a general heavy equipment. High temperature pyroclastic flow deposit immediately after the excavation (light gray soil in **Fig. 8**) often caused the hydraulic pressure hoses of heavy equipment to damage and the shoe

sole of construction workers to melt. These damage affected the progress of the construction work. Since the heavy equipment had to be operated manned, there was the possibility of encountering unexpected disasters.

In order to improve the efficiency and safety of construction, it is ideal to introduce heat-resistant heavy equipment and unmanned construction system. However, it is not always possible to introduce the ideal system for emergency measures in all volcanoes. Further research is necessary for temperature change of pyroclastic flow deposits, but the measures introduced here may be applicable to similar cases in other volcanoes.
