Maintenance of Historical Sabo Facilities by the Tateyama Mountain Area Sabo Office - An Evaluation of the Soundness and Utility of Sabo Facilities -

This paper examines recent efforts by the Tateyama Mountain Area Sabo Office to maintain the Hongu Sabo Dam, a large sabo dam located in the middle reach of the Joganji River that has been designated a cultural property

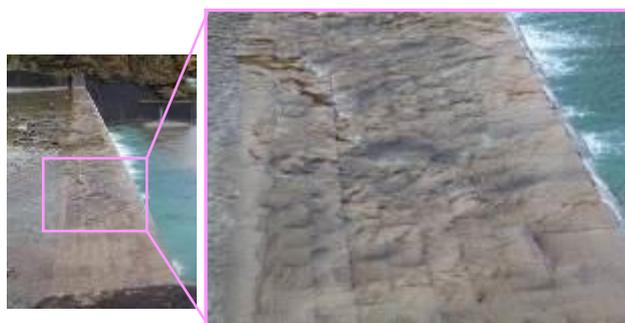
Fig. 8 Deterioration at the crest of the dam

Hongu Sabo Dam is a large-scale check dam constructed in the middle reach of the Joganji River. Recent inspections have found that some stone was missing or abraded at the crest of the dam, exposing the material in the interior (Fig. 8).

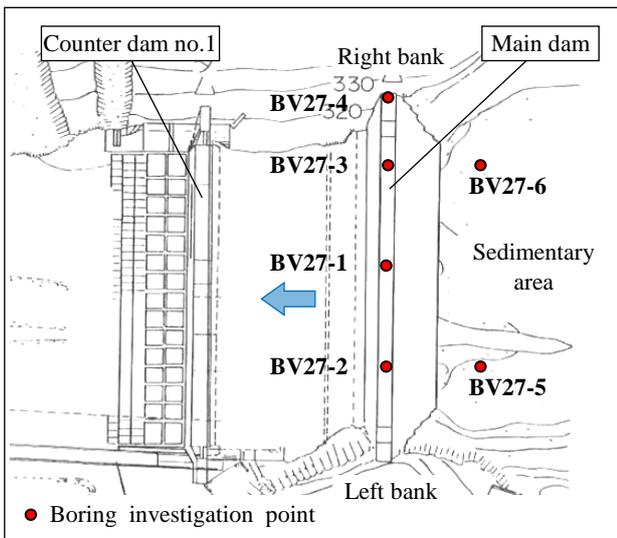
Fig. 9 Boring investigation point

Boring investigations were conducted at four locations (Fig. 8 and 9) at the crest of the dam where the interior rubble concrete was exposed. Water leakage and internal cracks were investigated within the borehole using a borehole video camera. Rubble concrete collected from four locations on the body of the dam permitted an evaluation of its physical properties in a laboratory investigation. The sedimentary area was also investigated at two locations, including observations of the sediment condition and water level.

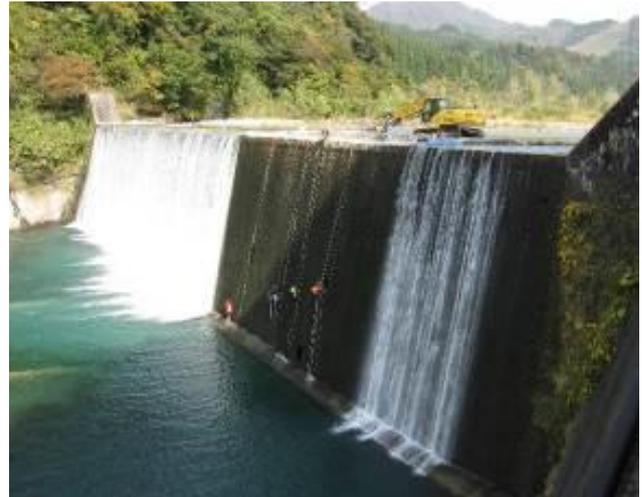
Fig. 10 Detailed visual inspection

To confirm the material, color, shape, arrangement, and condition of the stones used at the crest and downstream of the Hongu Sabo Dam, a detailed visual investigation was conducted (Fig. 10).

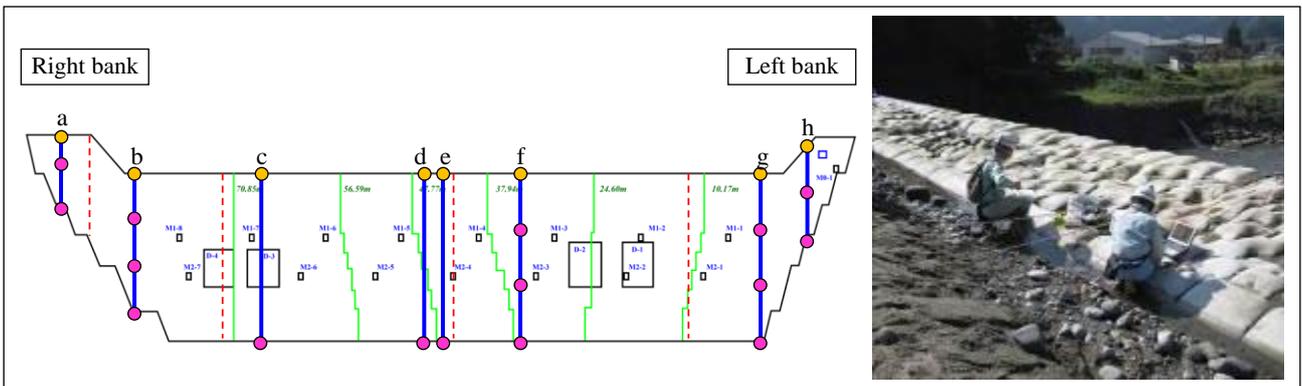
Fig. 11 Elastic wave exploration

The elastic wave exploration was conducted along eight lines (eight sections) as shown in Fig. 11.

Hongu Sabo Dam, as an 80-year-old rubble concrete structure, was expected to have a low elastic wave velocity. However, contrary to expectation, the elastic wave velocities exceeded 4.4 km/s in all sections. From these results and those of the aggregate and cement that form the rubble concrete of the dam interior, the dam materials remain firmly adhered to each other and are considered to be hard.

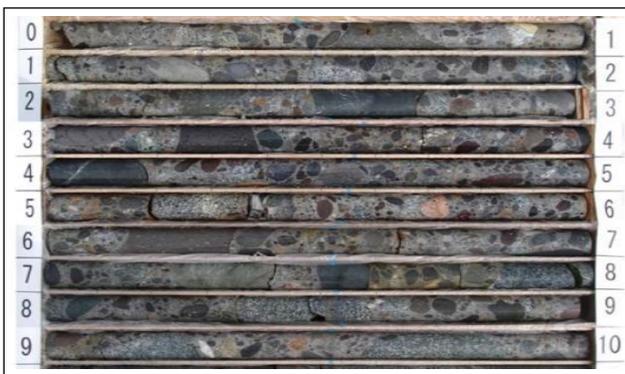
Fig. 12 Example of a boring core picture (BV27-1 0.0–10.0 m)

Rubble concrete within the Hongu Sabo Dam consists mainly of 3- to 4-cm gravel and stones (rubble) with diameters ranging from 10 to 30 cm. The boring core did not exhibit many cracks, and almost no cracks were found by the borehole video camera (Fig. 12 and 13). The aggregate and cement in the rubble concrete were firmly adhered, unweathered, and hard. Therefore, the condition of the rubble concrete within Hongu Sabo Dam was determined to be in good condition (Table 2).

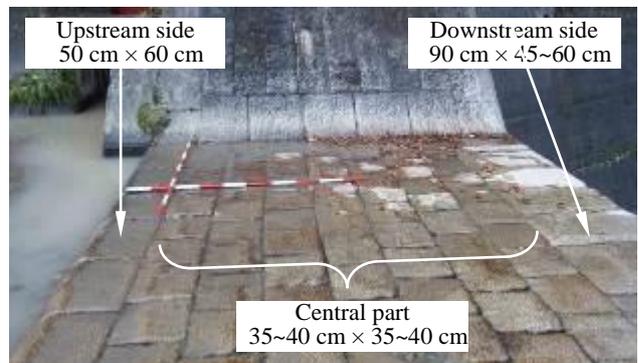
Fig. 14 Stone material on the crest of Hongu Sabo Dam

As a result of detailed investigation, the material, color, shape, and arrangement of the stones used in the crest and downstream of Hongu Sabo Dam were confirmed. The following signs of deterioration were also detected (Table 3, Fig. 14–16). The stone at the crest of the dam and the mortar in the joints were abraded. No damage to the stone on the upstream or downstream sides of the crest of the dam was detected. Seven central rows of stone and mortar at the crest of the dam were missing, over a maximum area of $2 \text{ m} \times 2.5 \text{ m}$ and a depth of 0.4 m.

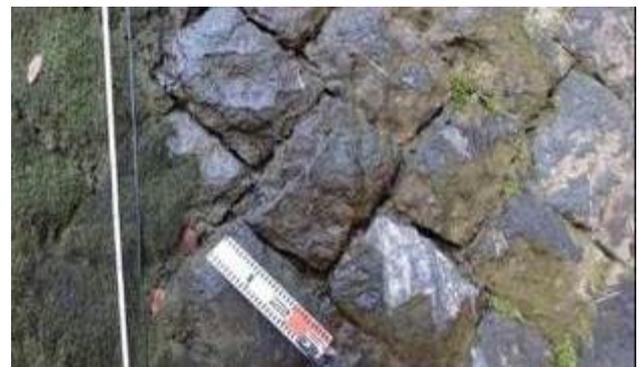
Fig. 15 Stone material downstream of Hongu Sabo Dam

In the past, abrasion countermeasures were implemented downstream of the Hongu Sabo Dam; abrasion was found to have occurred again in a downstream part of the dam.

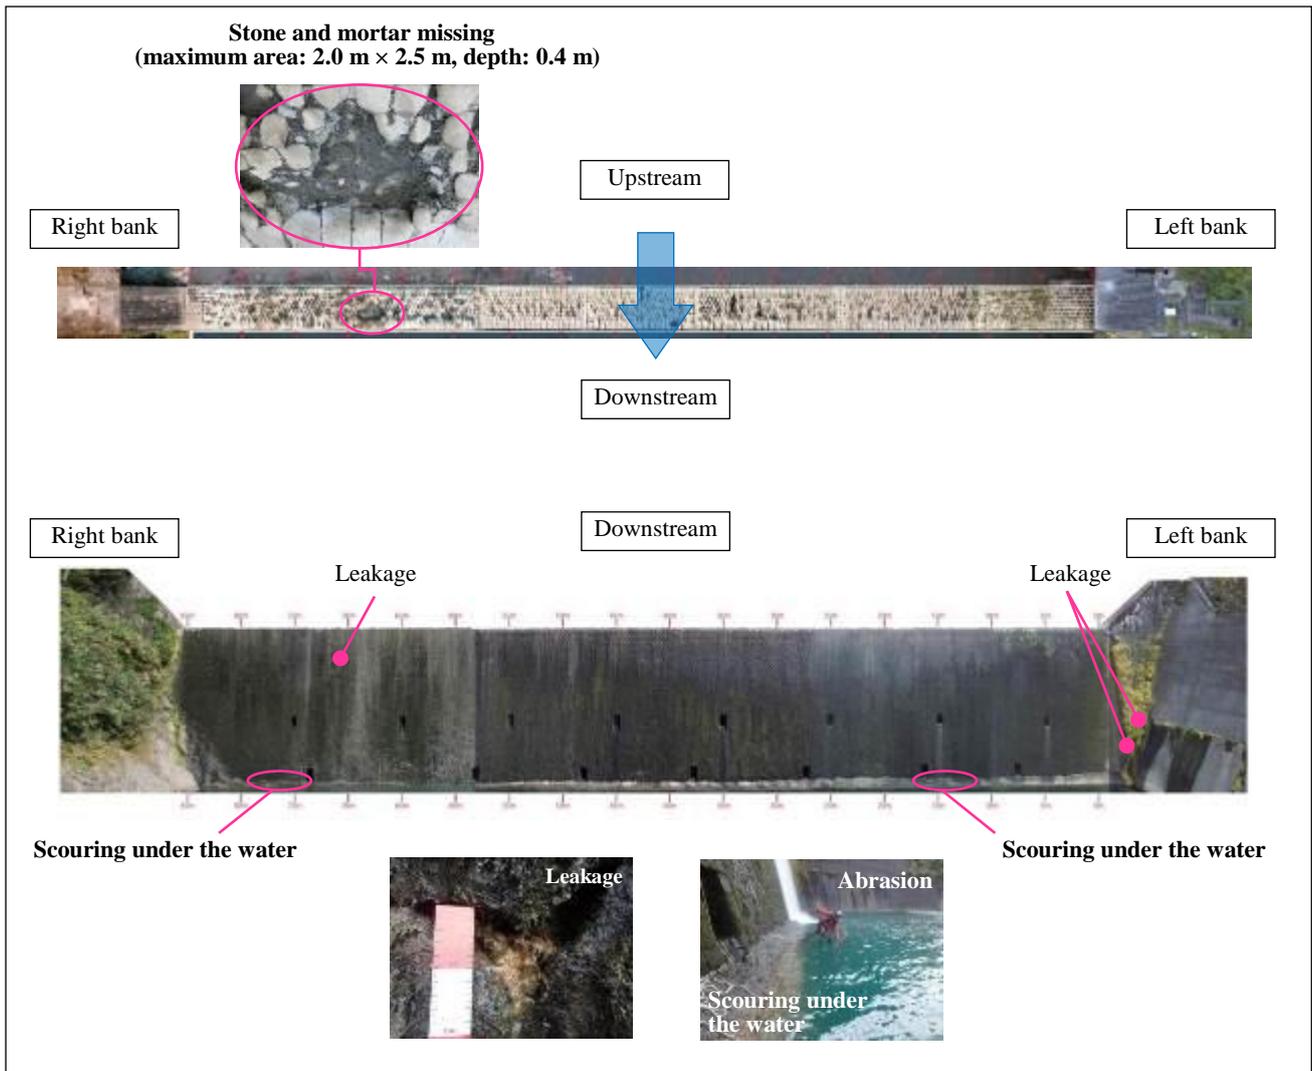
Fig. 16 Main deterioration on the crest and downstream of Hongu Sabo Dam

As a result of the boring investigation, visual inspection, and elastic wave exploration, two types of damage were identified: missing stone material and mortar at the crest of the dam, and re-abrasion of repaired concrete downstream of the dam, which has the potential to cause loss of function in terms of

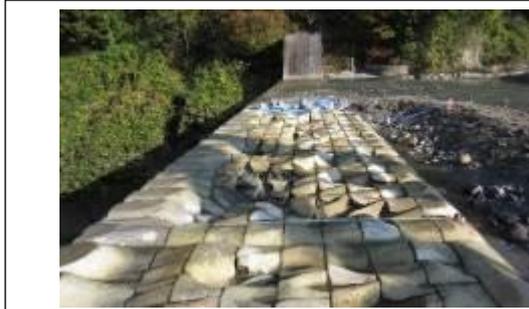
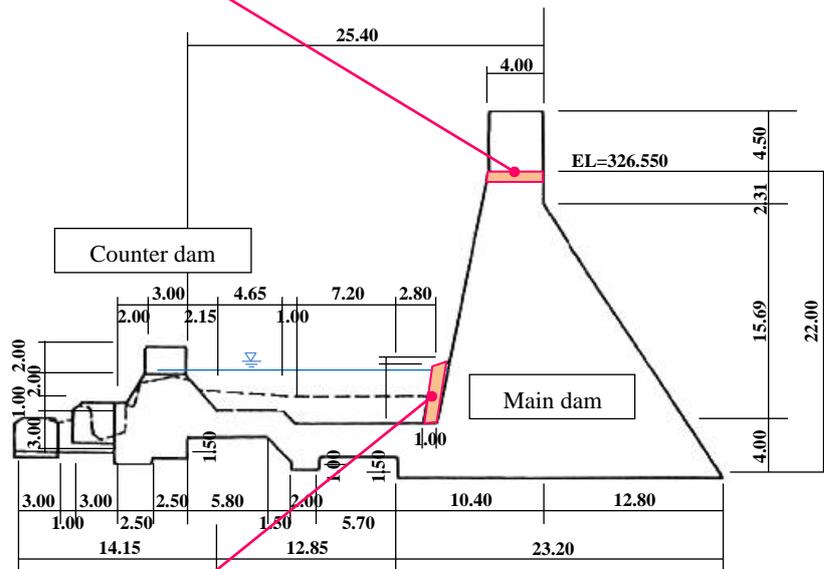
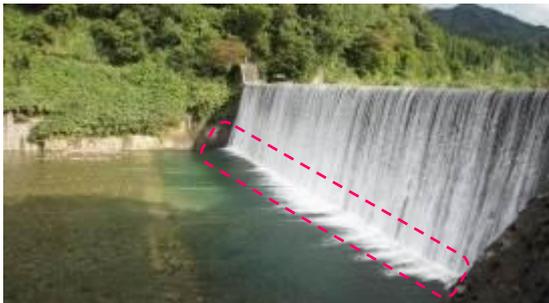
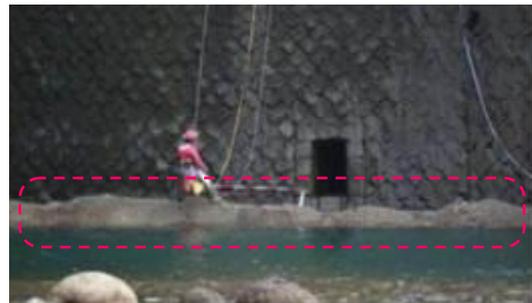
Fig. 17 Timing of repair measures

detected during the inspection described in this report will continue to be monitored. Rubble concrete within Hongu Sabo Dam was determined to be in good condition. As such, the dam did not require immediate repair. In the future, extensive damage or large missing stone sections upstream or downstream of the dam crest will initiate repair actions beginning at the dam ends (Fig. 17).

In the future, when a large stone is missing from the upstream or downstream side of the dam crest, repair will begin at the dam crest.

Future repair will start when scouring or abrasion reaches the dam foundation.
