Subsurface Investigation and Landslide Monitoring as a Basis for Planning Protection Measures - Case Study Doren Landslide -

Thomas FRANDL¹ and Margarete WÖHRER-ALGE¹

¹Forest Technical Service for Torrent and Avalanche Control, Regional Office Vorarlberg, Austria

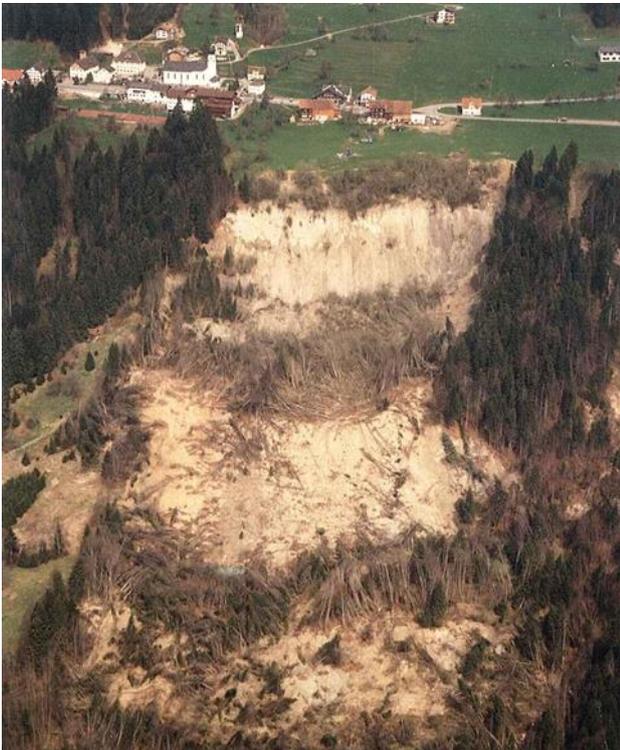
Fig. 1 Landslide area of Doren after the event of 1988. At the left side of the upper image border the center of the village Doren is visible.

The oral tradition about a landslide area on the orographic righthand side of the Weißbach river in close vicinity to the town center of Doren/Austria reach back to the year 1847. Mass movements in 1927, 1935, 1988 (see **Fig. 1**) and 2007 in each case involved the movement of 2 – 3 million m³ of material. In 1935 and 2007 the Weißbach was completely dammed up by this material, causing a lake of approximately 500 m in length behind the landslide deposit. Following the mass movement of 1935, the first geological investigations were carried out and drainage tunnels of circa 700 m length were mechanically bored and filled with coarse boulders for stability. The aim of the study is to find out the advantages and disadvantages of each system.

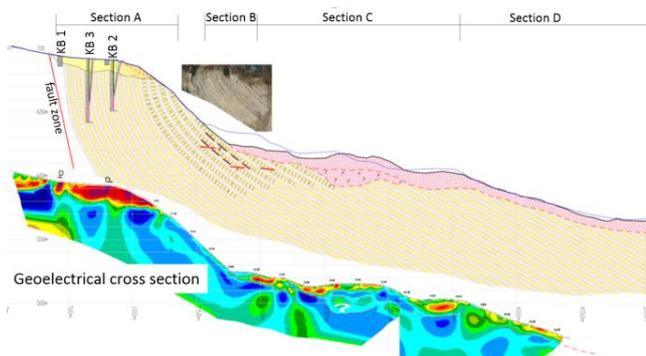
The geological subsurface in the landslide area consists of rocks of the so-called Weißach layers of the Lower Freshwater Molasse. The landslide area is divided into various sections (see Fig. 2):

- Section A: Terrace covered with quaternary sediments that lead to subordinate secondary slides in the upper sections of the head scarp.
- Section B: A scarp face of up to 70 m height with slope parallel marlstone and sandstone layers of the Lower Freshwater Molasse. The marl layers contain up to 45% swellable clay minerals and produce solid rock slips along the steeply inclined bedding planes that dip towards the valley bottom. These bedding planes consist alternately of formerly competent layers and incompetent layers.

- Section C: Rotational slide bodies at the foot of the scarp face that consist of loose rock masses, bedrock components that have slid downslope as well as moraine deposits that formerly overlay those bedrock components.

- Section D: Further downslope an approximately 600 m long earth and rock waste stream of loose rock masses that are predominantly saturated to the tributary Weißbach. [Van Husen et al., 2008]

Fig. 2 Schematical geotechnical cross section of the landslide with the different sections A, B, C and D.

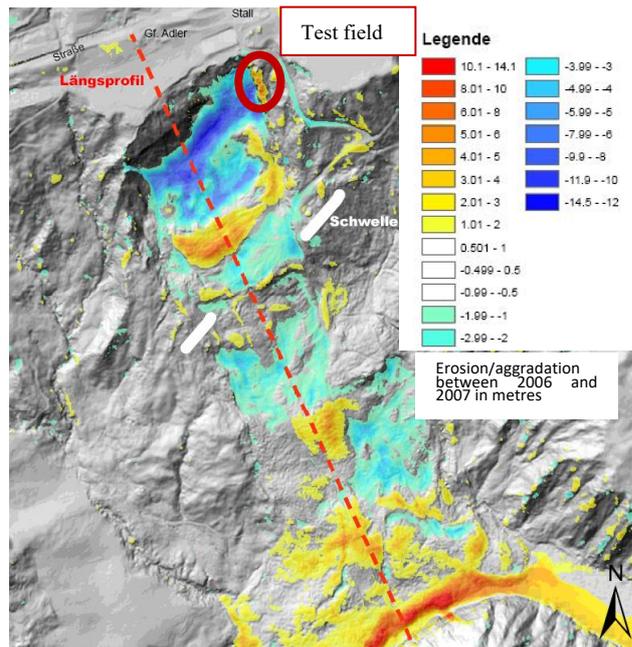
Primarily the slide affected the bedrock (interbedded strata of clay/marl/calcareous marl/sandstone), as well as the quaternary sediment cover. Today the landslide scar has the form of a conch and rotational slides are prevailing. The material in the accumulation area is creeping and flowing towards the axis of the river (earth/debris flow). The quaternary sediment cover atop of the Weißach strata provides supply of material to the earth/debris flow. The earth/debris flow is periodically mobilised by seeping water in the quaternary sediment cover and surface runoff. Fig. 3 shows the change in altitude between 2006 and 2007.

Fig. 3 Differences in the ground height between 2006 and 2007

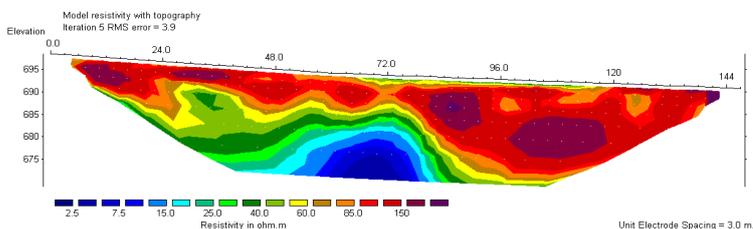
All profiles on the terrace showed a clear double segmentation in the distribution of resistivity (see Fig. 4). A horizon which shows a remarkable low resistivity [$< 40 \text{ ohm.m}$] is coated with a horizon of higher resistivity [$80 - 200 \text{ ohm.m}$].

Fig. 4 The cross section on the terrace shows a clear double segmentation in resistivity

The depth of the cover which shows high resistivity (glacial deposits) ranges between 1,09 m and $> 22 \text{ m}$.

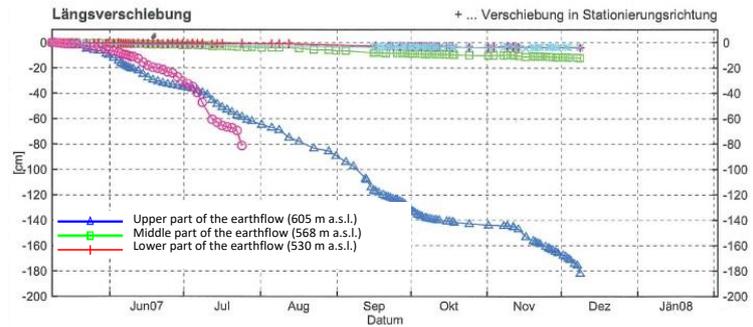
The survey points used to assess movement of the landslide had to be newly set numerous times following the high rates of movement in the years 2005 and 2007. Following the large surge of movement during Easter 2007, an automatic movement monitoring system was installed in May of the same year (see **Fig. 5**). In February 2010 it was decided to revert back to periodic manual measurements (of movement). This was due to financial reasons. At the first hints of a reactivation of the landslide, an automatic measurement can be reimplemented immediately, however.

Fig. 5 Longitudinal displacement of monitoring points in the Western part of the landslide Doren 2007.

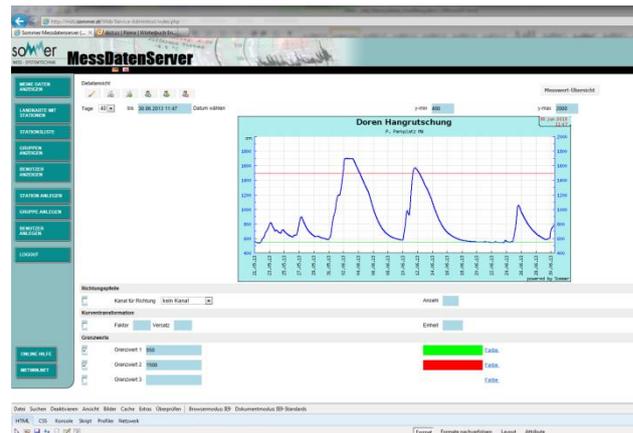
The water level in the probe drill hole (2010-13) was measured in part automatically with a gauge and in part manually with an electric contact gauge. Well discharges in the earth- and rock waste stream, discharges from horizontal drill holes at the foot of the scarp face as well as overflow of the vertical drill holes were all measured manually. All of the data does gathered provided important information about the ground water level within the landslide. During the heavy precipitation event from the 31st of May to the 1st of June 2013 the groundwater level in the drill hole situated in the conglomerates rose, with a temporal delay of only a few hours to the precipitation, approximately 12 m over the course of two and a half days (see **Fig. 6**).

Fig. 6 Chart of a groundwater gauge situated slightly above the Doren landslide during the floods in June 2013.

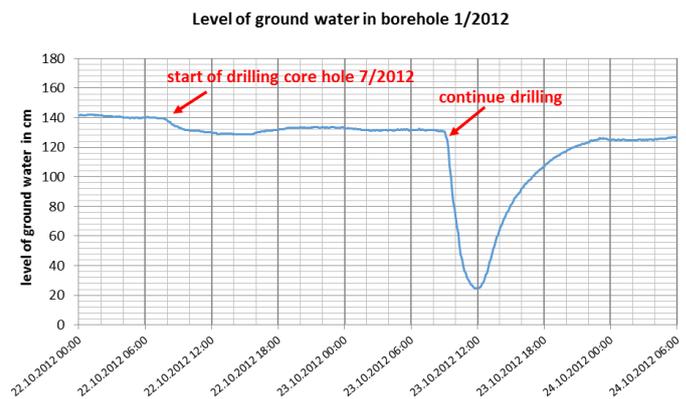
Robust gauge data loggers have proven to be very useful for speedy and mobile deployment. For example, they were used to establish the interrelation between the ground water level of two bore holes spaced 125 m apart, while boring was taking place at the site (see **Fig. 4**).

Fig.7 Response of the groundwater in the Doren landslide to drilling operations at a distance of 125 m.

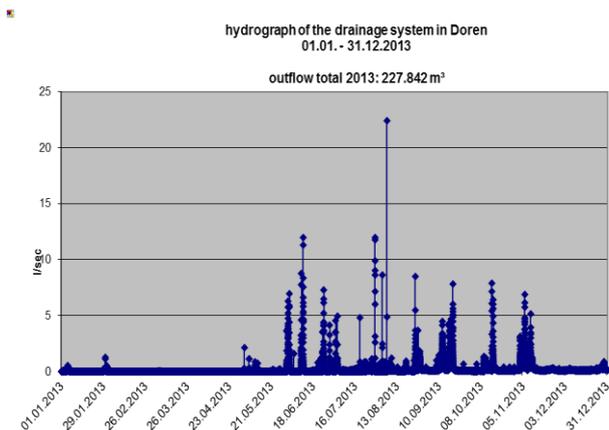
Measurements of the discharge from the subsurface drainage system allow inferences to be made about the size of the catchment area as well as the efficacy of the mitigations measures employed.

Fig.8 Hydrograph of the drainage in the landslide Doren 2013.

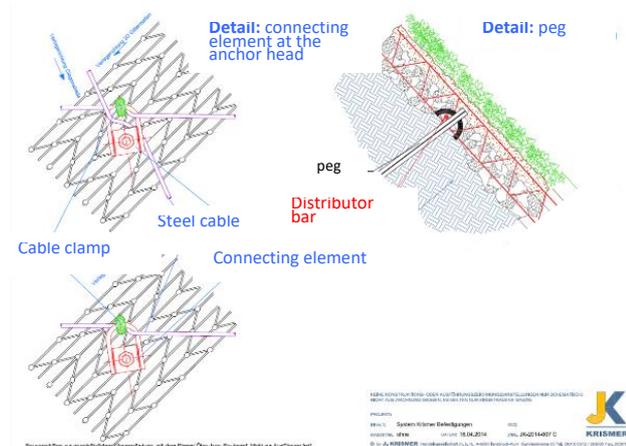
The Krismer-3D system is a three-dimensional steel wire mesh mat that forms a wire frame directly on top of the slope that needs to be secured. This wire frame is filled with angular particles of sizes 35-60 mm, over which a 1-2 mm thick humus layer is then applied and vegetated (see **Fig. 9** and **10**). This layered construction should provide a fast growing and well rooted biological protection measure against weathering. The criteria of geotechnical measurements are also met by this system. However, geologists in the provincial service have expressed misgivings that the system might in practice not be strong enough to withstand the resulting loads. Another disadvantage of the Krismer system concerns its installation: the steel wire mesh mats are delivered as separate parts, each 6

Fig. 9: Detail diagram of the Krismer-3D system

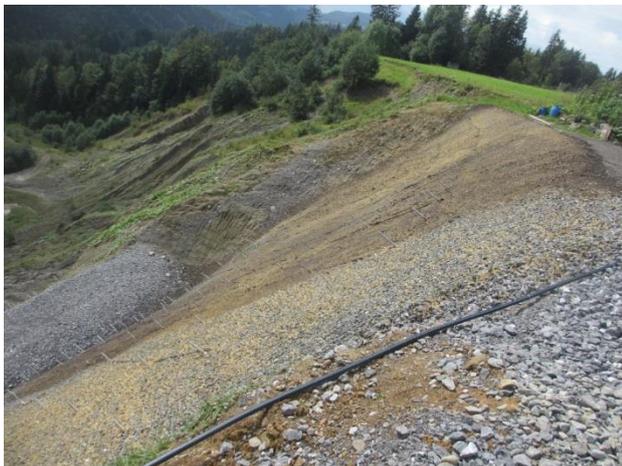
m² in size. These panels must be individually installed after all the nails or anchors have been set in the slope, following which, they must as a second step be filled. On slopes that are not too steep this presents no problem, however, on steeper slopes like that found in individual sectors of the Doren landslide (with over 80°), bringing the elements into place can be problematic and involves a significant effort. Moreover, on such steep slopes the filling material crumbles out of the wire frame holding it, thus losing its protective function against weathering processes.

All in all, the Krismer-3D system constitutes an appropriate solution to the problem in question here, as it forms a protective layer on the slope to be stabilized yet is water permeable, allowing water to be discharged from the slope through it.

Fig. 10 Krismer-3D system
