INTERPRAEVENT
2018 – Toyama, Japan

Large scale
sediment disasters
in orogenic zones
and countermeasures

Large scale sediment disasters
in orogenic zones and countermeasures

Symposium Proceedings

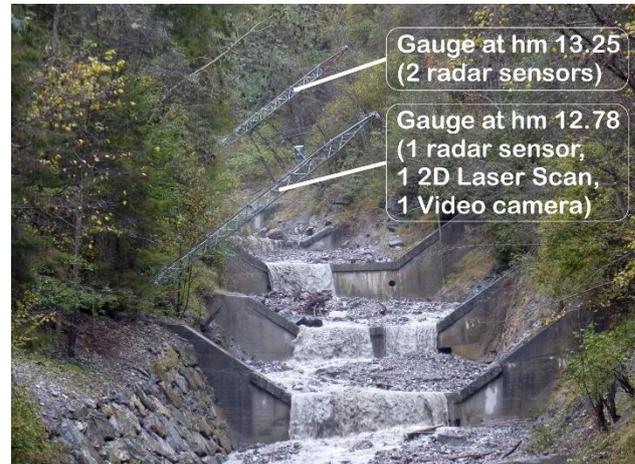
Fig. 2 Monitoring site “Grins” in the middle reach of Lattenbach, consisting of two single steel supports made of Garaventa elements with mounted sensors.

The discharge in the middle reach is calculated by the measurement of cross-section area and flow velocity with a frequency of 1 Hz. Therefore, three radar sensors for continuous level measurement, a 2D-laser scanner and a High Frequency Radar were chosen to collect the data (**Fig. 2**).

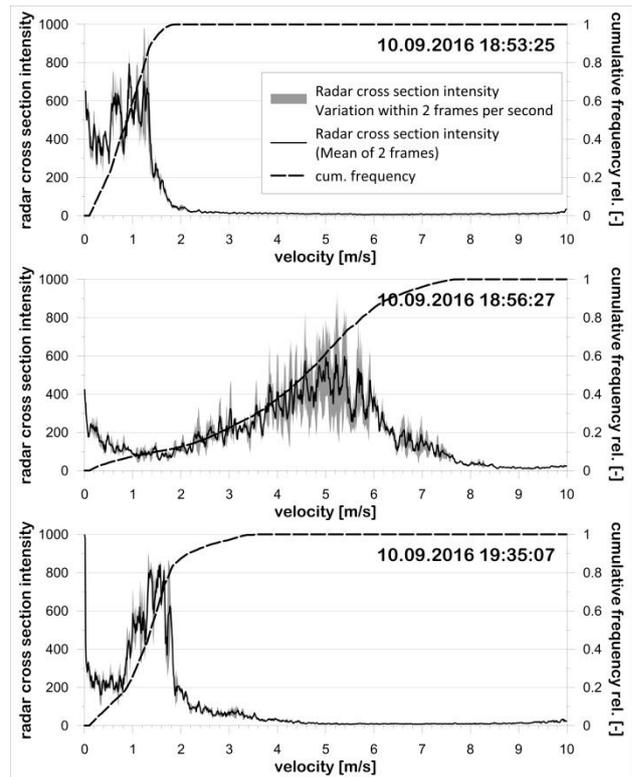
Fig. 4 Typical velocity spectrums of a debris flow surge at different times

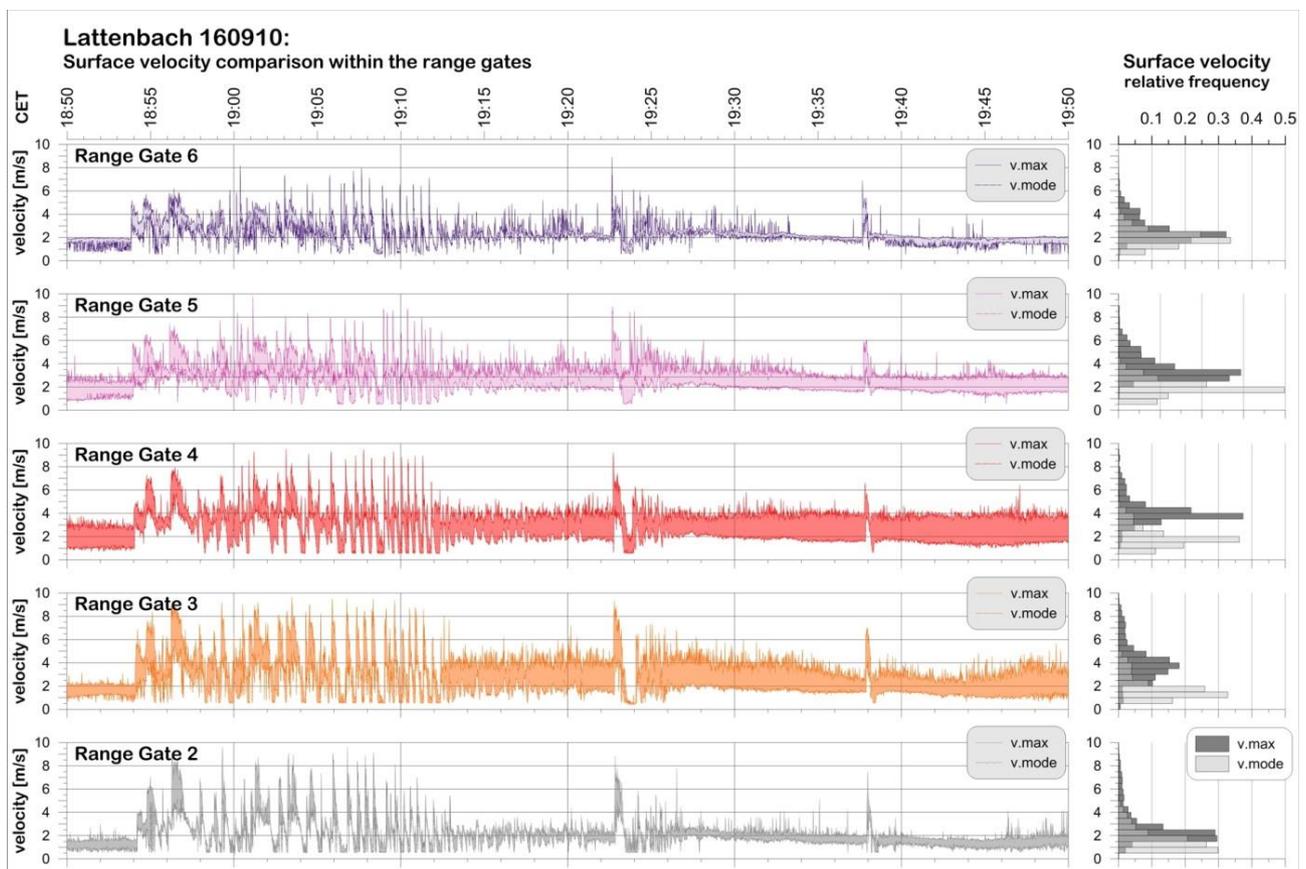
Fig. 5 Surface velocity distribution in the observed range gates (v.max means maximal velocity, v.mode stands for the most frequent velocity in the range gate)

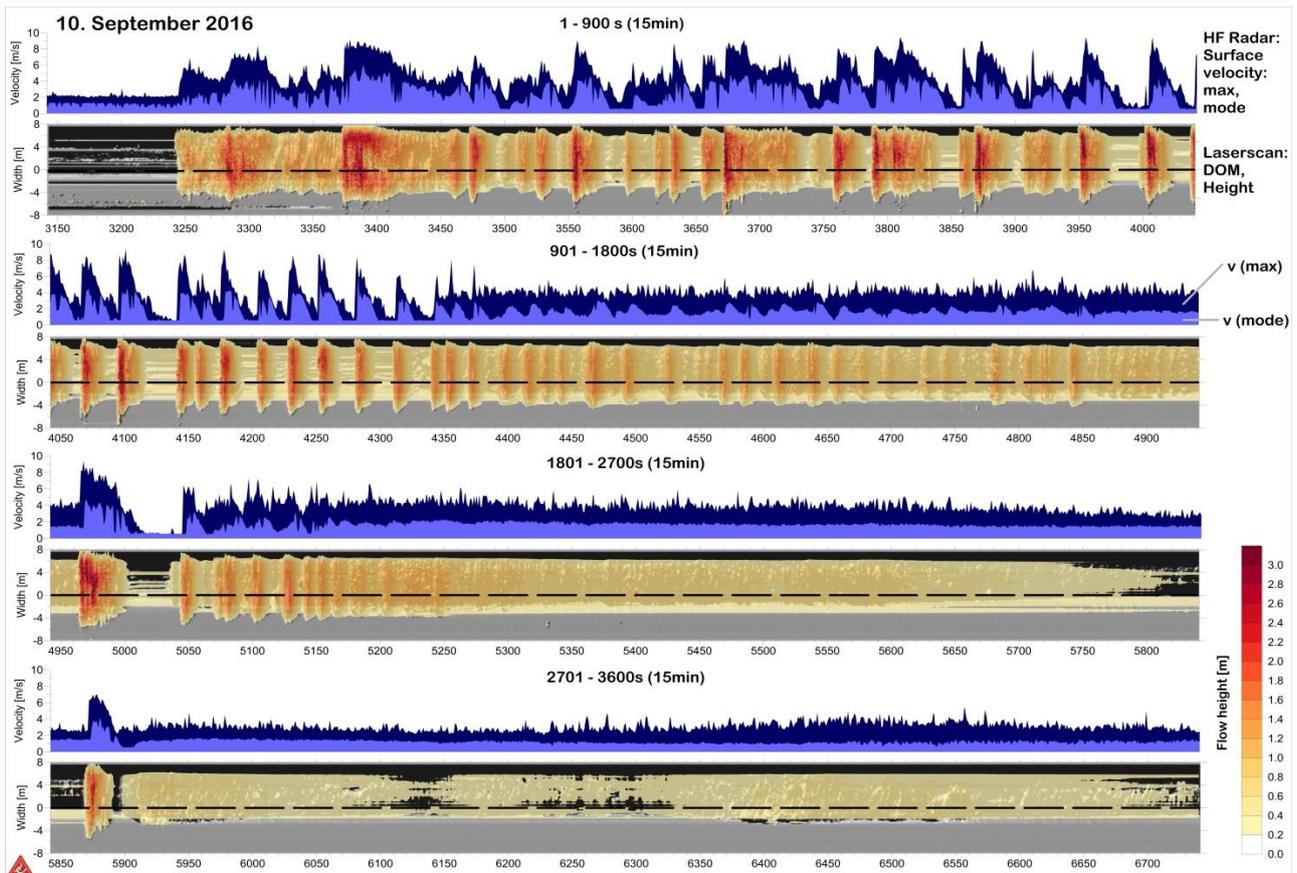
Fig. 6 Surface velocity distribution for the 10.09.2016 debris flow (v_{max} means maximal velocity, v_{mode} stands for the most frequent velocity in the range gate) in addition to the recorded flow heights by the 2D Laserscanner; sampling rate: 1 Hz

The whole debris flow consists of about 50 surges. Each debris flow surge starts with a rapid increase of flow height followed by a recession of several seconds. The largest peaks can be found at the frontal part of the event and again after half an hour. The surface velocities go in phase with flow

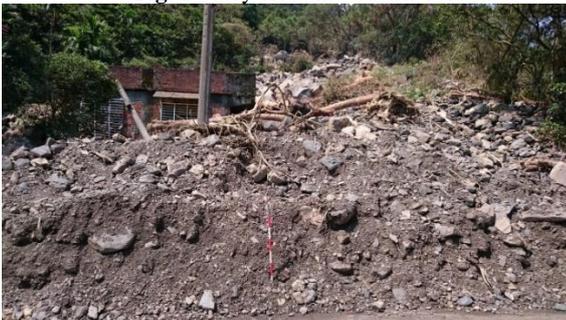
Fig. 2 Debris flow deposition in downstream reach in Ping-Guang Creek watershed (2015/08/13)

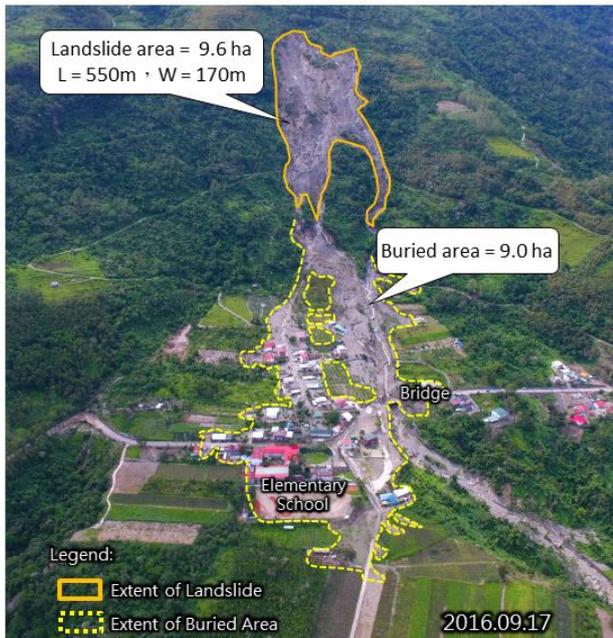
Fig. 1 Disaster caused by September 15, 2016 landslide

Typhoon Meranti invaded Taiwan from Sept. 12 through Sept. 16, 2016 and brought 633 mm of rain in 48 hours. A large-scale landslide occurred behind Hong-Yeh Village in Taitung County on Sept. 15, with an extent covering 7.8 ha from which 40,000 m³ of debris were yielded. The front lobe of debris rushing downstream damaged 39 housings, three public buildings as well as local traffic system that situated at the foothill of the mountain range (**Fig. 1**).

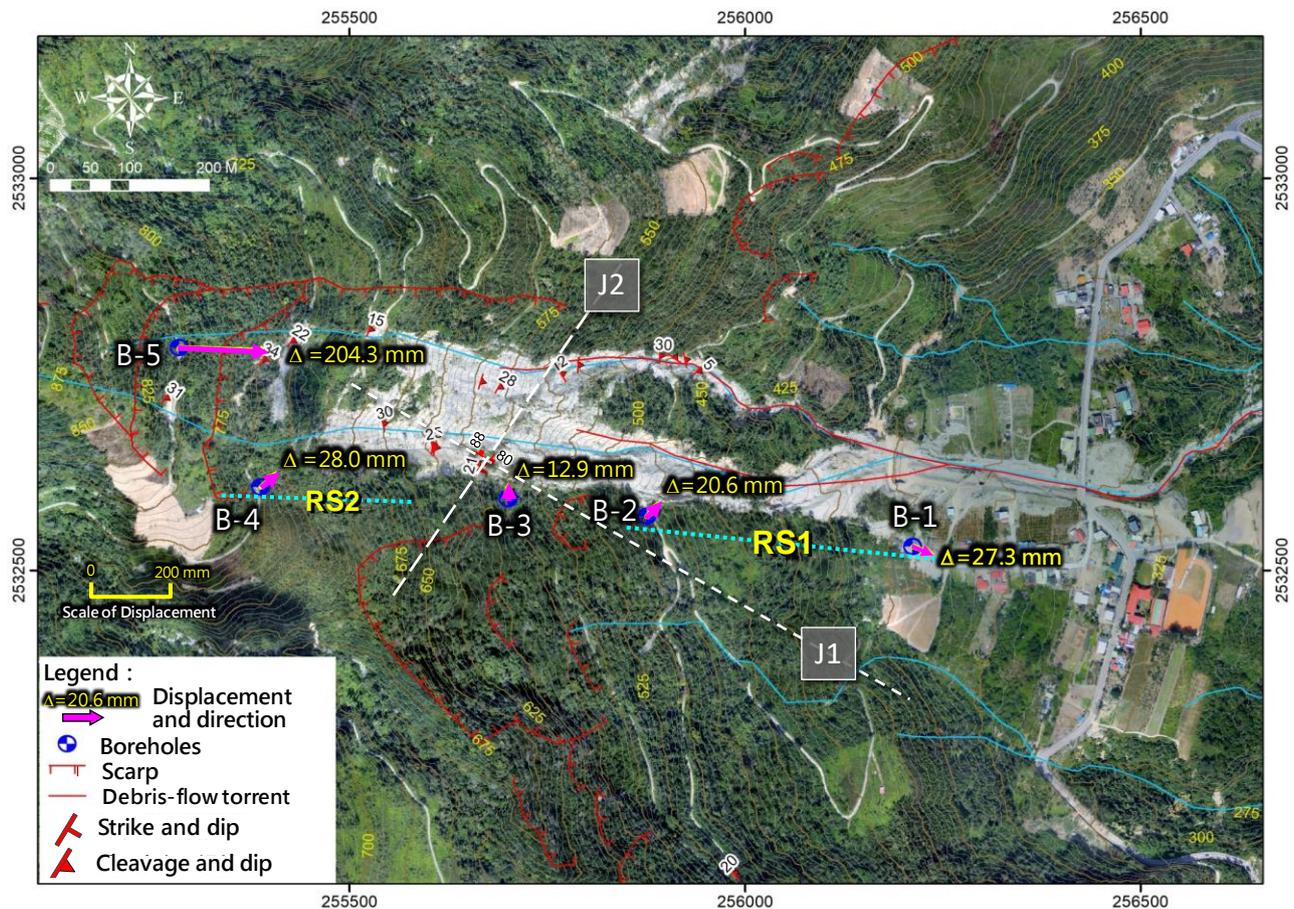
Fig. 2 Results of field geological survey and total displacement readings from each borehole

Field survey also found the representative weak planes formed by J1 and J2 joint (Fig. 2) respectively that affecting hillslope stability. J1 joint is less

apparent and discontinuous; whereas, J2 joint forms the major joint with good ductility that fractures the rock stratum for more than 1 m and quartz veins [Yang, 2010] was found along tension joint fissures. Evidence collected onsite suggested that J2 joint was the weak plane that mainly affected the hillslope stability and caused landslide to occur.

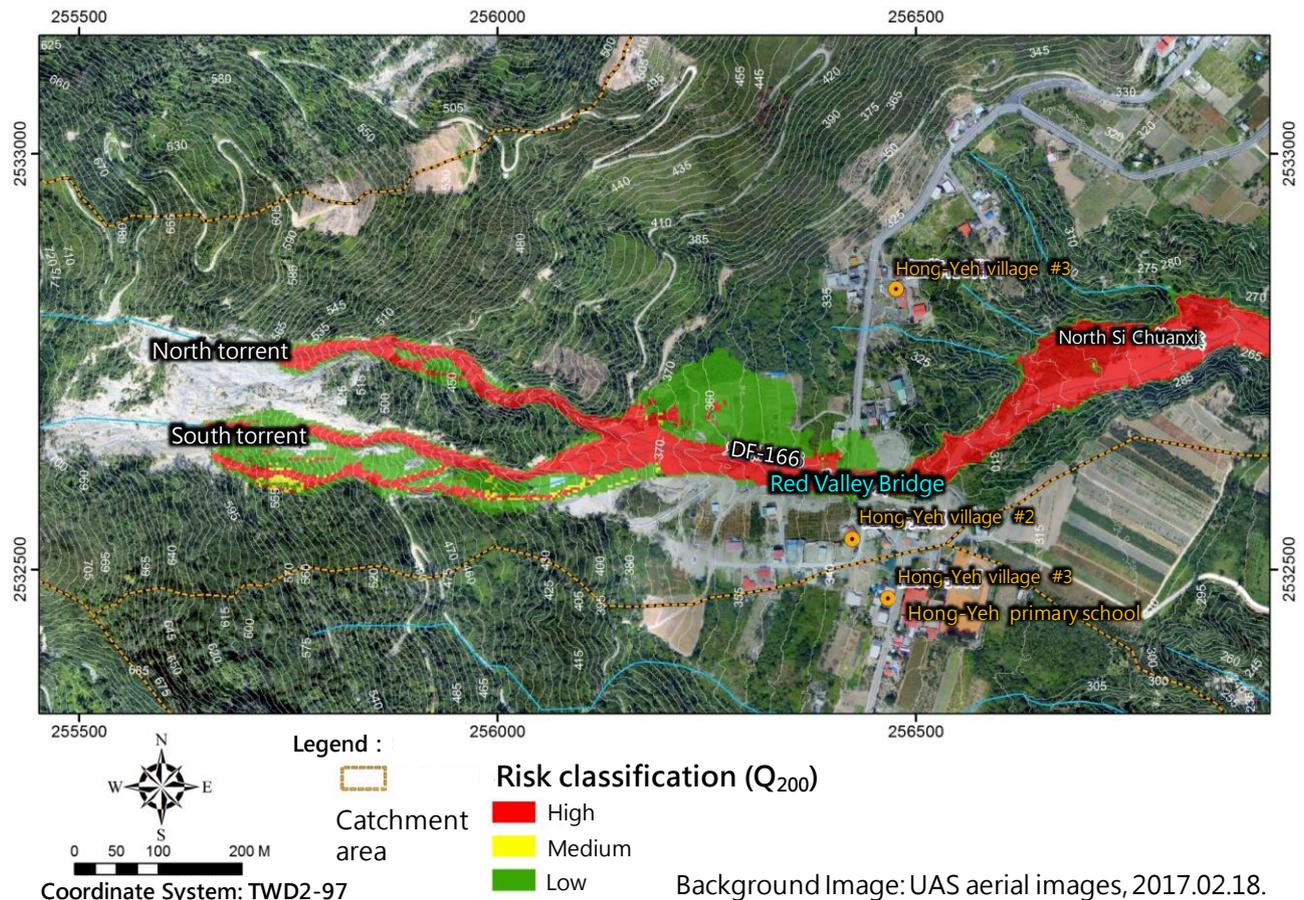
Fig. 11 Extent of debris-flow risk from 200-yr return period event if occurred during the construction of countermeasures

To cope with extreme event, sediment-laden runoff from 200-yr return period was used as inflow; whereas LiDAR survey when 50% of the control measures reaching to its completion was conducted to generate an updated DEM topographic base map for FLO-2D simulations. The extent of debris-flow risk caused by 200-yr return period is shown in **Fig. 11**.

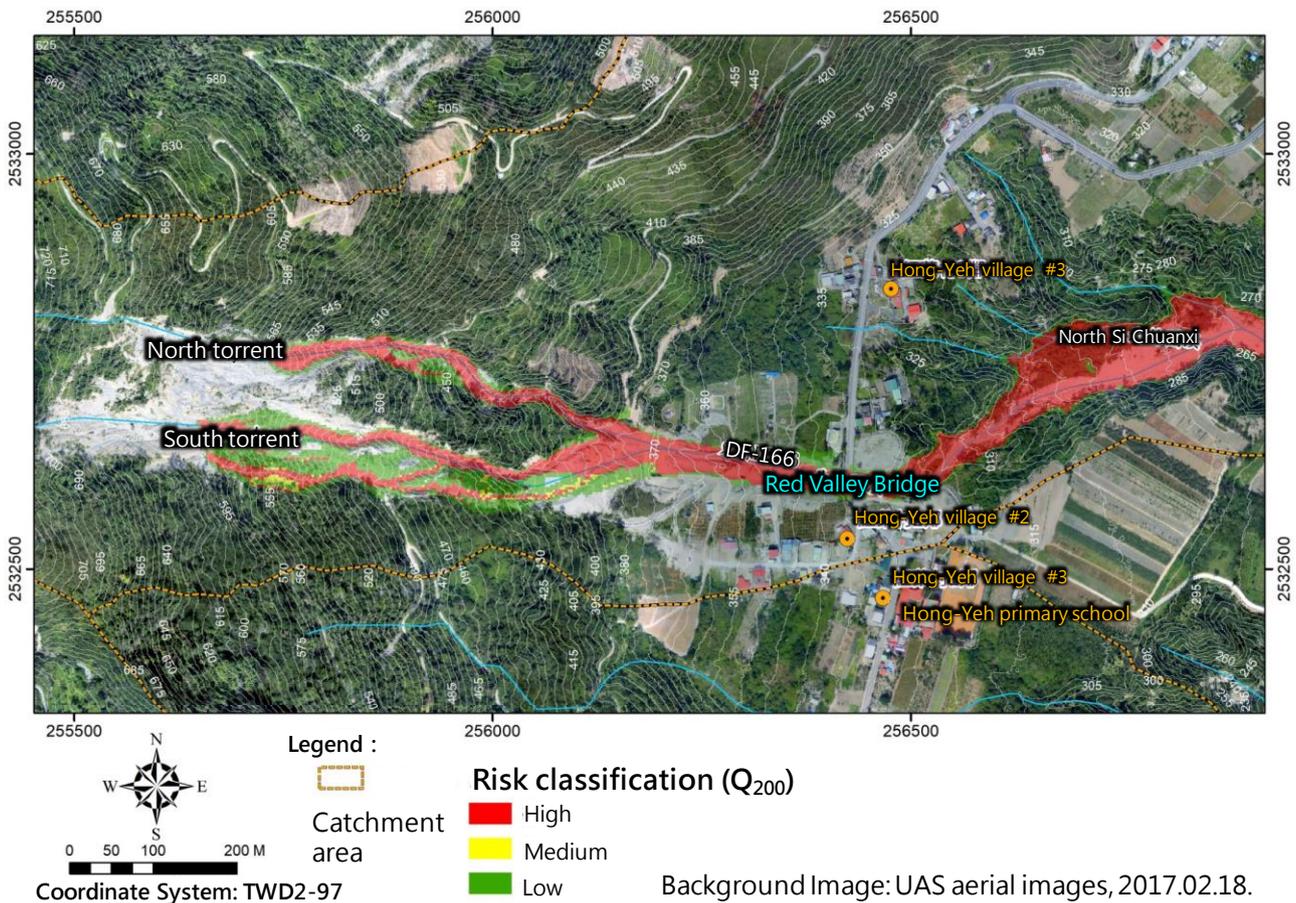
Fig. 12 Extent of debris-flow risk from 200-yr return period event if occurred after the construction of countermeasures

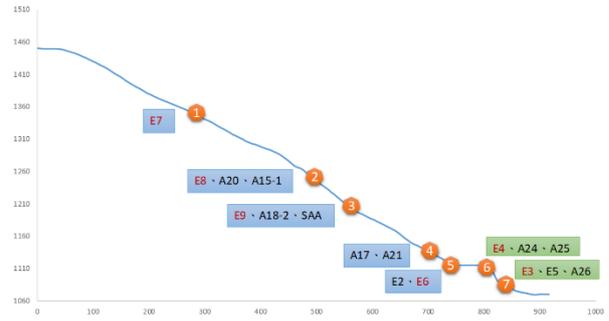
Fig. 3 The location of monitoring system on slope

Soil and Water Conservation Bureau initiated a monitoring project in study area from 2005 to 2006. Central Geological Survey followed the monitoring system and started a long-term monitoring project from 2007. We collected data from these projects and carefully check abnormal conditions. Fig. 3 illustrates how the monitoring works were aligned in the slope locations. The slope located in the circle area of Fig. 2. The prefix E denotes in-hole extensometer, A denotes ground water observation well with slope indicator, and SAA denotes shape acceleration array. Relationship between rainfall and groundwater is as shown Fig. 4. The figure shows that groundwater is highly related to rainfall but varies with their location within the slope. Also Fig. 5 shows rainfall condition with groundwater level variance at site A-20. The result shows that regression has better result once lower rainfall events were removed from database. The same condition also revealed in Fig. 6, which is Shape Acceleration Array (SAA) displacement monitoring results comparing with accumulated rainfall events.

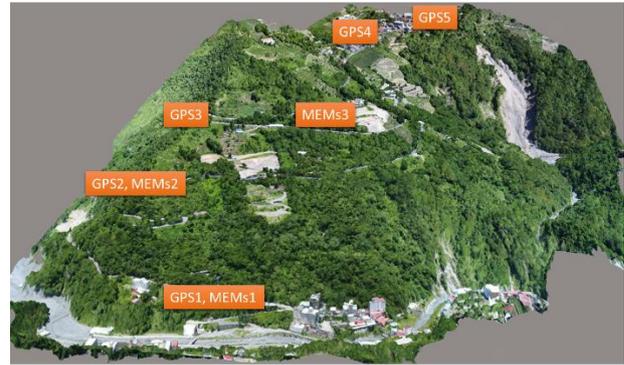
Fig. 9 Locations of dual frequency GPS and MEMs

Owing to landslide instrumentation is too expensive and unnecessary. In this work, we present a low-cost slope-monitoring device. The device is constructed using components purchased online at reasonable costs. The device is capable of recording triaxial accelerations at 200Hz onto standard SD (secure digital) memory cards. In addition, the sensed triaxial accelerations can be converted to tilt, which can then be sent via onboard GPRS module to a cloud server. Thus, the constructed device can be used for both static measurements of the slope surface and dynamic measurements of ground-surface acceleration. This information can assist assess slope condition regularly and dynamic force experienced by the slope after earthquake. **Fig. 9** illustrates distribution of dual frequency GPS and MEMs installed in to selected landslides, which are as shown rectangular in **Fig. 8**. The recorded data has been calculated to tilt as shown in **Fig. 10**. The results shows the tilt direction s toward landslide direction at toe.

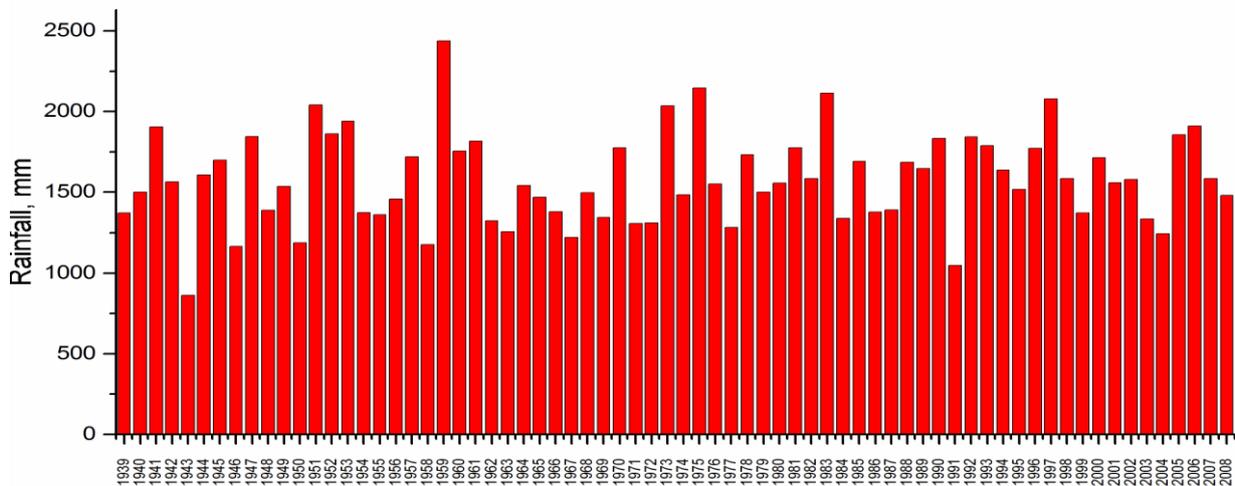
Fig.4 Rainfall bar chart of Shanghang county for 70 years from 1939 to 2008

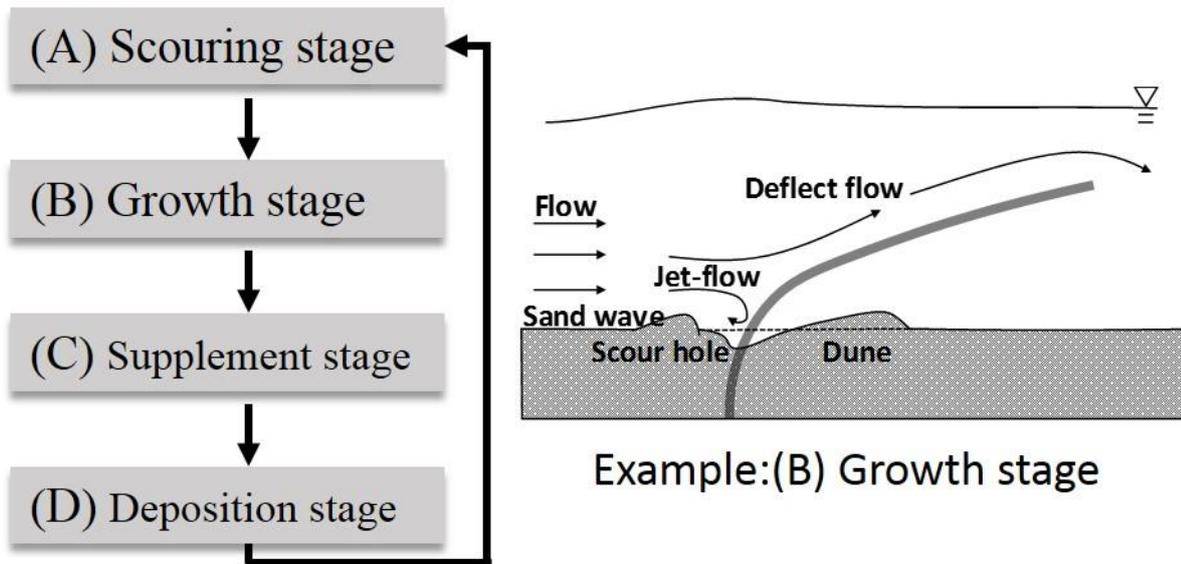
Fig. 2 Flowchart of the dynamic process of the sand-bed evolution.

We observed the process of sand-bed evolution around the single vegetation during the experiments. The mainly evolutionary process could be divided into four stages, as follows: (A) scouring stage; (B) growth stage; (C) supplement stage; and (D) deposition stage. The flowchart are shown in **Fig.2**.

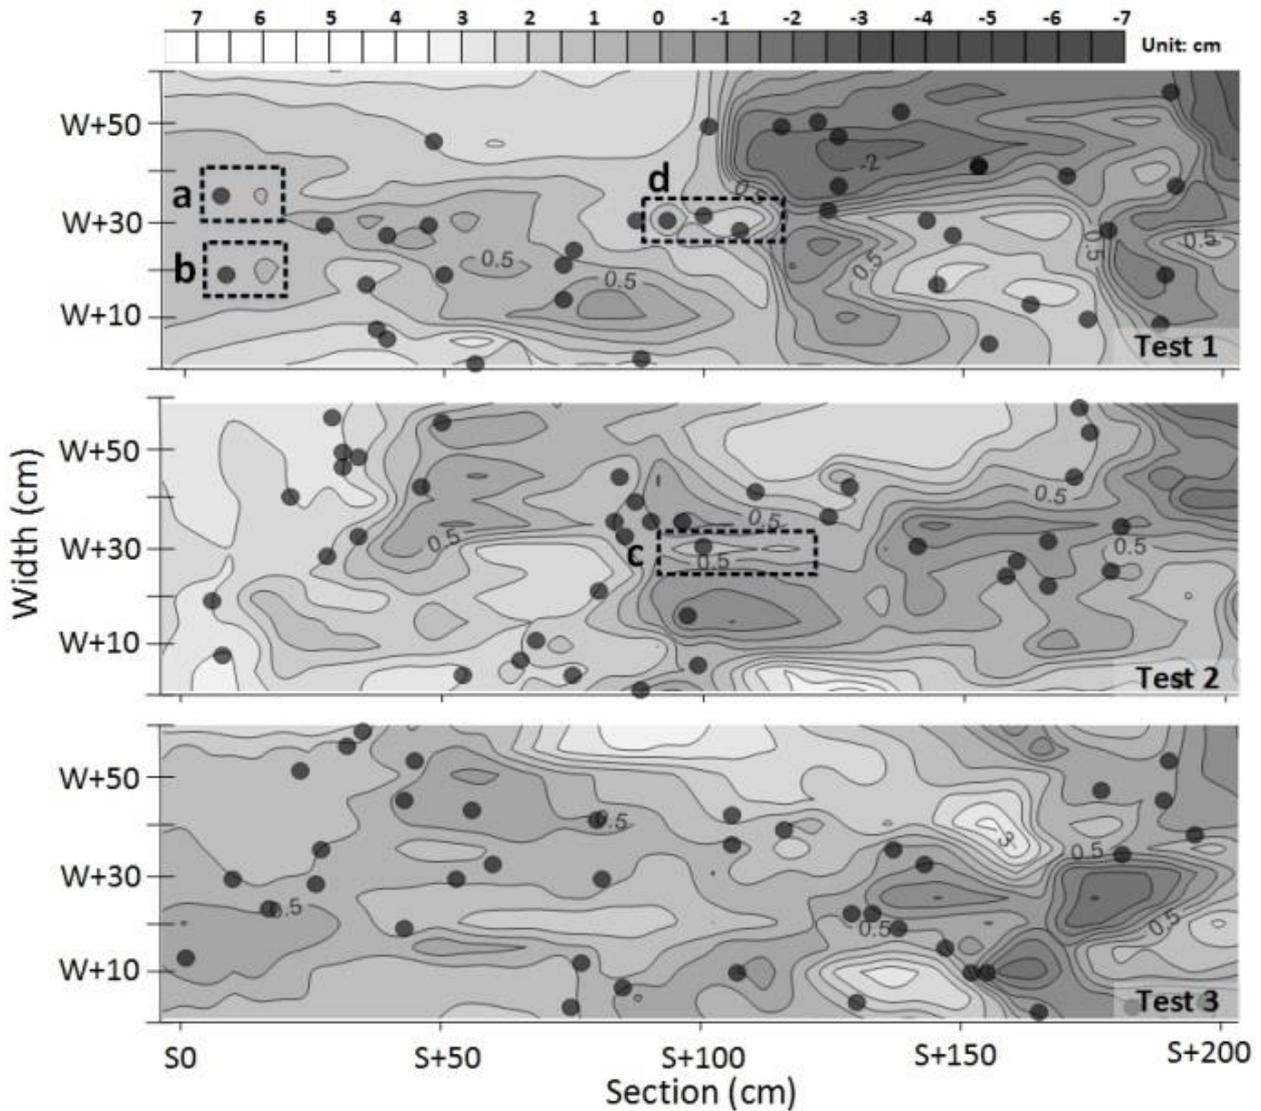
Fig. 3 The final sand-bed topographies after the 33.33 stems/m² experiments. (a) The dune type of the scouring stage. (b) The dune type of the growth stage. (c) The dune type of the supplement stage. (d) The dune type of the deposition stage. Black dots represent vegetation. Color-bar on top shows topographic height.

We observed the final sand-bed topographies of three different vegetation densities, 33.33, 66.67, and 100 stems per square meter, in the vegetation area ($S_0 \sim S_{+200}$). The topographies of 33.33 stems/ m^2 experiments are shown in **Fig. 3**. In these minimum density experiments, most of the sand invaded the entire vegetation area to form a depositional sand-bed. The cross-sectional area for water passage was not significantly reduced, so the rate of velocity increase was inconspicuous. In addition, because the distance of each vegetation was wide, we found some evolutionary processes of sediment, which were caused by the single vegetation, on the sand-bed. **Fig. 3(a)** represents the type of scouring stage; **Fig. 3(b)** the type of growth stage; **Fig. 3(c)** the type of supplement stage; **Fig. 3(d)** the type of deposition stage.

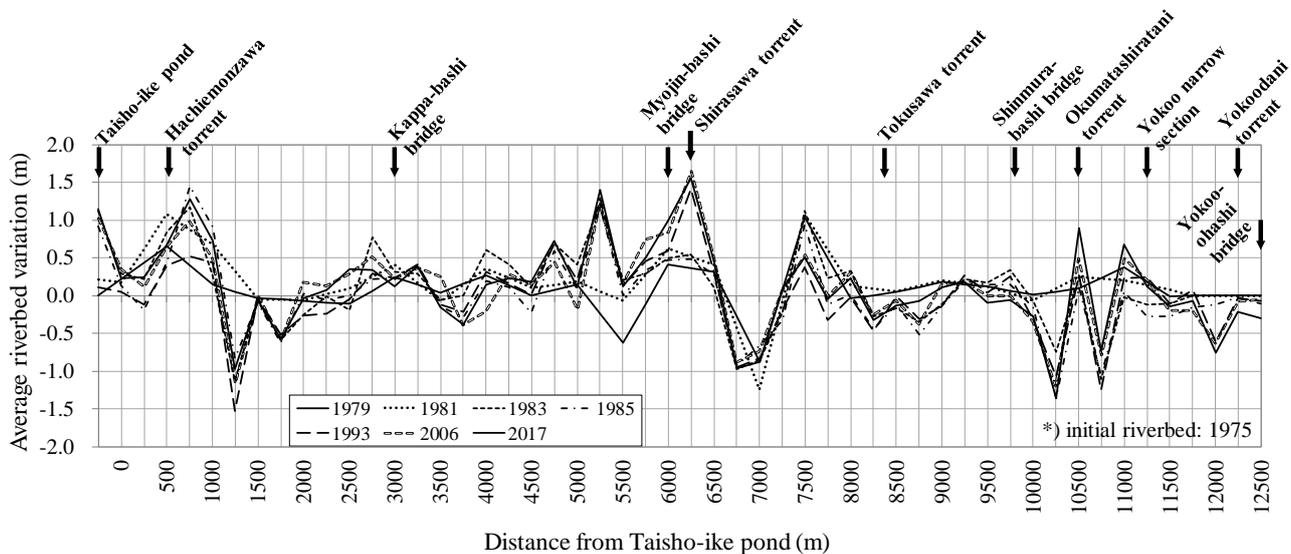
Fig.2 Average riverbed variation from 1975 to 2017

Figure 2 shows the average riverbed variation from 1975 to 2017 of the main stream. In this period, 4 large-scale flood occurred in 1979, 1983, 1993 and 2006 that caused inundation damage and also eroded mountain trail and road along the riverbank in the upstream. In the section of Yokoodani torrent to Yokoo narrow section that is the upstream end of the main stream, significant riverbed degradation caused by 1993 flood but no major riverbed change causes since then. At the junction of Okumatashiratani torrent, huge amount of sediment discharge flows out forming a wide debris fan that causes the expansion in the main stream. Furthermore, this fan blocks the main stream and causes a riverbed aggradation in the upstream toward Yokoo narrow section. Along with this, downstream section of this fan toward Shinmura-bashi bridge that is the contraction point, significant riverbed degradation has caused. In the section of Shinmura-bashi bridge to Tokusawa torrent that little change in the riverbed width, 1993 flood flushed out the riverbed deposit and causes significant riverbed degradation, no major riverbed

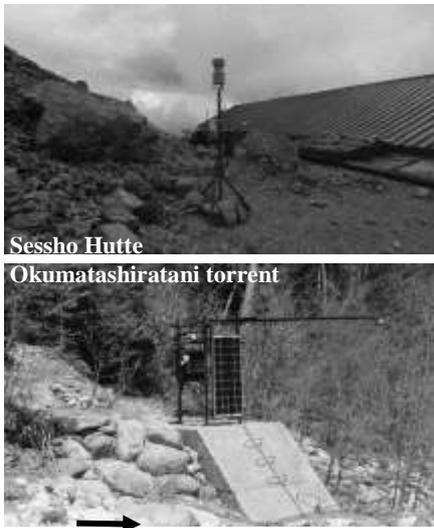
Fig.3 Installation of rainfall and water level gauges

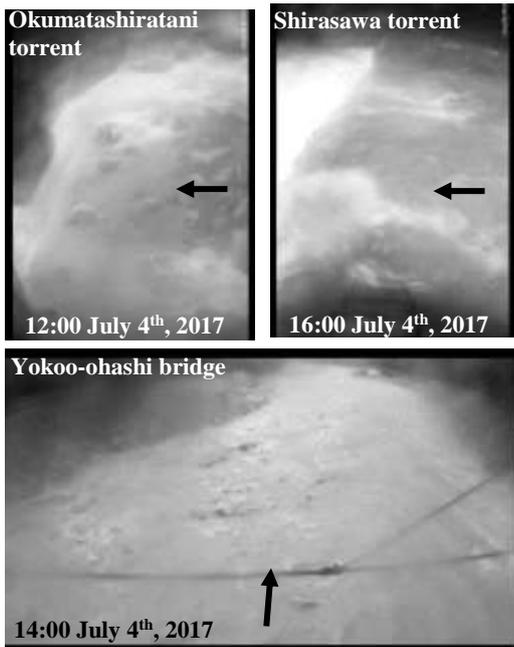
Fig.5 Time changes of discharge and flow condition during the flood on July 1st to 4th in 2017

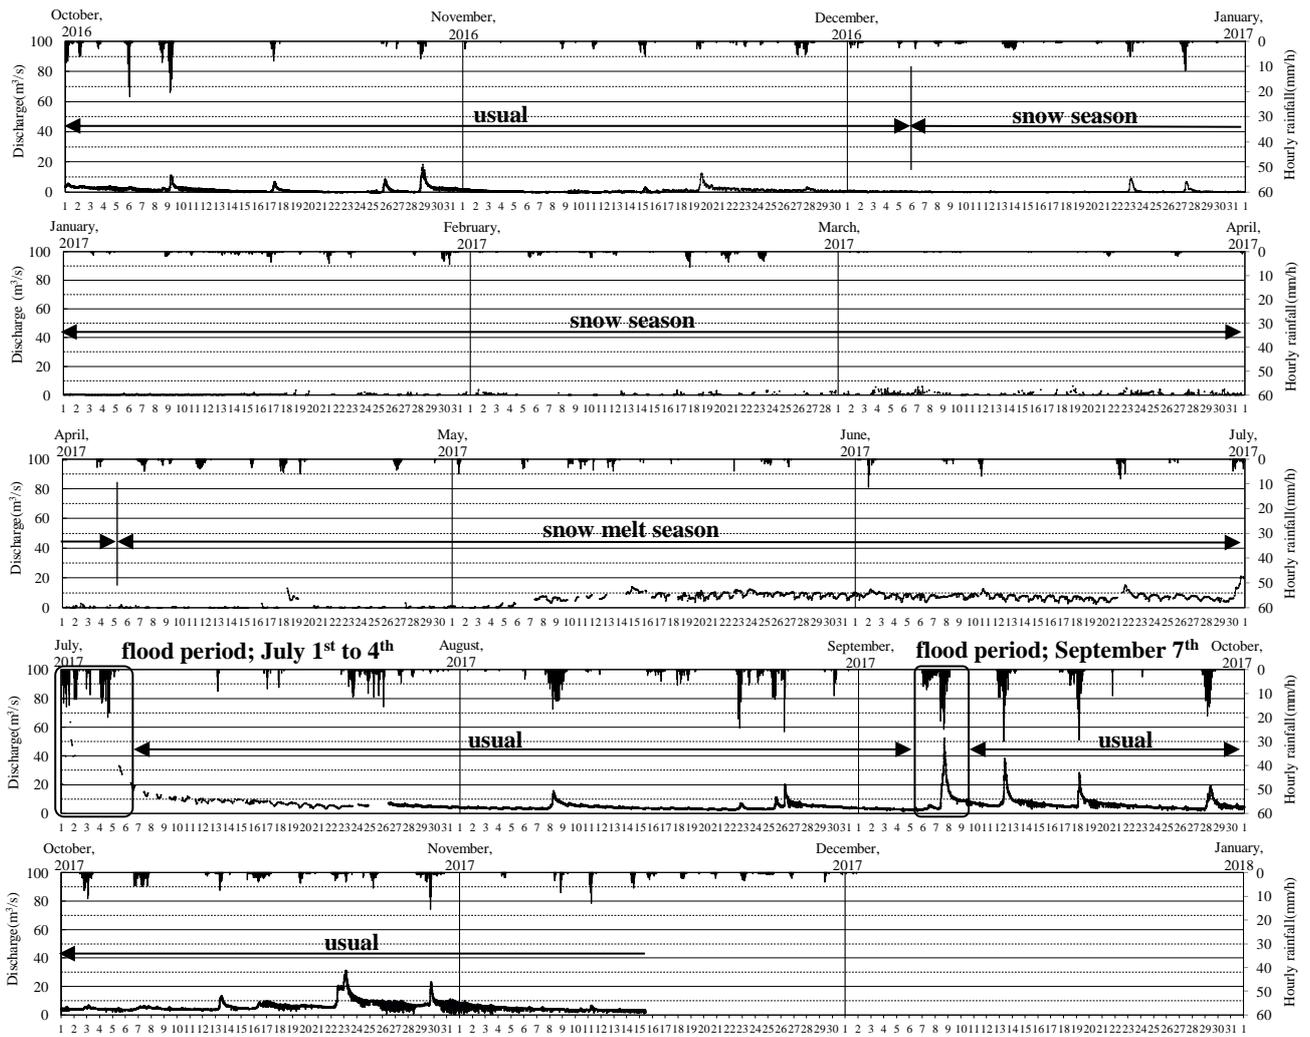
Fig.6 Time changes of discharge and flow condition during October, 2016 to November, 2017 at Yokoo-ohashi bridge

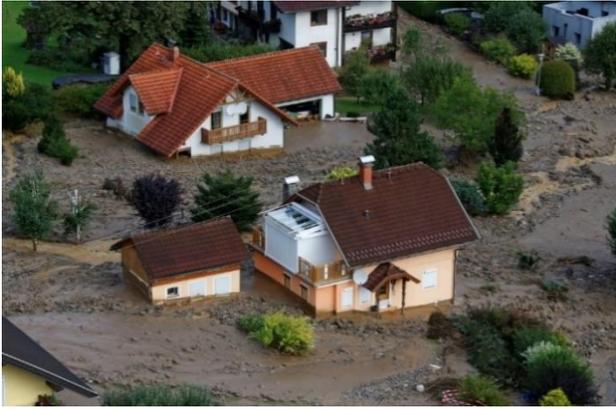
Fig. 6 Damaged buildings after the 2nd debris flow on 4th of September 2016

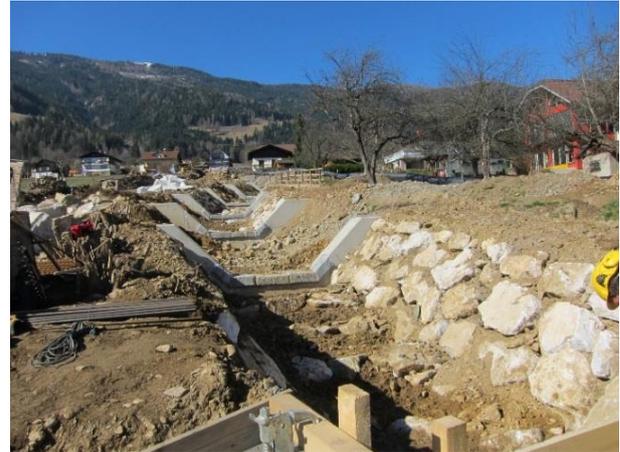
Fig. 10 Bedded rockfill and concrete sills along the lower reach

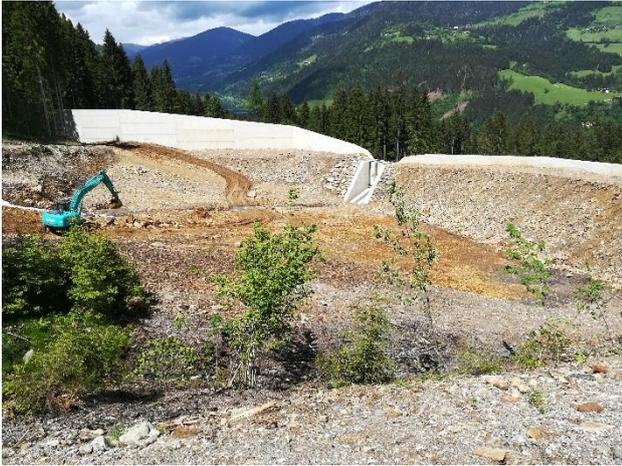
Fig. 11 Bedload sorting dam with a retention capacity of 37,000 m³ with a length of 250 m and a height up to 14 m

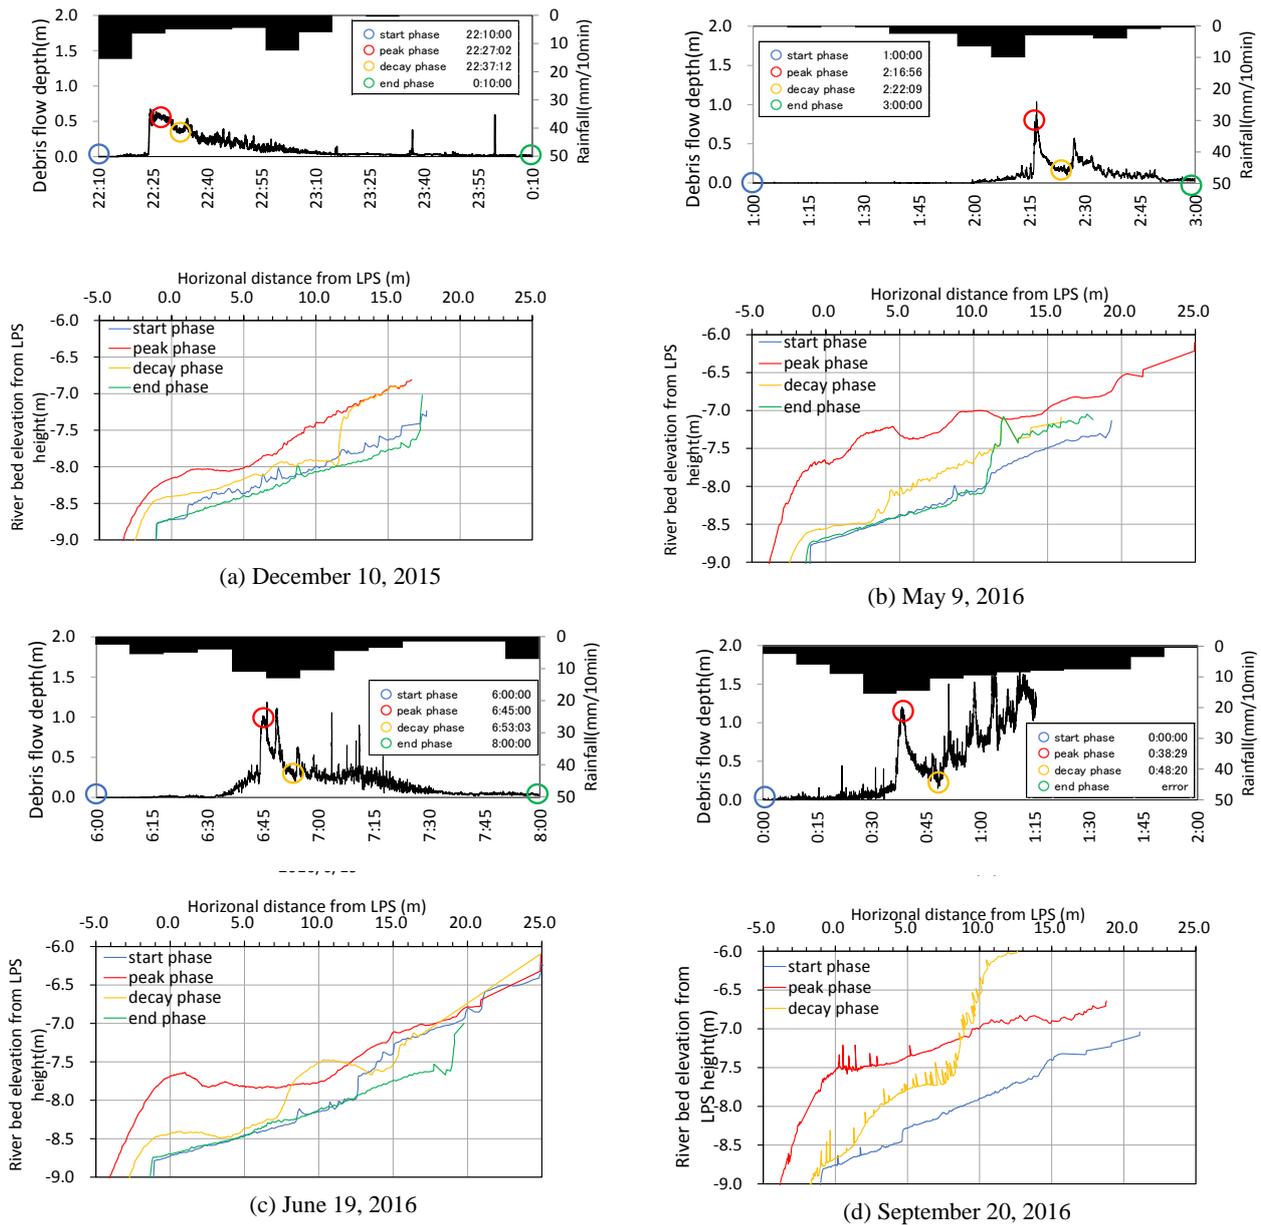
Fig. 6 Depth of debris flow and river bed elevation

The depths of each event, including the debris flow, are shown within 2 h. The start phase is the situation before the debris flow. The peak phase is the first peak of the depth of the debris flow. The decay phase is the time immediately before the depth increased after the first peak. Concerning (c) June 19, although second peak appeared right after the first peak depth tended to decrease. Thus, in this case the

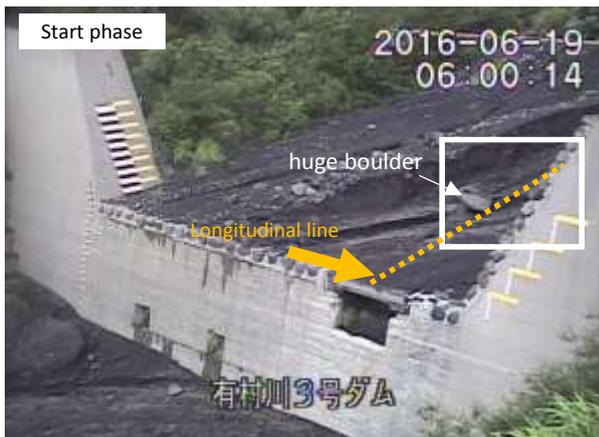
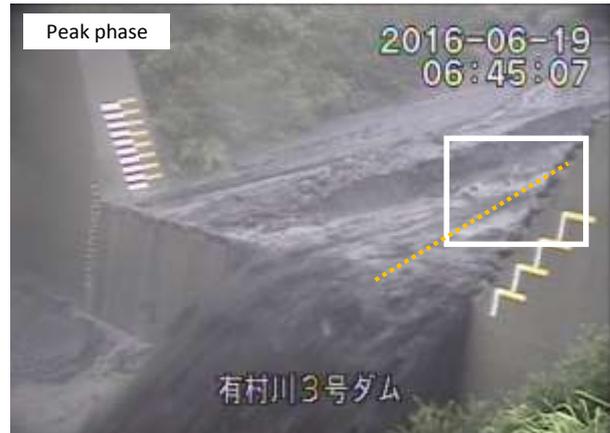
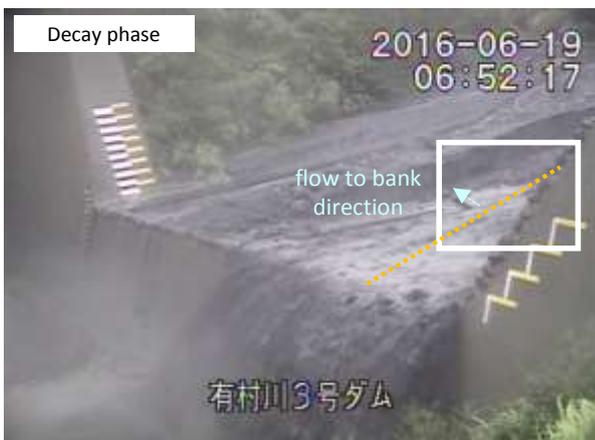
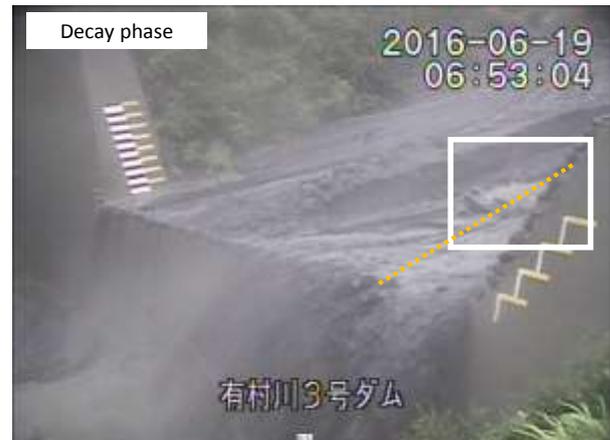
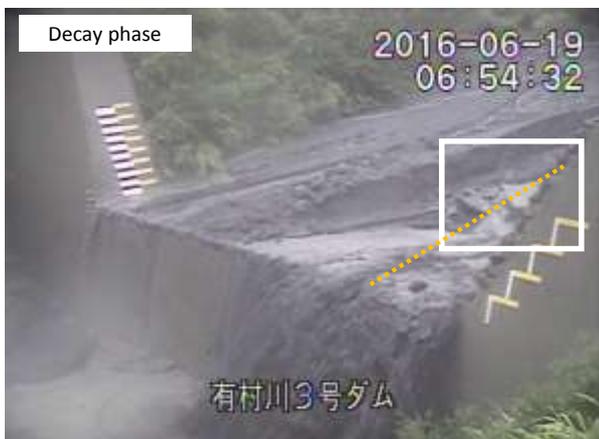
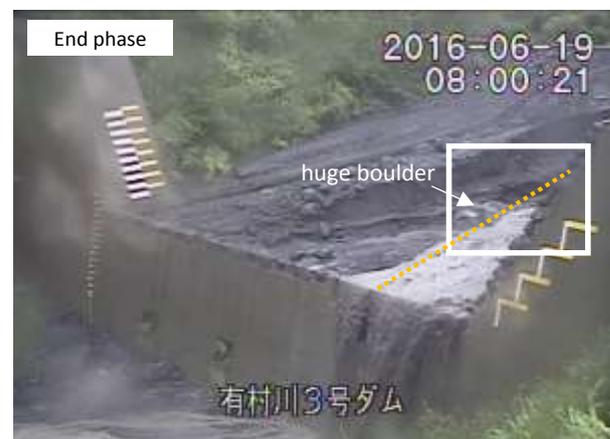
Fig. 9 Temporal change of condition of river bed during debris flow, June 19, 2016

The yellow line represents the longitudinal line, which was measured by the LPS, whereas the white line is the range where the sediments were deposited during the decay phase.

At 6:00, a boulder was confirmed to be at the legs of the sediment, which was deposited at the center of the river channel of the area surrounded by a white rectangle. At the peak of the debris flow at 6:45, the boulder was almost invisible. At 6:52, it was confirmed that there was a flow towards the bank in a direction perpendicular to the debris flow. Thereby, the progress of the sediment deposition was confirmed by the intermittent occurrence of sediment-containing flow at the legs of the sediments deposited at the center of the river channel. As a result, the sediments were accumulated upstream where the boulder was located. At approximately 6:53, the depth of the debris flow decreased near the

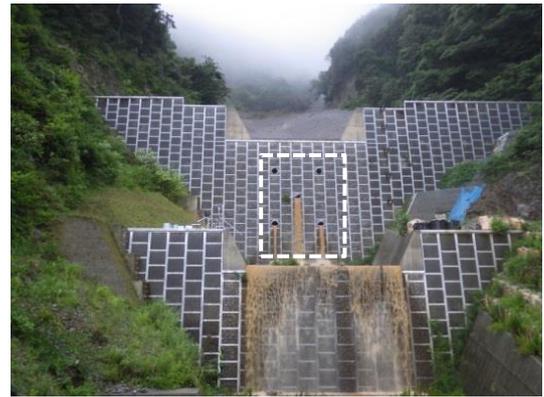
Fig 2 Observation of subsurface flow discharge at drainage holes of the No.6 Sabo dam

except for heavy rainfall. Rainfall runs as a subsurface flow inside the riverbed sediment prior to discharging from drainage holes in the No. 6 Sabo Dam.

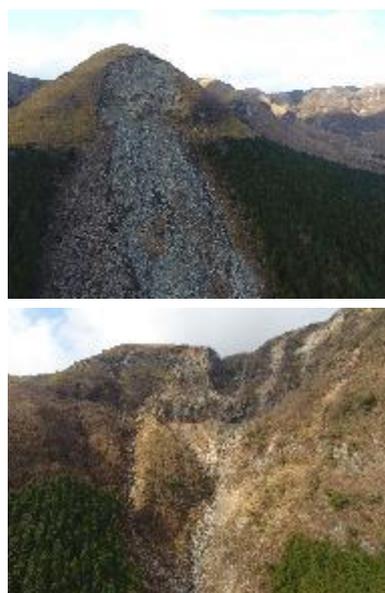
Fig.1 Photographs of slope failures in the Aso Caldera wall (taken by the authors, December 19–20, 2017)

A series of earthquakes with epicenters mainly in Kumamoto Prefecture, Kyushu Region, Japan, occurred in April 2016. The main shock of the 2016 Kumamoto earthquake on April 16 had a maximum seismic intensity of 7 on the Japan Meteorological Agency (JMA) 7-stage seismic scale and a JMA magnitude of 7.3. The Aso Caldera is a large caldera in Kumamoto Prefecture that was formed by catastrophic eruptions 270,000–90,000 years ago, and which measures about 17 km in the east–west direction and about 25 km from north to south. A JMA seismic intensity of 6 lower occurred in the Aso Caldera wall, which resulted in numerous slope failures and extensive damage (**Fig. 1**).

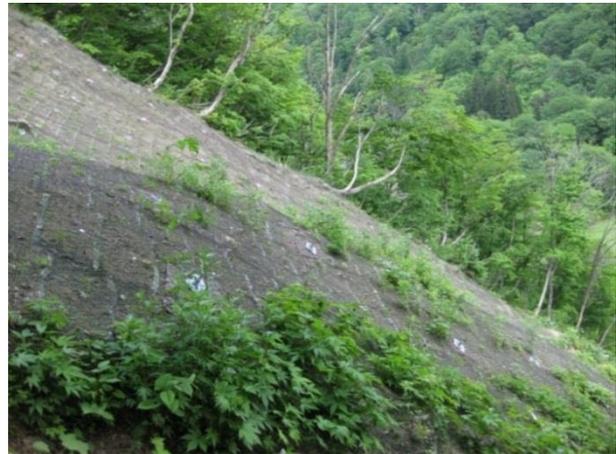
Photo 3 An example of slope stability works used by high tensile strength steel net

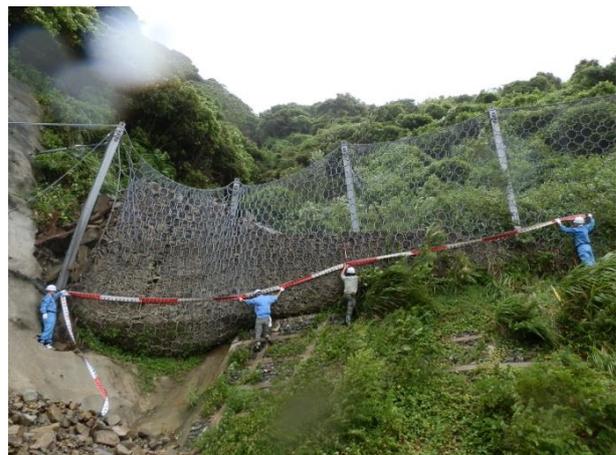
Photo 4 An example of capture of debris by the flexible debris flow barriers

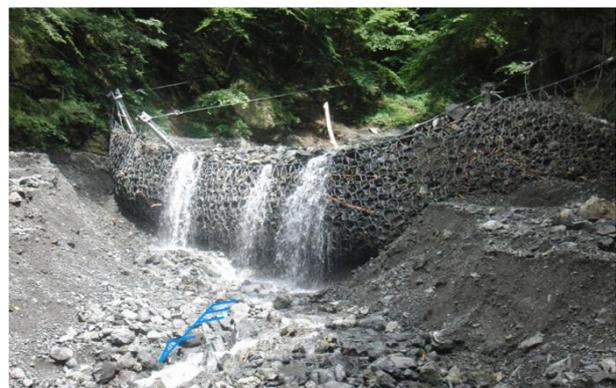
Photo 5 An example of capture of debris by the flexible debris flow barriers

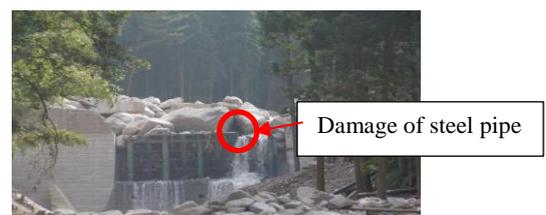
Fig. 2 Damage of steel open dam by large rocks

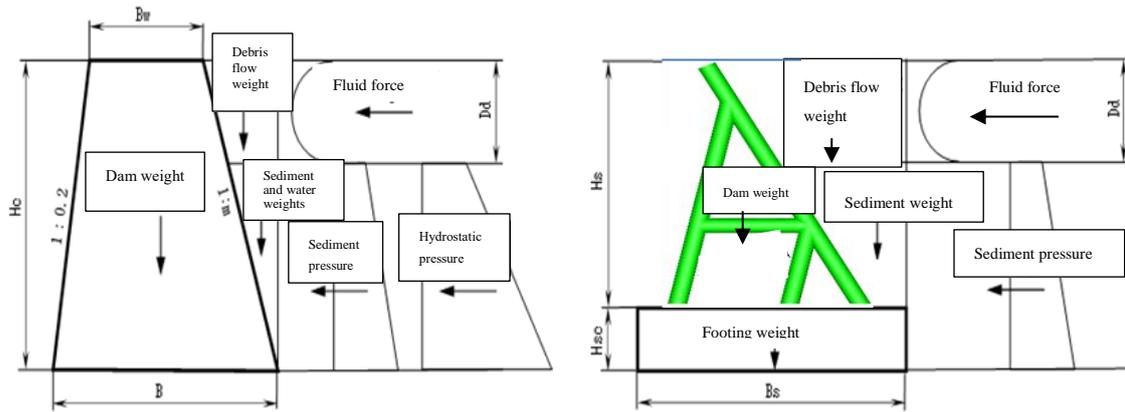
(a) Concrete dam model (b) Steel open dam model
Fig.8 Dam and debris flow models

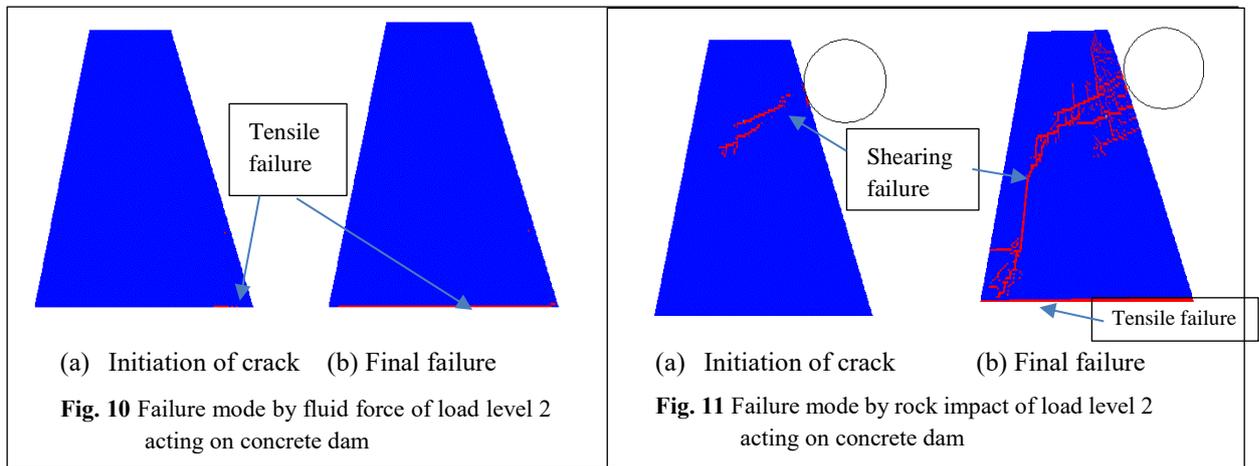
Fig. 10 Failure mode by fluid force of load level 2 acting on concrete dam
