INTERPRAEVENT
2018 – Toyama, Japan

Large scale
sediment disasters
in orogenic zones
and countermeasures

Large scale sediment disasters
in orogenic zones and countermeasures

Symposium Proceedings

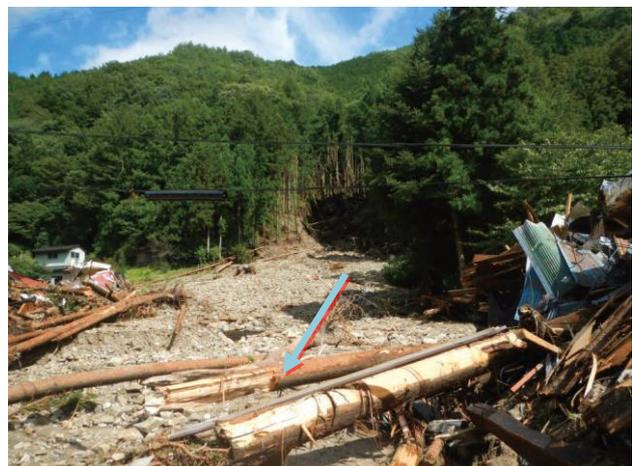
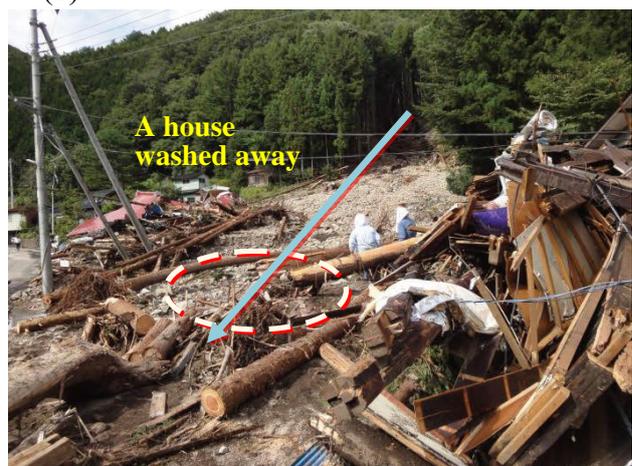
Fig. 6 Damage in Takimukaisawa, Serizawa District
(a) Sediment and driftwood run off
(b) A damaged house (two people injured and three houses completely destroyed)

In Takimukaisawa, two people were injured and their houses were washed away. Debris flows completely or partially destroyed many houses. Luckily there were no deaths. Later we interviewed the inhabitants. “The house tilted after being hit by a debris flow. I was shocked and jumped out of the house.” “A fallen beam fell onto the bed board where it stopped, which created a space and saved me.” “I was covered in mud up to my waist. Somehow I managed to crawl out by following the directions of my neighbors. This is how I survived.” These are some of the stories from the inhabitants whose houses were completely destroyed. Considering these stories, it was clearly miraculous that there were no deaths.

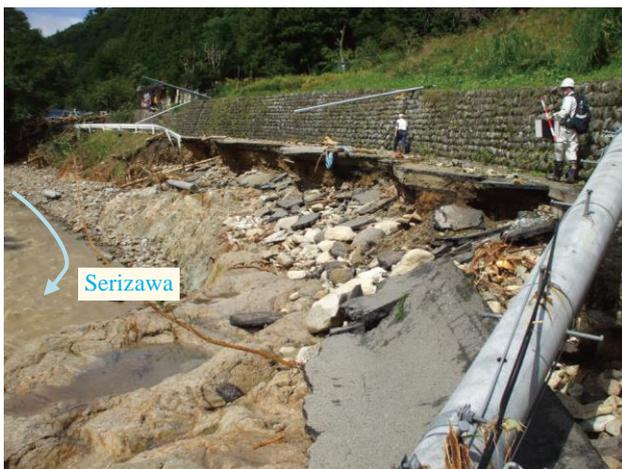
Fig. 7 Municipal road washed

Sediment runoff from the mountain streams cut off traffic on the municipal road. River bed aggradation and swelling of the main river of Serizawa eroded river banks and partly washed away the municipal road (Fig. 7). Lifeline utilities installed along the municipal road, such as electric, telephone (land line and mobile), water and communication lines were also severed and 25 inhabitants in 14 households were temporarily isolated in an upstream village [Uenaka, 2016; Nikko City, Tochigi prefecture, 2016].

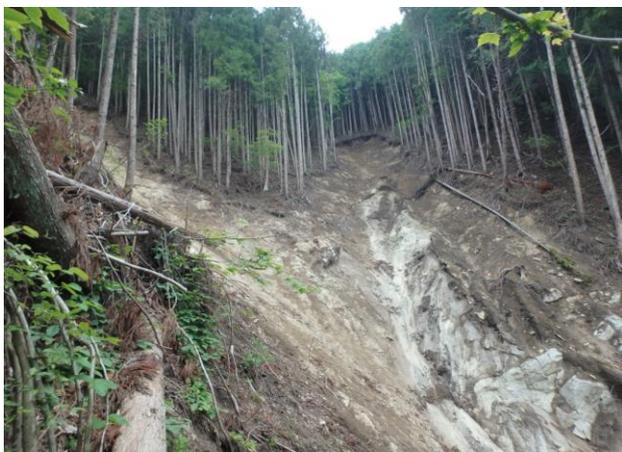
Headwaters in Shimotsubouesawa
Fig. 8 Sediment production

Traces of sediment production phenomena such as slope failures, longitudinal erosions, gully erosions and bank collapses were recognizable in the mountain streams. These phenomena occurred from torrential rains and the resultant swelling of the water. The swollen water may have combined with the sediment before turning into a debris flow (Fig. 8).

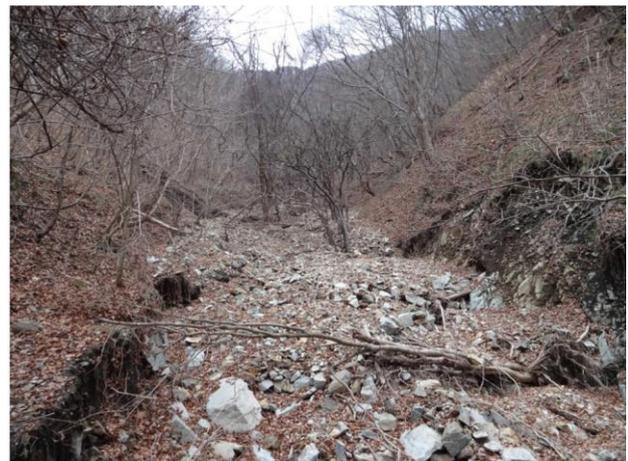
Shimotsubosawa
Fig. 9 Sediment runoff

According to interviews with the inhabitants, the sediment runoff occurred in Takimukaisawa around 4:00 a.m. on September 10, in Nakatsuboshimosawa

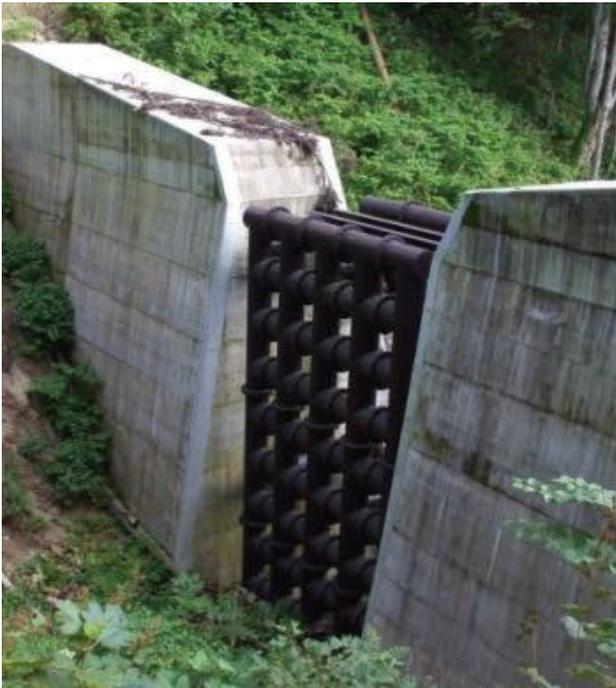
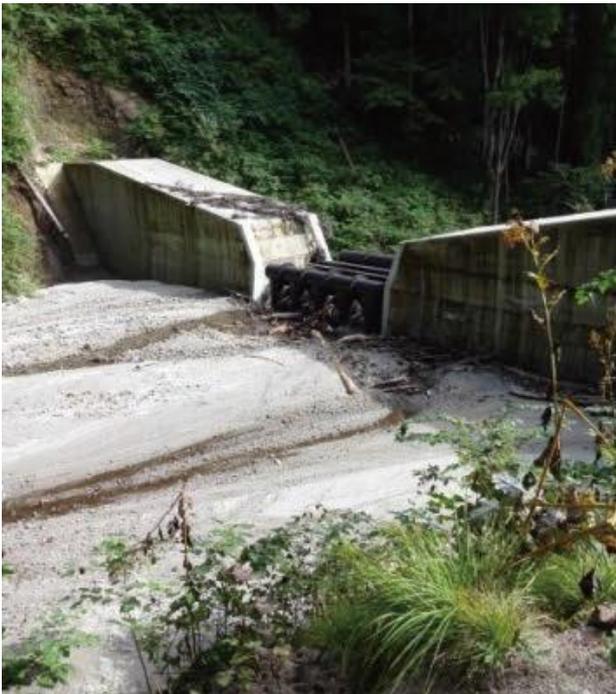
Fig. 11 Effect of an erosion control facility (Tamozawa Erosion Control Dam 1)

(a) Before catching the debris flow (August 18, 2015)

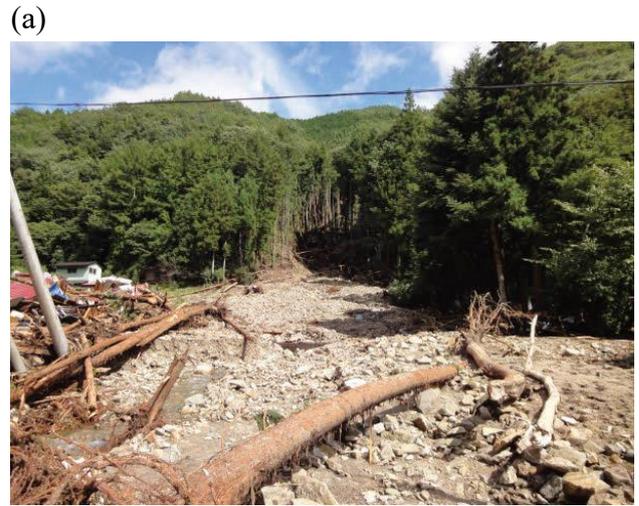
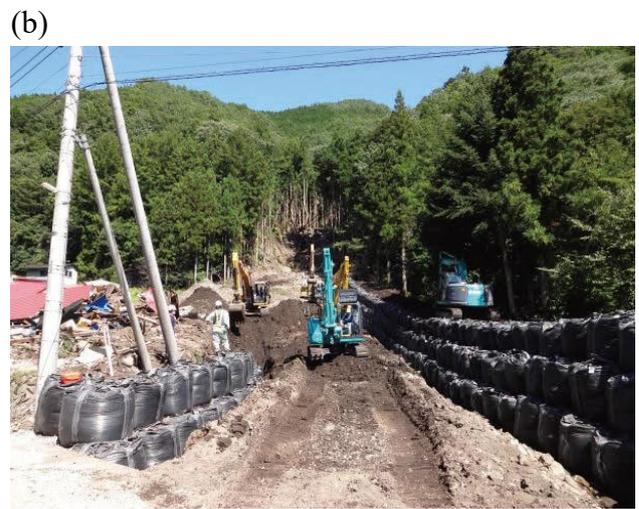
Fig. 15 Emergency construction
 (a) Right after the disaster
 (b) A temporary diversion channel is constructed with large sandbags

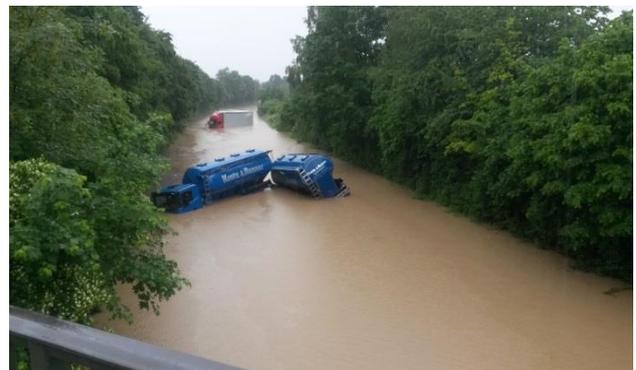
Fig. 3 Flooded federal road B12 (Source: Polizei Niederbayern)

The event caused very high damages. Besides the high damage to property five casualties were to be mourned. A lot of people had to be evacuated or rescued from acute danger to life. Several citizens could not return to their homes due to danger of collapse. Fresh water supply and waste water disposal was limited and partly broken down. Important traffic routes were interrupted causing major traffic problems (**Fig. 3**).

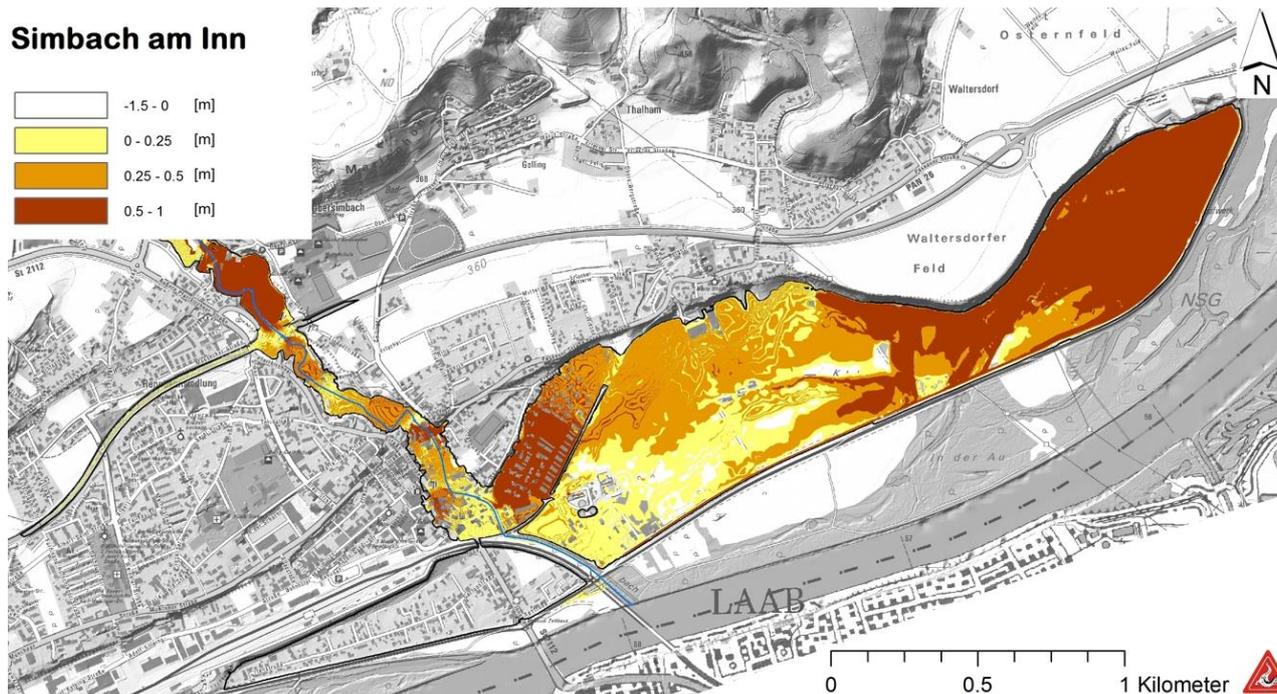
Fig. 8 Difference of flow heights in the flooded area of Simbach by comparing the results of the flood under “natural” conditions versus the results of the flood including the effects of the failures of the structures.

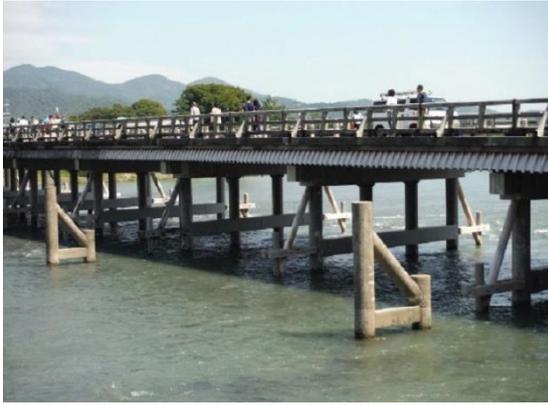
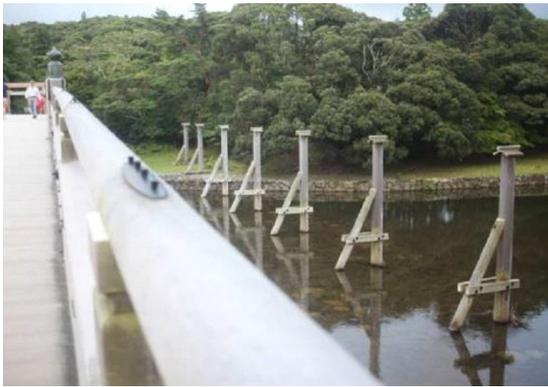
Fig. 1 Traditional Japanese technique to prevent damage to historical bridges using stakes, Upper: Togetsu Bridge, Arashi-yama, Kyoto; lower: Uji Bridge, at the Ise shrine, Mie

Historically, stakes installed before bridges that control the direction of driftwood flow have been used to protect bridges from blockages, for example, at Togetsu Bridge in Arashi-yama and Uji Bridge in the Ise Shrine (**Fig. 1**). Stakes also prevent other types of natural debris from blocking the bridges; Takebayashi [2014] described how stakes functioned during a 2013 flood (**Fig. 2**). Many bridges have narrow intervals between piers; these require protection from blockage by driftwood and other natural debris. Traditional stakes are considered effective countermeasures against blockage by debris. However, design codes for the stakes have not been established; thus, the arrangement of stakes differs between bridges.

At Togetsu Bridge (**Fig. 1**), one stake is installed at every other pier. At other bridges, such as Uji Bridge

(**Fig. 1**), stakes are installed at every pier.

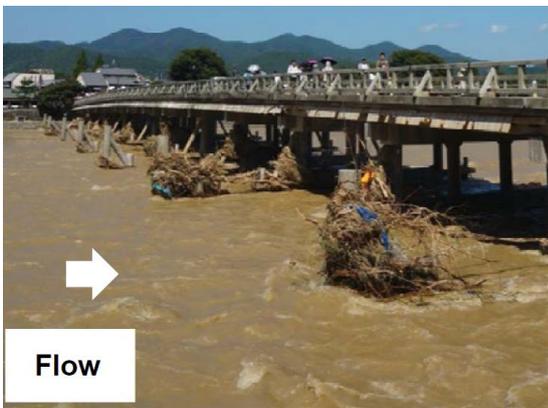
Fig. 2 Stakes at Togetsu Bridge during a 2013 flood [Takebayashi, 2014]

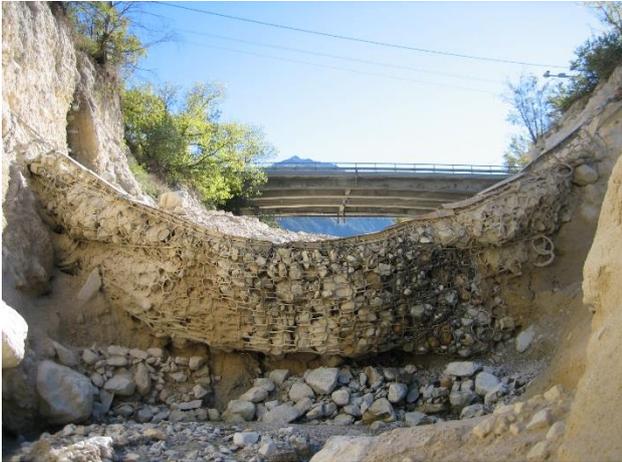
Figure 1: Testing of debris flow retention system with ring net in the Illgraben channel, 2006. Retention volume approx. 1000 m³

Two key characteristics were defined and analysed with testing. On one hand, a single barrier could, depending on the channel geometry, retain

over 1000 m³. On the other hand, it was observed that over 10'000 m³ were flowing over the barrier without damage. This led to planning and constructing a debris flow retention system with several flexible nets in a row in order to retain successfully most of the

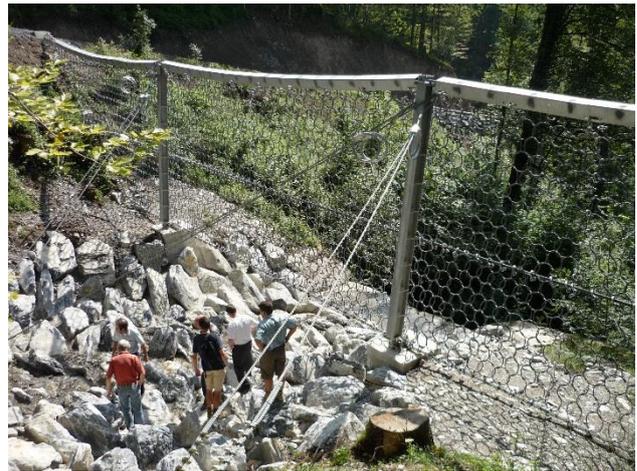
Figure 2: UX debris flow barrier, with posts for wider stream channels application. Example of the Trachtbach in Switzerland. Additional scour protection, rip-rap and lean concrete were placed along the stream bed.

Following the first projects, flexible standardized debris flow barriers were designed with a given load capacity in kN/m². VX-barriers are conceived for channels up to 15m in width und barrier height of up to 6m, taking loads up to 160 kN/m². UX-barriers find their application in larger channels, are installed with additional posts, a barrier height up to 6m and taking up loads of 180 kN/m² (Geobrugg, 2016) (see **Figure 2**).

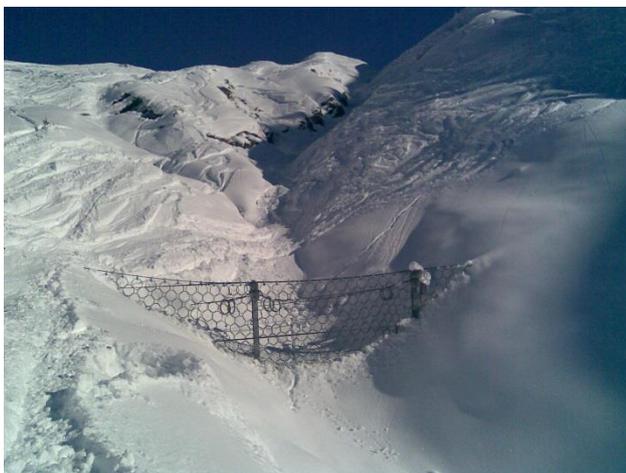
Figure 4: Same net than in figure 3, partially snowed in during winter. The snow load has to be taken into account when designing the barrier.

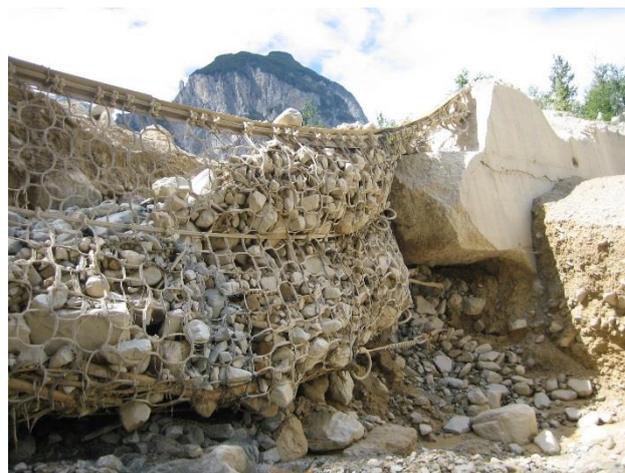
Figure 5: Washed out anchoring of the debris flow barrier number 25 in the Illgraben channel. Anchoring partially in loose material and partially in disused concrete debris flow barrier.

Without additional flank stabilisation, a certain degree of washing out can be observed along these stream banks, especially in loose soil (see **figure 5**).

When exchanging the net, the anchoring can technically be reused when the top of the anchor is cut off, a loading test is performed and a new flexible anchor head is mounted. Assuming that the anchor length was drilled the first time with a safety factor and possesses a certain length in reserve. In the case of frequent filling of the net it is recommend to design the anchors with sufficient length or to prevent the washing out of the banks with structural countermeasures.

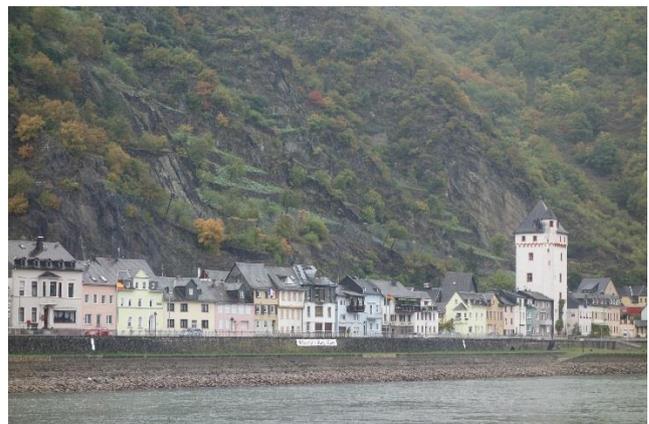
Figure 7: Almost invisible debris flow barrier close to Koblenz along the Rhine above an Unesco World Culture Heritage protected village.

Debris flow barriers instead of concrete dams are more and more an alternative in regards to landscape protection and visual aesthetics. The filigree design is almost invisible from far away and a primary argument for protection measure construction in landscape protection zones.

An example is the Unesco World Cultural Heritage along the Rhine close to Koblenz (**Figure 7**). At the back of the village debris flow barriers are installed and even with one barrier partially filled in 2017, the nets are still barely visible but fulfilling their purpose (**Figure 8**).

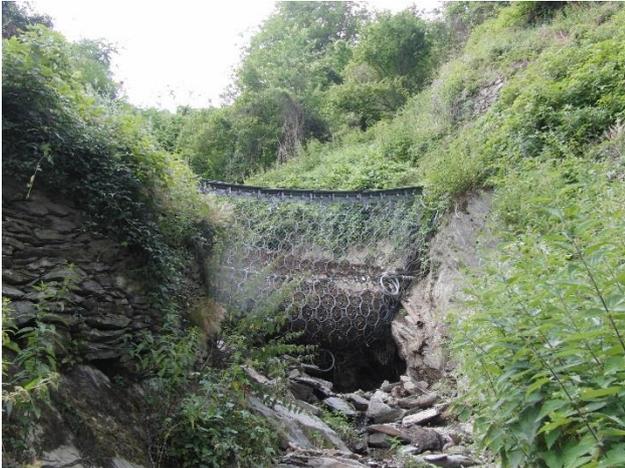
Figure 8: Partially filled debris flow barrier above the German Railway close to Koblenz.

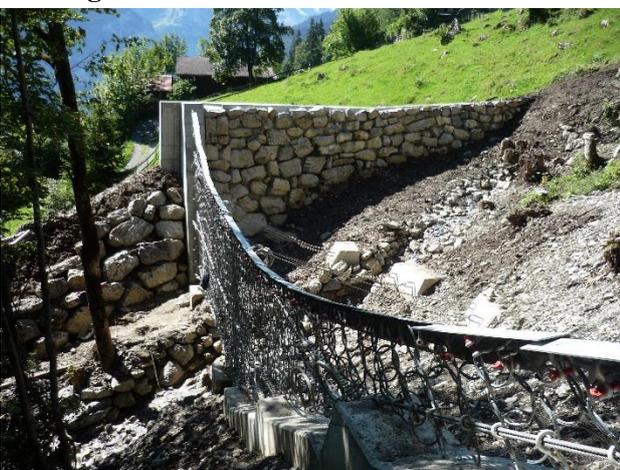
Figure 9: Debris flow barrier in Isenflue above a settlement. The outer bank of the stream was reinforced with a rock wall.

Most barriers installed are single barriers along roads and railway tracks or above settlements (see **Figure 9**).

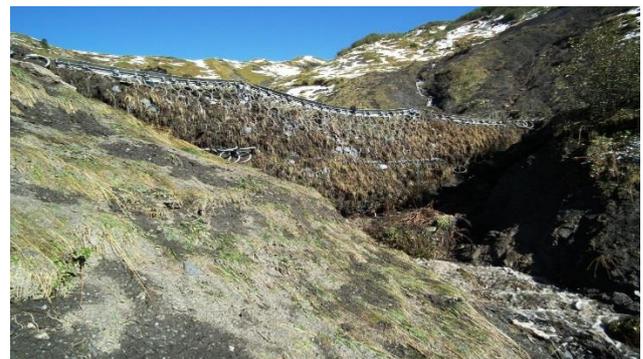
Figure 10: 11 debris flow protection barriers, successfully filled in Hasliberg in 2011.

Most of the multi-level barriers have already been successfully filled during events (see **Figure 10**). Chosica is the most recent example in 2017, protecting efficiently several cities built downstream (see **Figure 11**).

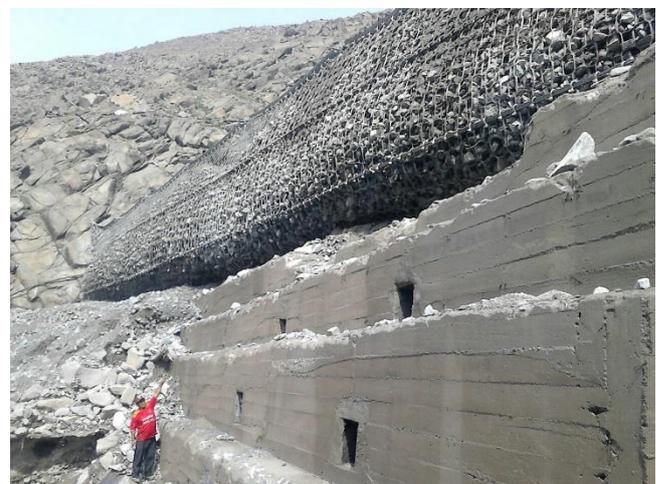
Figure 11: Filled debris flow barrier in 2017 in Peru, protecting successfully a large city downstream.

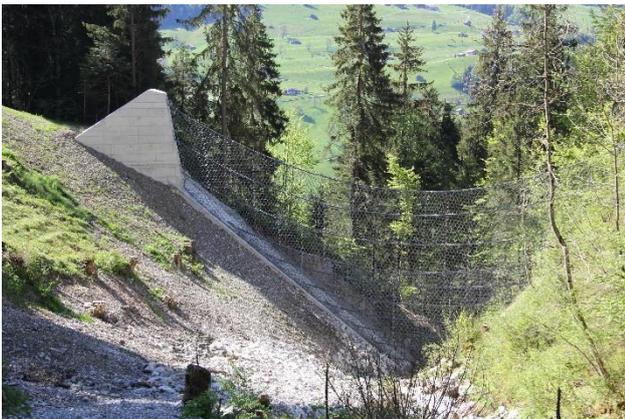
Figure 12: Special construction of a debris flow barrier in Hüpach, in Switzerland, with a width of 40m and a netting height of 10m.

This barrier has a retaining capacity of more than 12'000 m³. Such a construction necessitates strong abutments of steel reinforced concrete, long anchors and needs special ropes used for cable cars which need precise adjustment (see **Figure 12**). Special calculations for the netting and the ropes, adjustment to the anchoring and special foundation engineering in exposed terrain was necessary to complete the project. The decision to install a large retaining structure with netting was based on the topography, the difficulty of access and lack of alternatives to protect the village below. The debris flow barrier has not been filled yet.

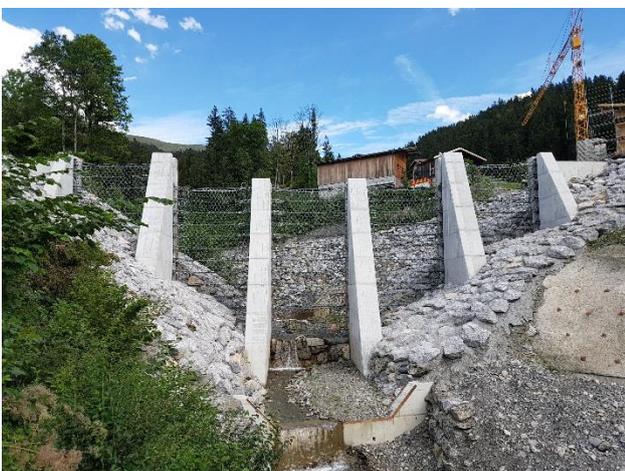
Figure 13: Another special construction acting as a debris flow

barrier in Sitäbach consisting of concrete slices piled up and netting mounted in between.

Another special construction is situated in Sitäbach along the stream Lenk, in Switzerland. The construction is based on concrete slices and netting in between (see **Figure 13**).

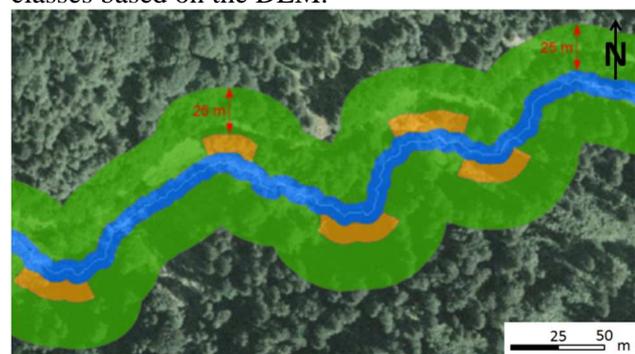
Fig. 4 Identification of process-relevant areas: Windthrow-affected areas with a distance of one tree-length from the channel are depicted in green. The areas related to erosion of forest covered riverbanks are shown in blue. Bank erosion related-areas are plotted in orange. In this example, no landslide reaches the channel

Windthrow: Storm events can cause the input of woody debris into the channel from the adjoining slopes up to a distance of one tree-length [Handschin and Duss 1997]. At steep slopes logs from a distance of up to two tree-lengths can reach the channel. The identification of the affected areas is achieved automatically by generating slope angle classes based on the DEM.

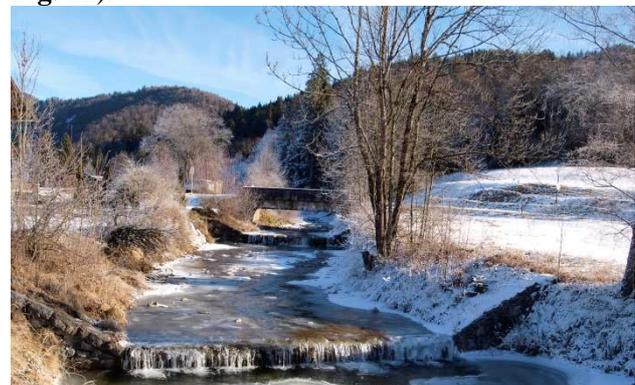
Fig. 12 Bridge at Entfelderstrasse

Due to the bridge's dimensions and constructive design it is regarded as a critical structure, especially as the flow depth exceeds the clearance height. Further aspects are: rough and unsurfaced channel bottom, structures upstream and downstream of the bridge. Furthermore the free surface width of the channel is wider than the bridge's inner width (see **Fig. 12**).

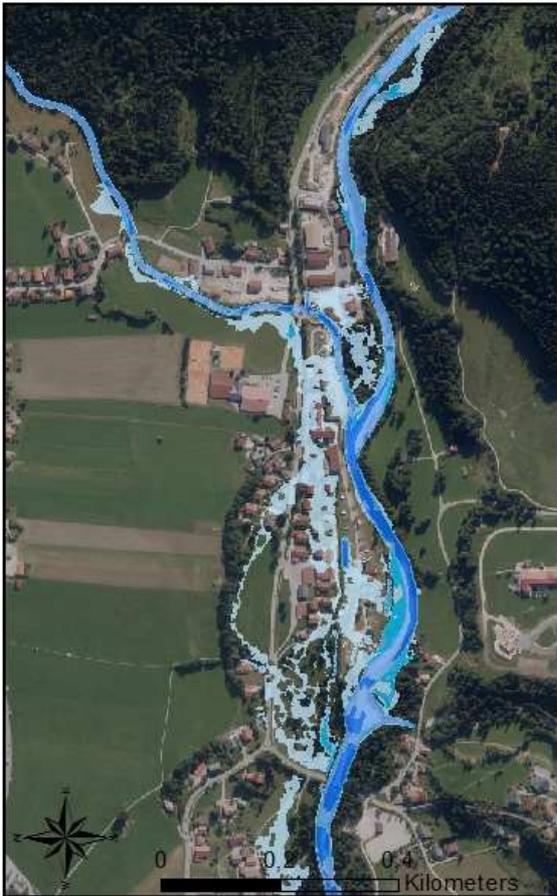
Fig. 13 Simulation result for the default scenario without any log jams or sediment accumulations. The Entfelderstrasse bridge's position is marked with a *green* dot. The bridge at Alpenstrasse is marked with a *red* dot

The first hydraulic simulation run considers the basic scenario without log jams or other scenarios (**Fig. 13**). The results show minor flooding near the bridge at Entfelderstrasse mostly affecting lawns and agricultural land. At the adjacent bridge where the Weisslofer is crossed by the Alpenstrasse, the simulation results show an overtopping of the banks resulting in major inundations along the Alpenstrasse. The overflowing affects settled land to a large extent even in the scenario with an unblocked bridge at Alpenstrasse.

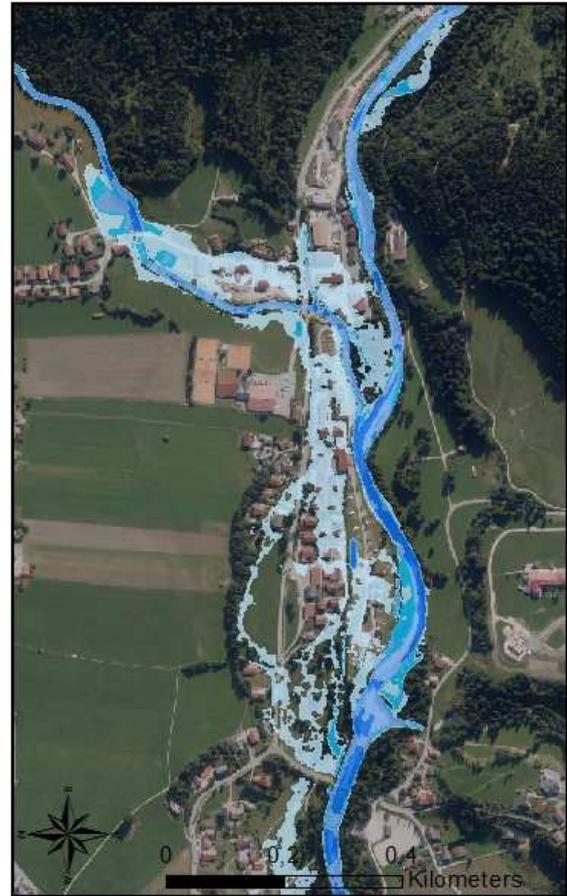
Fig. 14 Simulation result for the scenario considering a log jam at the bridge at Entfelderstrasse. The Entfelderstrasse bridge's position is marked with a *green* dot. The bridge at Alpenstrasse is marked with a *red* dot

The second scenario (see **Fig. 14**) takes into account the log jam at the bridge at Entfelderstrasse. Compared to the default scenario, the river overtops near the Entfelderstrasse bridge. This results in an additional inundation of major settled areas east of the Entfelderstrasse. However, the log jam at the bridge at Entfelderstrasse does not affect the extent of the inundated areas along the Alpenstrasse.

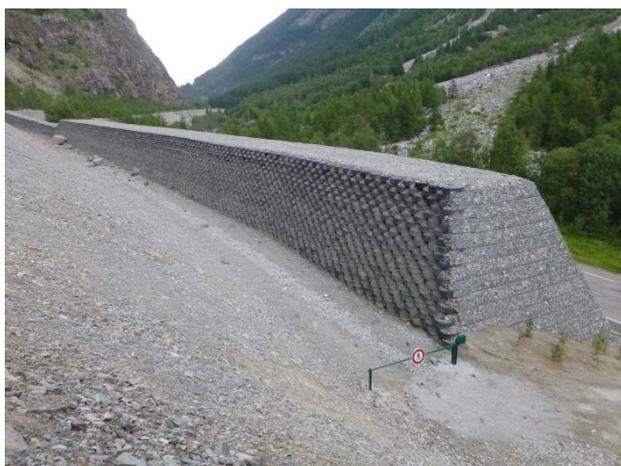
Fig. 1 Example of a 7m-tall reinforced embankment protecting a road (S. Lambert)

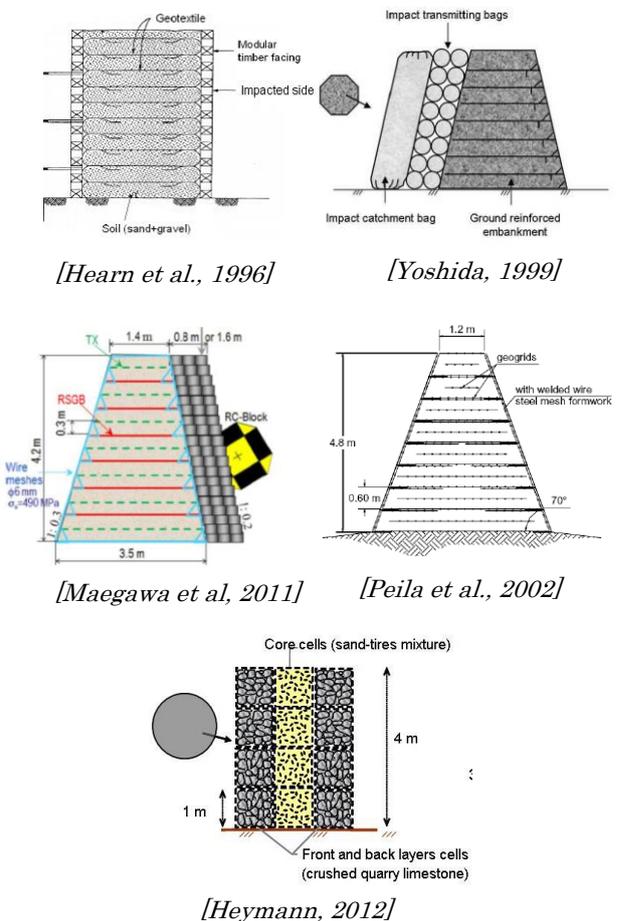
Fig. 3 Embankments subjected to real-scale impact experiments by different authors

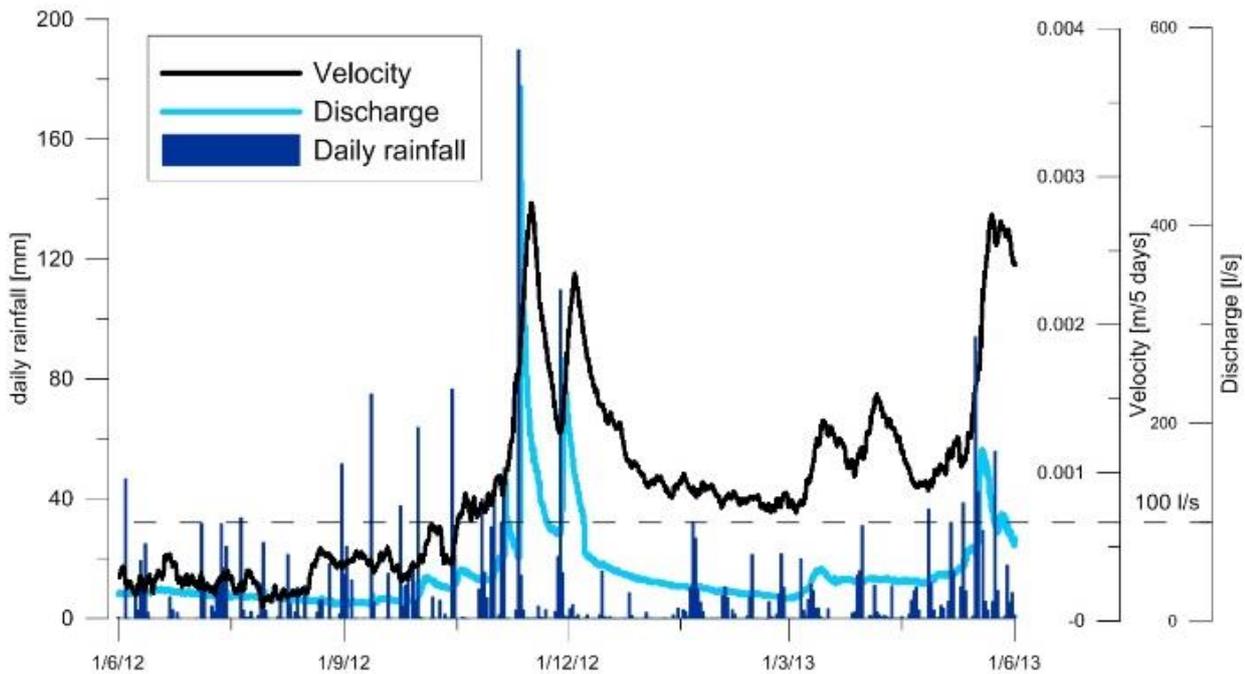
Fig. 5 Velocity of the landslide along the slip surface in I21bis in comparison with the daily rainfall and the discharge in the Rio Verde – the dashed line represents the proposed plant’s maximum discharge

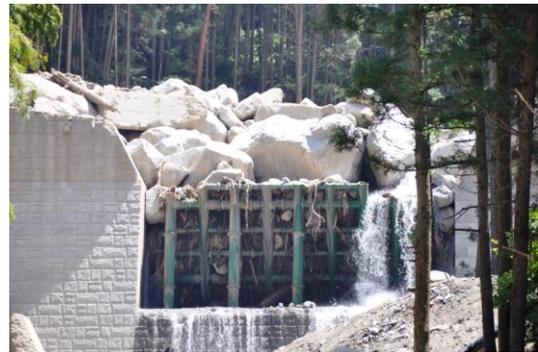
Photo 1 Steel open Sabo dam

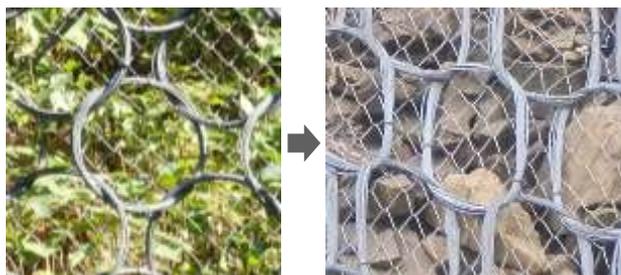
Fig. 3 Deformation of ring net - (left) unloaded, (right) loaded

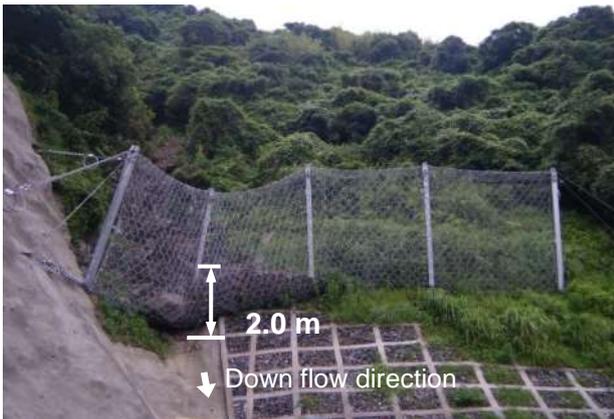
Fig. 7 Capture case of collapsed sediment (a)

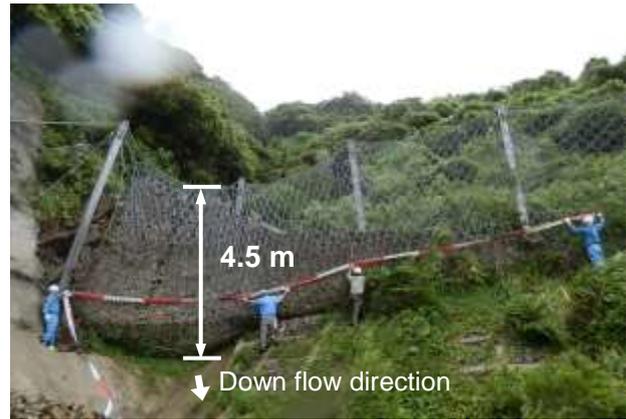
Fig. 8 Capture case of collapsed sediment (b)

For impact barrier, replacement criteria are set for each component, and when the amount of deformation of the component exceeds the standard, it has to be replaced. Therefore, we choose case (b), where the estimated impact force was closest to the design condition and the components deformation exceeding the replacement criteria were observed, to be the performance verification study case.

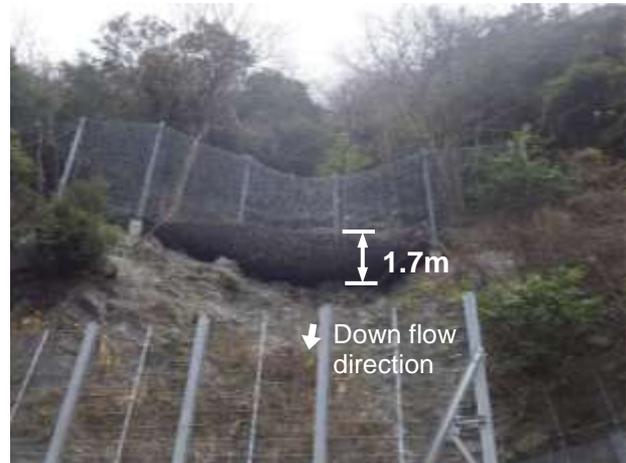
Fig. 10 Capture case of collapsed sediment (d)

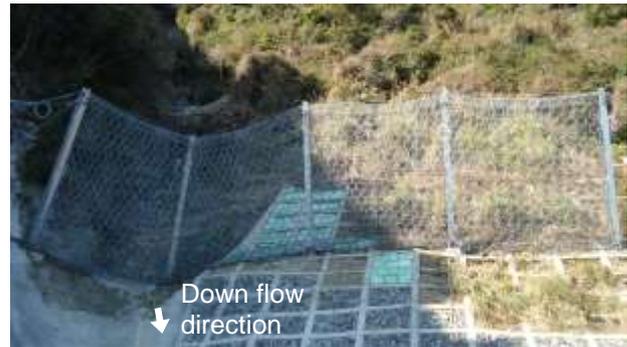
Fig. 11 Works completed

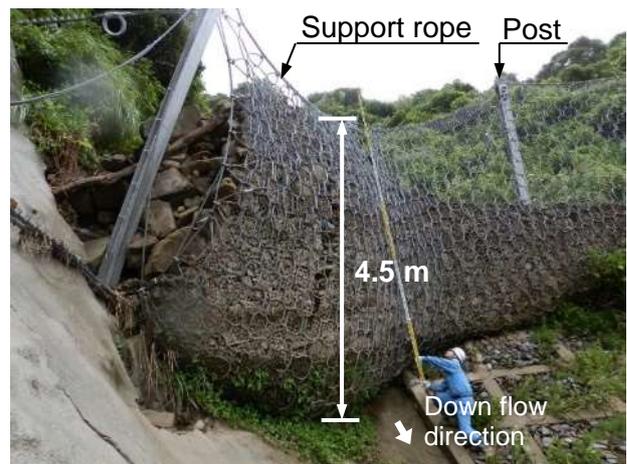
Fig. 12 Sediment deposit height

pressure were calculated using the calculation equation specified by MLIT Notification No. 332 (March 28, 2001). The calculation results indicate an impact force smaller by about 10% than the design value and a deposited earth pressure, calculated from the sediment deposition height at the site that was larger by about 22% than the design value. This is due to the difference in internal friction angle. Although the internal friction angle was set to 35° under design conditions, in the actual phenomenon, it was set to 30° with reference to the sediment gradient of the sediment deposited inside the impact barrier.

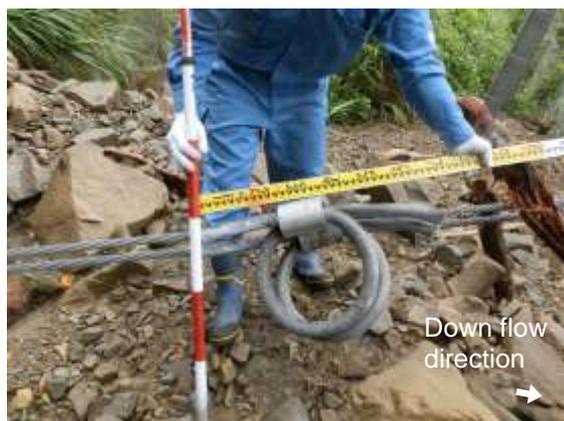
Fig. 17 Measuring the reading of the brake ring travel

deformation. For example, in the case of ring net, replacement is performed, when the wire of ring is greatly plastically deformed or fractured. In the case of brake ring, replacement is performed, when the travel of brake ring exceeds 40cm (Fig. 5 and 6).

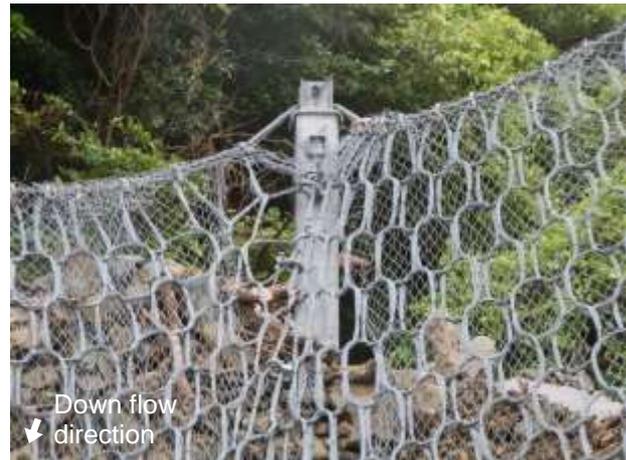
Fig. 19 Deformation of the ring net

The deformation of the net, post head and post base after capturing sediment are shown in **Fig. 19**, **20**, and **21**. Deformation that may affect sediment capture performance was not confirmed at any component.

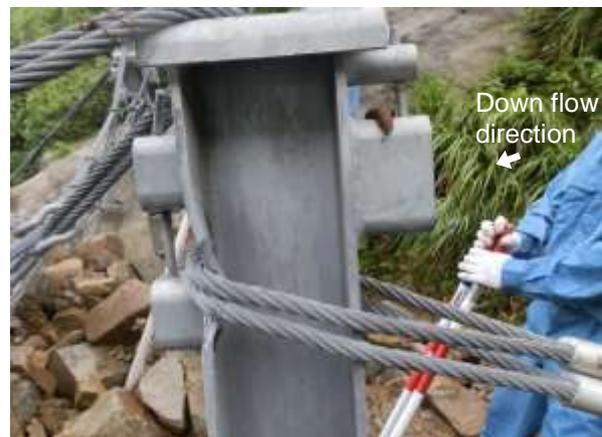
Fig. 20 Deformation of the post head

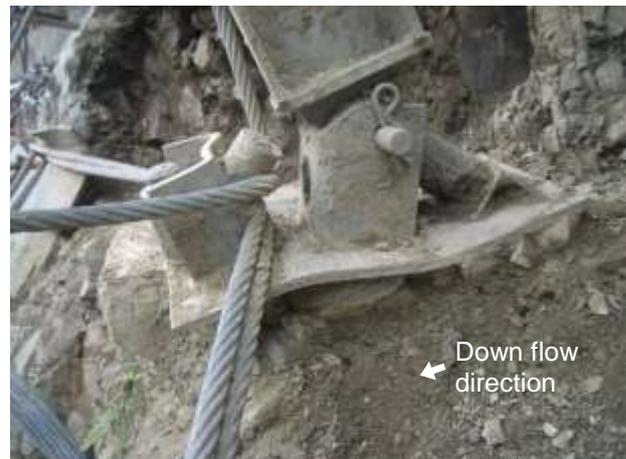
Fig. 21 Deformation of the base plate

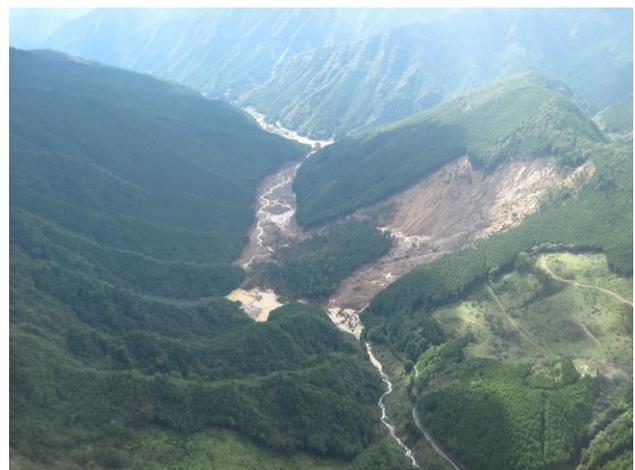
Fig. 3 Damage situation of the Iya area

In particular, in the Iya area (Tanabe city), a landslide dam was formed by a large-scale deep-seated landslide. The potential damage that may be caused by the collapse of the landslide dam was under apprehensiveness and stimulated urgent circumstances. As for the Nachikatsu-ura town, debris flows occurred at many branch torrents in the Nachi-River basin and debris flow sediments deposited in its river area. As the result, the river area was affected by widespread flood damages. Emergency Sabo works were required in order to avoid the occurrence of secondary sediment disasters. The damage situation of the Iya area and the Nachikatsu-ura town is shown in **Fig. 3** and **Fig. 4**.

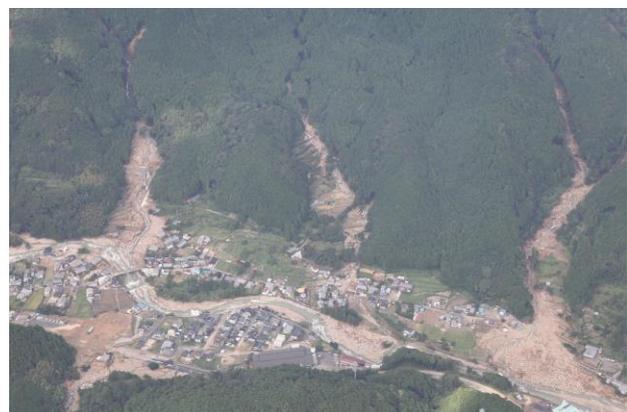
Fig. 4 Damage situation of the Nachikatsu-ura town

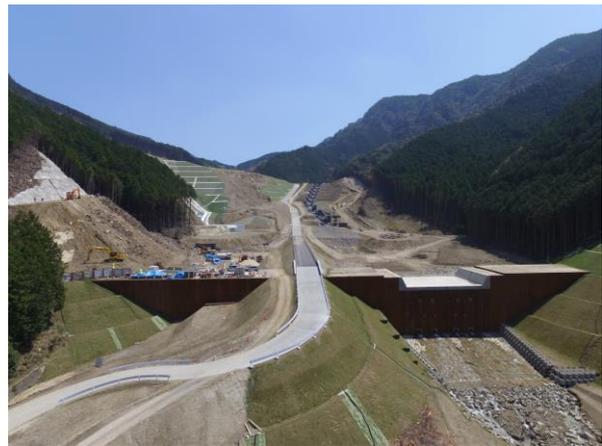
A landslide dam with a reservoir was formed due to the occurrence of a large-scale deep-seated landslide. The size of the landslide recorded approximately 450m in width and 650m in length. The volume of sediment caused by the landslide was estimated approximately 410,000m³.

Drainage works, backfilling of the reservoir and temporary channel works were carried out as emergency works. Sabo dam, stream preservation works and surface drainage works, etc. are carried out as restoration measures. Disaster prevention works are shown in **Fig. 5**.

Fig. 5 Disaster prevention works of the Iya area

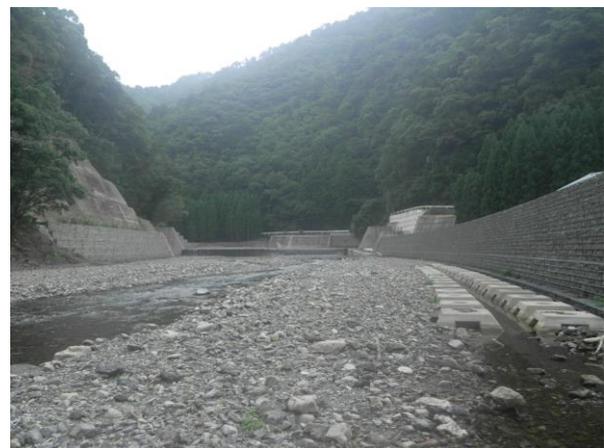
A large-scale deep-seated landslide blocked the Mikoshi-River temporarily and a new river channel was formed in the center of a residential area located in left bank of the river.

Temporary revetment works and backfilling of reservoir were carried out as emergency works. Groundsels and revetment works are carried out as restoration measures. Disaster prevention works are shown in **Fig. 6**.

Fig. 6 Disaster prevention works of the Mikoshi area

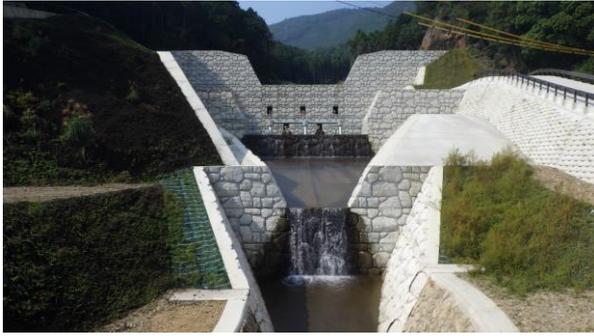
The Nachi-River area was affected by debris flows and drift woods, which were caused by surface failures at many branch torrents in the Nachi-River basin, and widespread flood damages that are accompanied by the debris flow sediments.

As the restoration works, Sabo dams are constructed at branch torrents where debris flow occurred and Sabo works are also constructed at main steam of the Nachi-River in order to entrap debris flows and drift woods. Disaster prevention works are shown in **Fig. 7**.

Fig. 7 Disaster prevention works of the Nachi-River basin

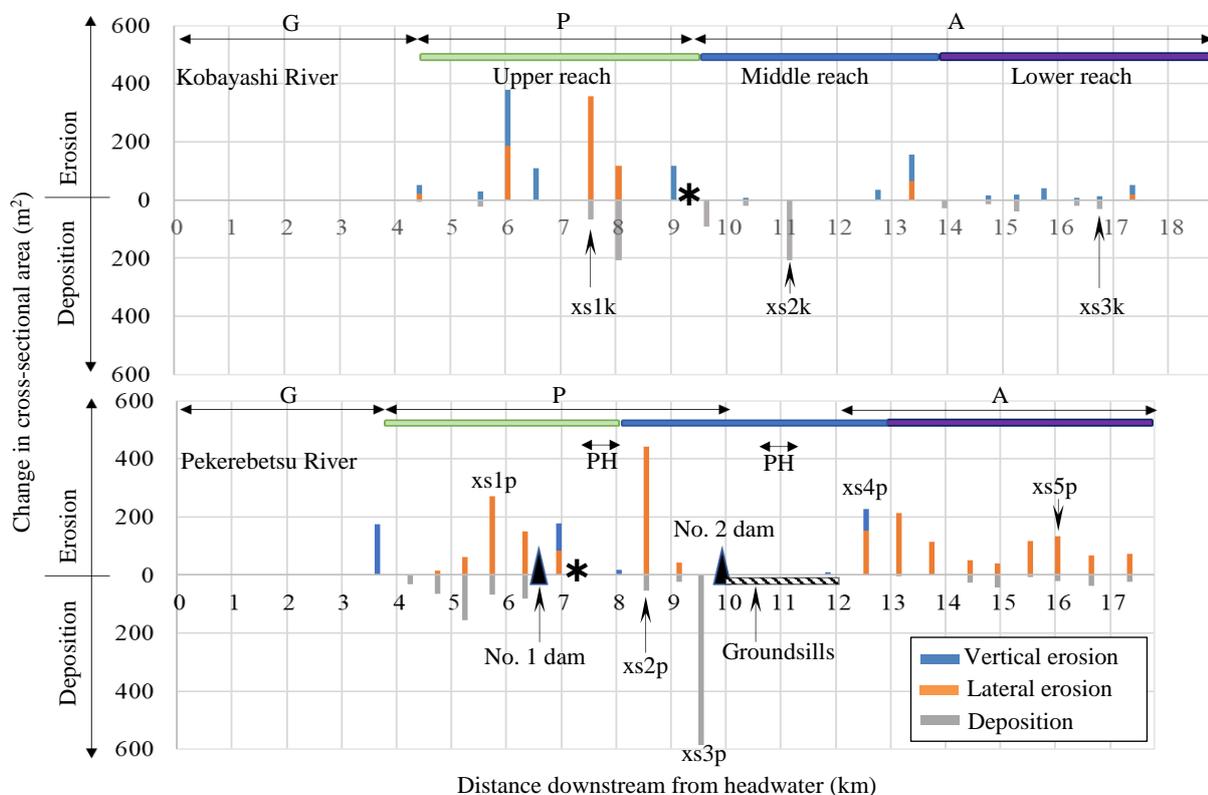
Fig. 4 Sediment deposition and channel erosion by the typhoon Lionrock. G: granite, P: periglacial colluvial deposits, A: alluvial deposits, and PH: pelitic hornfels forming gorges. *: The most downstream point that debris flow deposition was found.

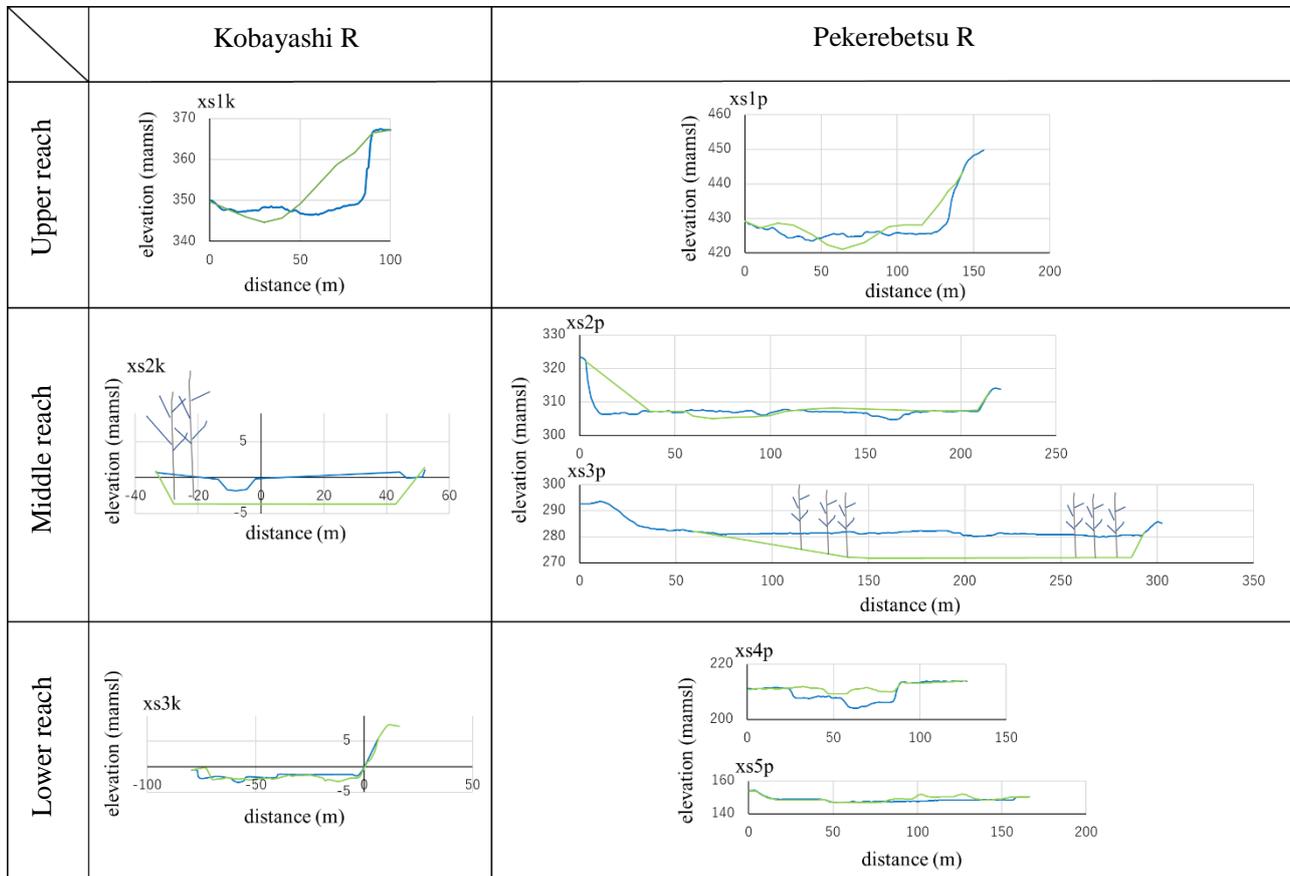
Fig. 7 Representative cases of cross-sectional changes. The locations are indicated in Fig. 4

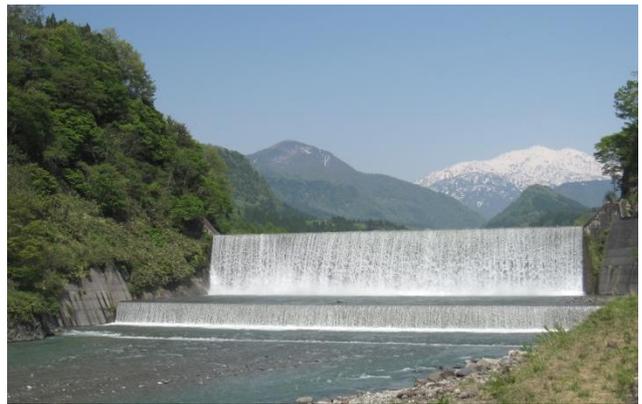
The Hongu Sabo Dam has been highly praised for demonstrating “the technical level of sabo facility design in the early Showa period”. The dam has been deemed a “valuable example of mechanized construction techniques”. In November

Fig. 5 Hongu Sabo dam (present day)

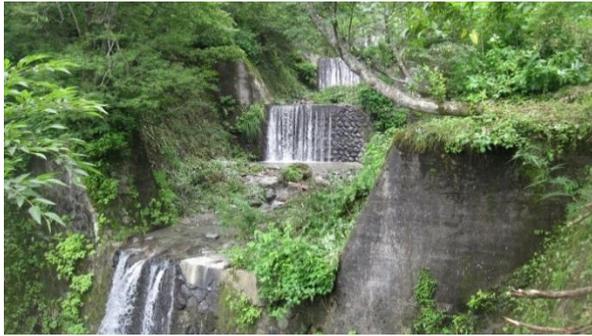
Fig. 6 Dorodani Sabo Dams (under construction)

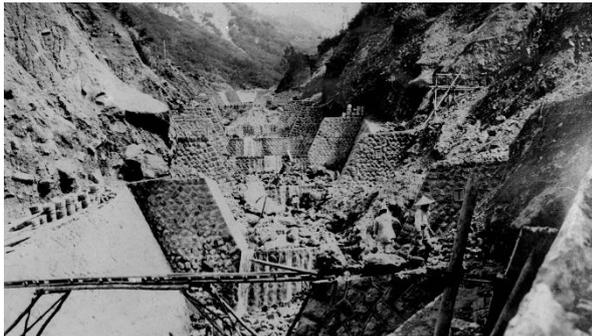
Initially, Toyama Prefecture constructed sabo facilities in Dorodani, but these were damaged during the heavy rains of 1929. The Ministry of Japan started re-construction of the Dorodani Sabo Dams in 1930 (Fig. 7).

Fig. 7 Dorodani Sabo Dams (present day)
