INTERPRAEVENT
2018 – Toyama, Japan

Large scale
sediment disasters
in orogenic zones
and countermeasures

Large scale sediment disasters
in orogenic zones and countermeasures

Symposium Proceedings

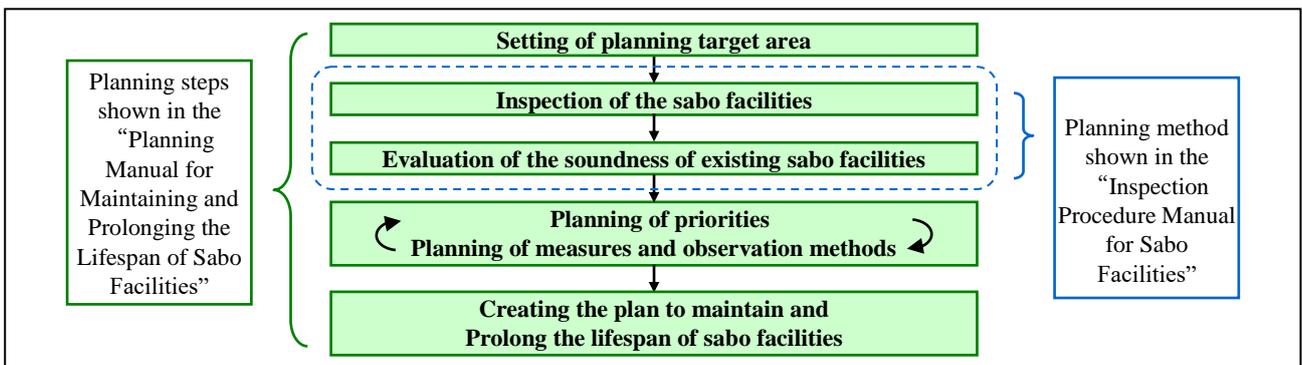
Fig. 8 Contents of the “Planning Manual for Maintaining and Prolonging the Lifespan of Sabo Facilities” and the “Inspection Procedure Manual for Sabo Facilities”

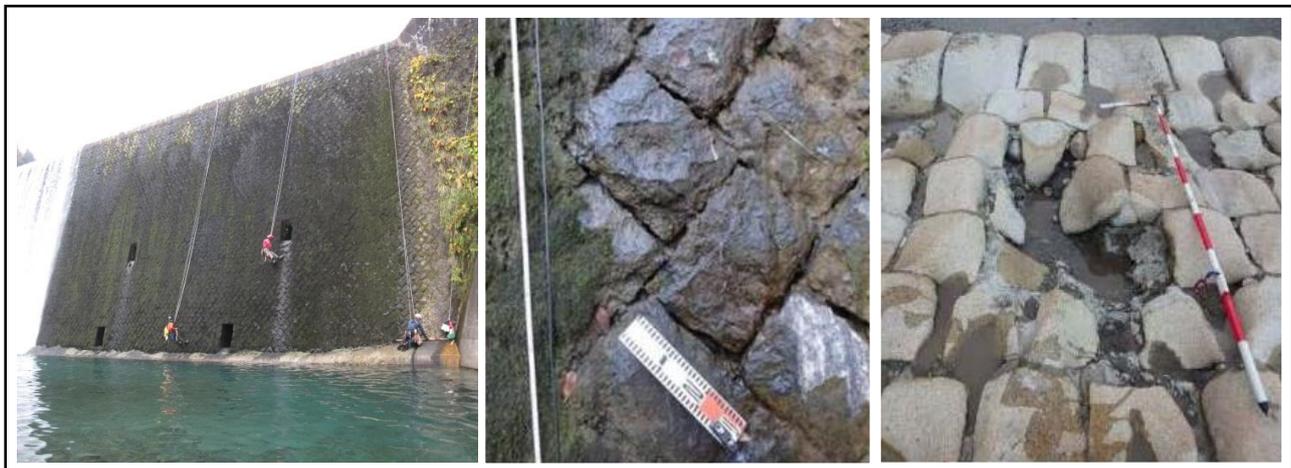
Fig. 10 Example images of detailed visual inspections of sabo facilities

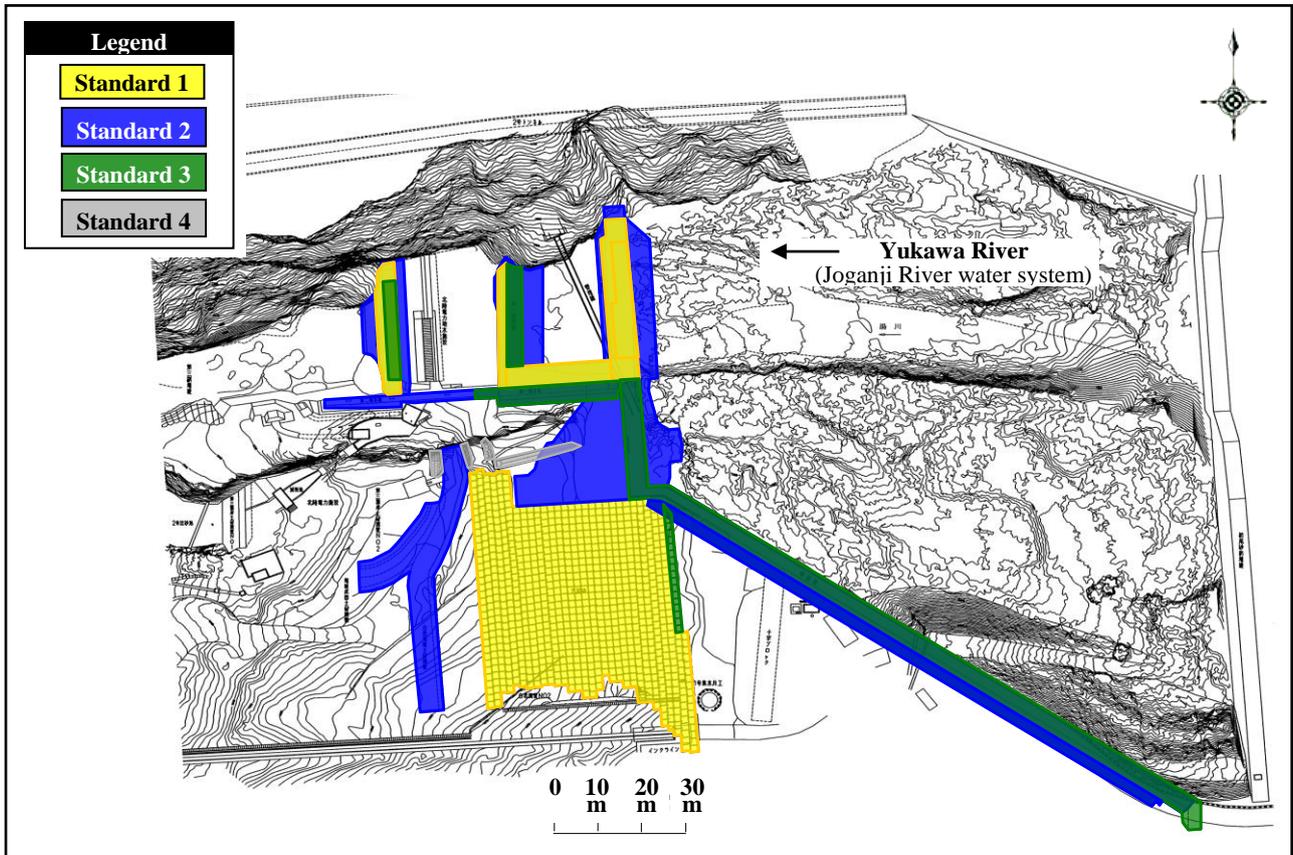
Fig. 12 Extent of the Important Cultural Property designation and standards for the conservation of each “position” of the Shiraiwa Sabo Dam

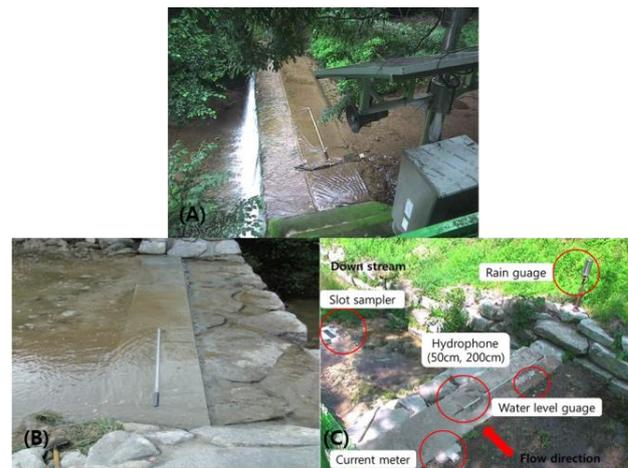
Fig. 1 Site photos of the bedload monitoring sites (A: Control site, B: Landslide site, C: Forest fire site)

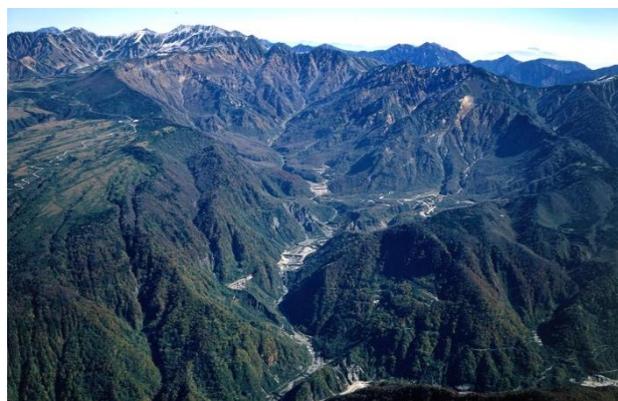
During the 1858 Hietsu earthquake (7.1 magnitude), the massive Tonbi landslide occurred, originating at the Tateyama Caldera (**Fig. 1**). About 400 million m³ of sediment were accumulated, of which 200 million m³ flowed down the mountainside. As a result, 140 people died and 8,945 people were injured.

Fig. 1 Tateyama Caldera

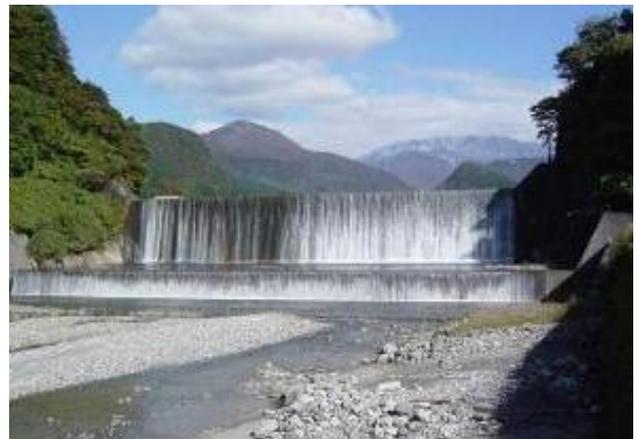
Its height is 22.0 m, and its crest length is 107.4 m, a total of 23,500 m³ of concrete was used in the construction of the dam body, with a sediment trap capacity of 5 million m³ (Japan's largest). It has five counter dams.

Hongu Sabo Dam was built before the existence of the materials and machine tools now used for dam construction. To save cement, which was then prohibitively expensive, stone material was used for the outside of the dam (front and crest) and rubble concrete was used for interior construction.

Fig. 3 Hongu Sabo Dam

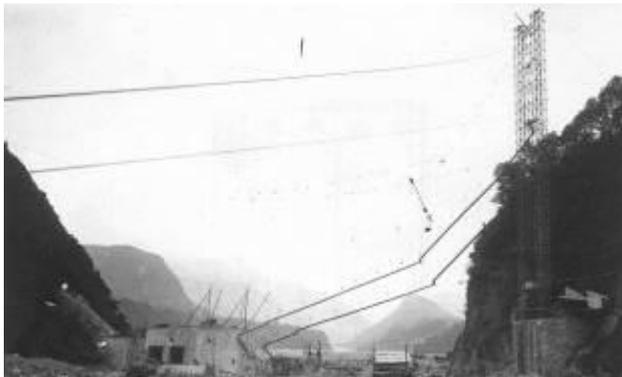
(Figs. 4 and 5), large tower cranes, chutes, and rubble concrete were introduced. These were state-of-the-art equipment, materials, and methods for the period. Despite its size, the dam was completed in less than 2 years.

Fig. 4 Large tower cranes and chutes (1935)

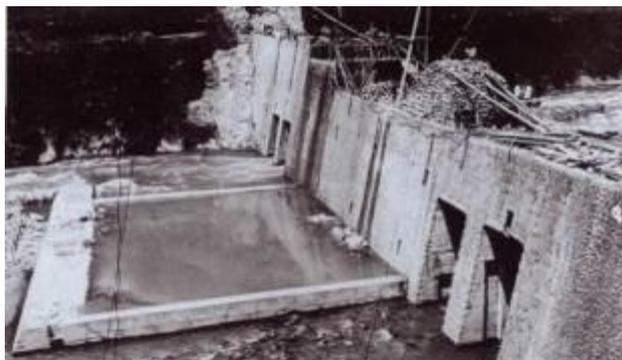
Fig. 5 Hongu Sabo Dam construction (1936)

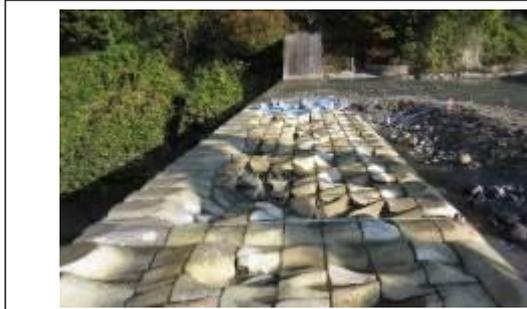
In the future, when a large stone is missing from the upstream or downstream side of the dam crest, repair will begin at the dam crest.

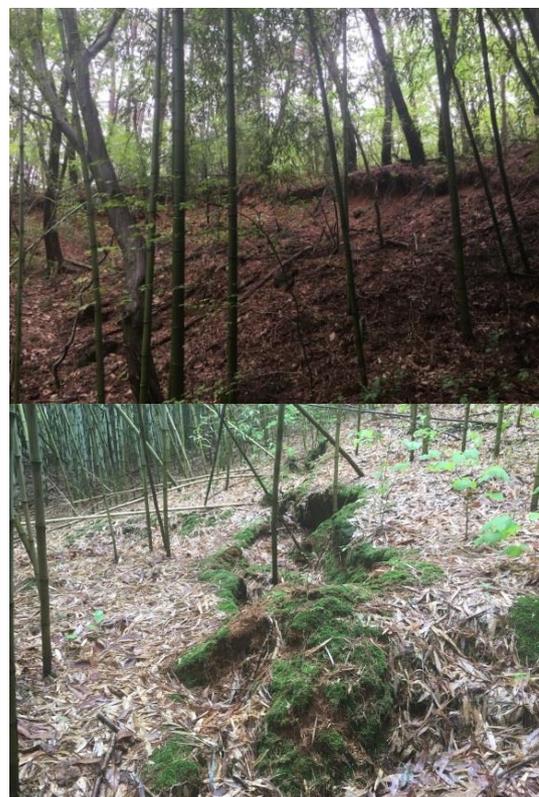
Fig. 2 Site photos taken from the tensile crack of the study site (upper: crack ①, lower: crack ②)

cracks were found in 4 areas (**Fig. 1** and **2**) and assumed that tensile cracks developed as slow-moving landslide progressed toward south-east. The width of each tensile crack ranged from between 0.2 to 0.5 m with its level difference from 0.25 to 0.45 m. A total length of 4 areas of tensile cracks is 170 m, and among which, the longest crack of more than 100 m is situated in the upper slope.

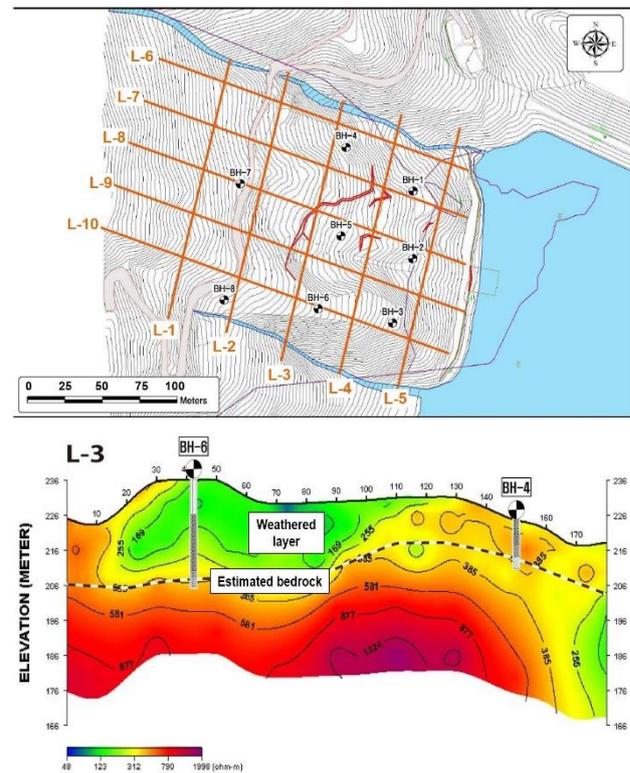
Fig. 3 Result of the electrical resistivity survey (L-3 cross section) on the study site

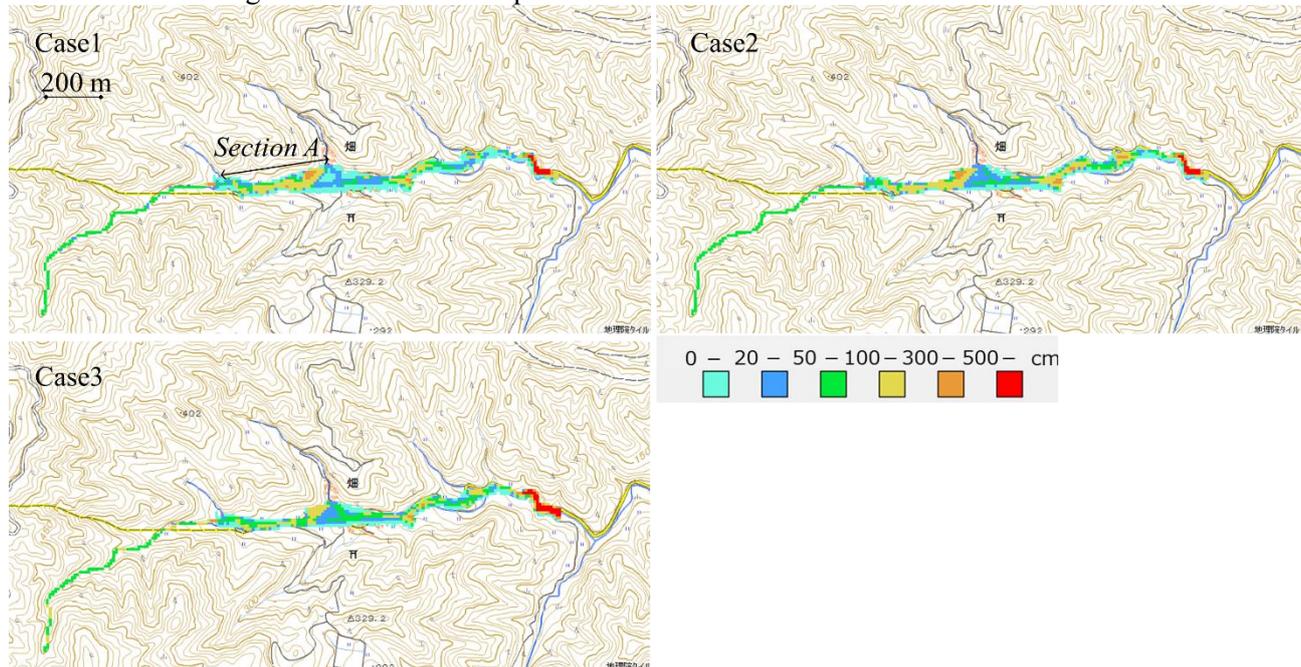
Fig. 11 Debris flow simulation results in Hata river; maximum flow depth and deposition thickness during simulation

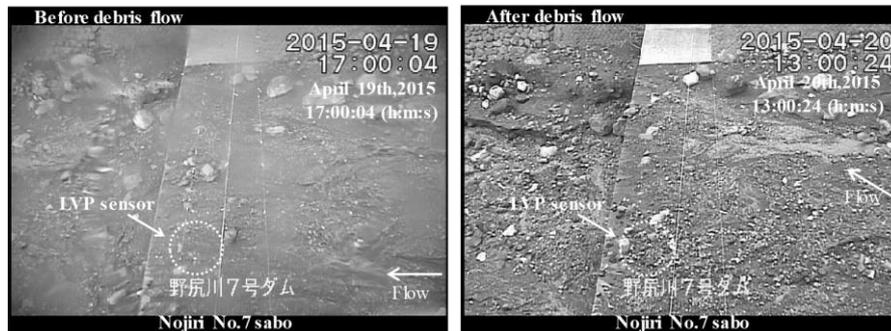
Fig. 5 Debris flow events with transvers flow shifting on April 19th in 2015

after wires were disconnected. Debris flows on September 20th, 2016 cut the 1st to 3rd wires, and were of a relatively large magnitude. Debris flows detected by both the wire and the LVP sensors after wires were disconnected were observed on April 6th, 2015 and June 19th, 2016. However, the LVP sensor did not detect the debris flows on April 19th, 2015 because of transverse flow shifting.

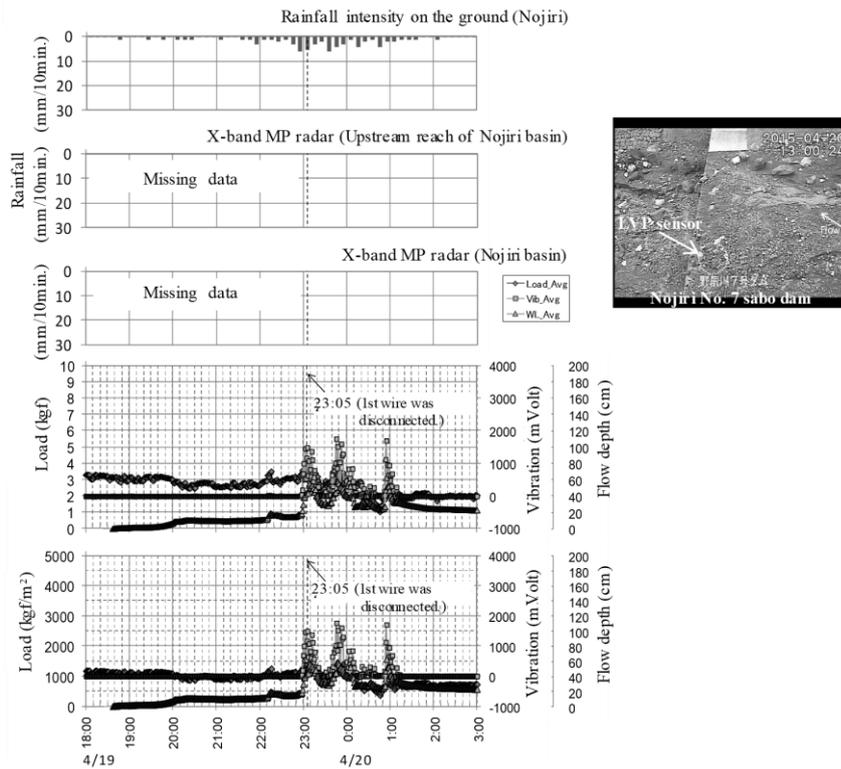
Fig. 6 Measured data obtained by the LVP sensor for debris flow events with transverse flow shifting (April 19th in 2015)

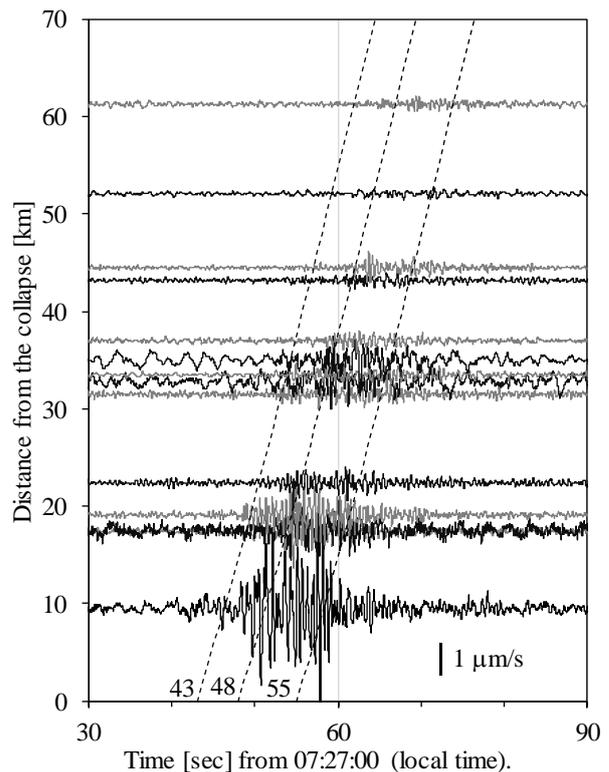
Fig. 6 1 – 7Hz filtered velocity waveforms of vertical component of the Akadani re-collapse in 2014. The waveforms are arranged by distance from the collapse. Adjacent records are shown alternately in black and gray for clarify. The oblique dashed lines correspond to the video image times in Fig. 7.
