Internationales Symposion INTERPRAEVENT 2004 – RIVA / TRIENT

DEBRIS FLOWS TRIGGERED BY THE 29 AUGUST 2003 CLOUDBURST IN VAL CANALE, EASTERN ITALIAN ALPS.

Domenico Tropeano¹, Laura Turconi²
in co-operation with Sebastiano Sanna³

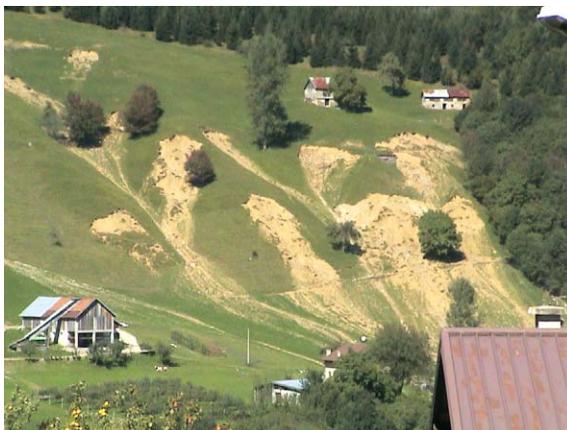
Figure 3. Soil slips on the left slope of Rio Studena, a right tributary of the T. Pontebbana stream above the village of Pontebba.

roots), soil slips occurred randomly, giving origin, as a rule, to muddy debris flows. Some grassland covered areas were equally affected by highly- concentrated soil slips (up to 10 slips per hectare in Studena, near Pontebba) (Fig. 3).

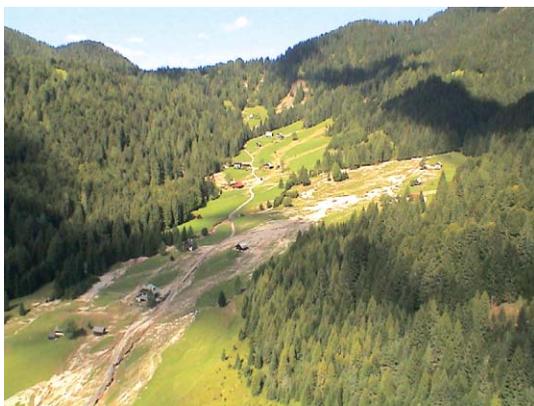
Figure 4. Several soil slips, on the left slope of the Valle Rauna sub-catchment of the Uque basin produced widespread flowpaths and irregularly distributed debris flow deposits over prairies and pastureland.

The Uque basin was affected by 30 such processes, concentrated in the right sector (Val Rauna and Rio Tamer sub-catchment) (Fig. 4, 5). Subsequent torrential processes deposited some 85,000 m³ of sediments on the alluvial fan, where the village of Ugovizza is located (90% gravel, pebbles and boulders, while finer materials were deposited at the margins of the fan or flowed into the main stream).

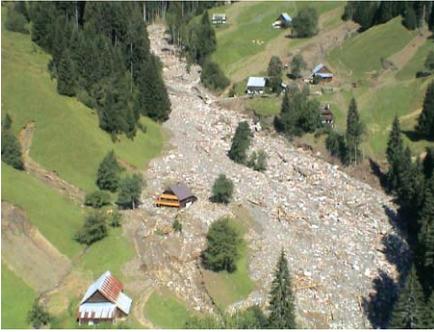
Figure 5. The stream channel of the T. Patamar, a right tributary of the T. Uque, was widened (up to 5-fold) by lateral erosion, menacing mountain huts with serious damage. .

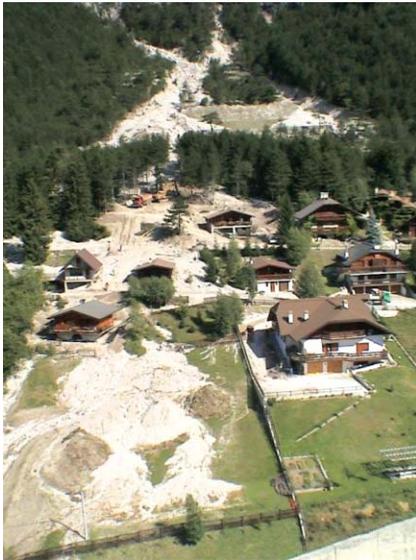
Figure 6. Huge debris flow deposits discharged from the dolomitic right slope of the Fella River invaded several houses in the village of Malborghetto, rapidly leading to the partial burial of buildings up to above 2 m, as illustrated here (Cucco locality).

Some 20 small catchments located on the right slope of the main valley discharged proportionally high amounts of debris, attaining $50,000 \text{ m}^3$ for a supply area of 2 km^2 (Rio Cucco) (Fig. 6).

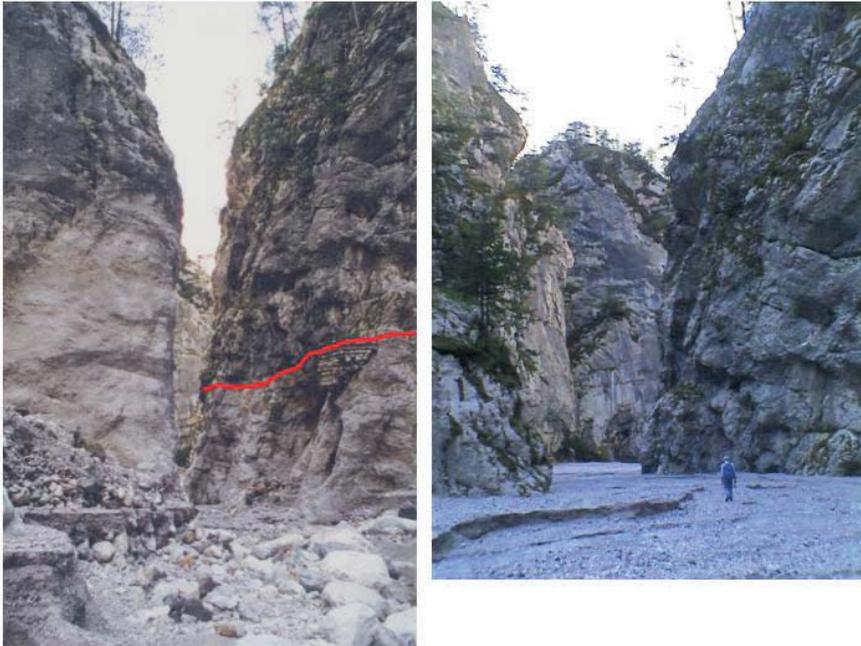
Figure 7. A stretch of the Vogelbach stream, Val Canale (Carnian Alps, Pontealba), some 100 meters above the fan apex, looking downstream. The person standing in the photograph testifies to the extraordinary thickening of debris flood deposits (rising to 8 meters) over the last 4 years, most of which was produced by the flood of, 29 August 2003 (right). A photograph taken in 1999 (left) still shows a remnant of the old retaining dam built between 1862 and 1866, originally rising 23 m above the stream channel incision.

Further westward, the “Rio degli Uccelli” stream (10.8 km^2) superelevated its channel up to 8 meters; the newly brought sediment load deposited over its fan totalled roughly $100,000 \text{ m}^3$ (Fig. 7).

For many years, the floods of a stream that could alter the discharge conditions of the Fella River by its “enormous” sediment transport (Scimone, 1927) were regarded as dangerous for the village of Pontealba/Pontafel, located downstream. For this reason, 10 years after the tremendous flood of November 1851, the Austrians (until 1918 the national border with Italy ran through the village) built a dam across the stream gorge, which was raised 4 years later to 23 m in height to restrain the impetus of the sediment-laden flood waves. No retaining dam has existed for at least 50 years (as witnessed by aerial photographs classified in the IRPI archives). In modern times, the channel was artificially restrained to make space for the highway and the freight station of Pontealba. The railway, which today runs through a tunnel under the fan channel (the gorge was spanned by a railway bridge until about 1977, as witnessed by aerial photographs) was totally filled by finer materials that poured onto the right side and then flowed down the railway trench up to the Pontealba station more than 1 km westward.

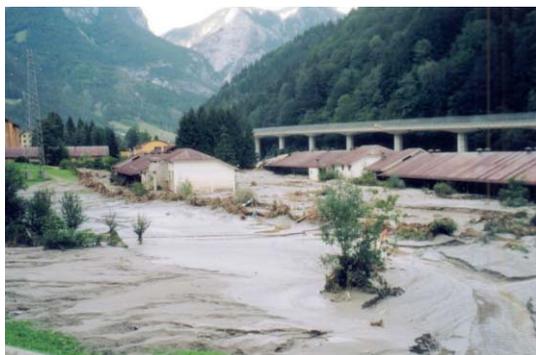
Figure 8. Valley bottom deposits (looking upstream) left by the flood of the Fella River near Pontebba. The stream channel is hidden by the buildings in background, where a stretch of the A-23 Highway is also depicted.

the village of Pontebba, a newly built fan (roughly accounting for 7000 m³) raised the channel bottom of the mainflow, thus provoking the partial flooding of the built-up area and a significant contribution to the Fella River downstream (Fig. 8).

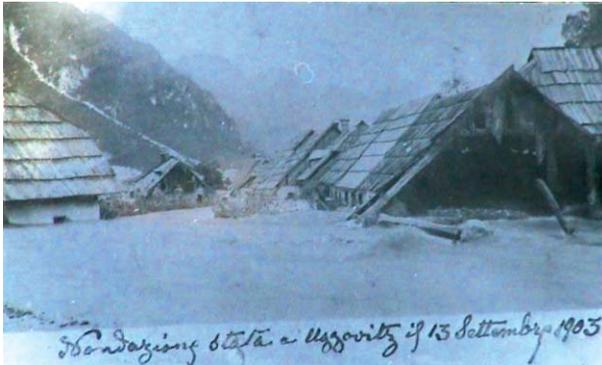
Figure 10. An old photograph found in the village parish archives. The original caption reads: “Flood occurred at Ugovitz on 13 September 1903”.

In the past, the Uque basin was affected by floods that invaded the village of Ugovizza 5 times between 1885 and 1923; in 1933 the houses were still menaced but nothing more happened in the 80 years following the event of 1903, which is remembered as being particularly serious (Gariup, 1986), during which a woman died inside her house (Fig. 10).
