Internationales Symposium INTERPRAEVENT 2004 – RIVA / TRIENT

THE STOŽE LANDSLIDE AND PREDELICA TORRENT DEBRIS FLOW

Consequences and Response to the Disaster

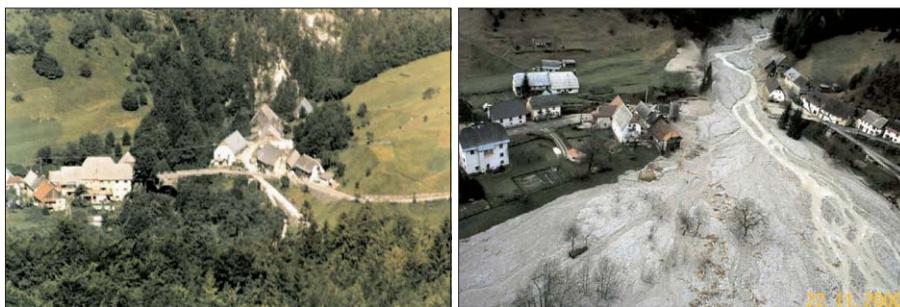
Fig.1., 2: The village Log pod Mangartom before and after the debris flow (Photo: Ž. Mlekuž, A. Horvat)

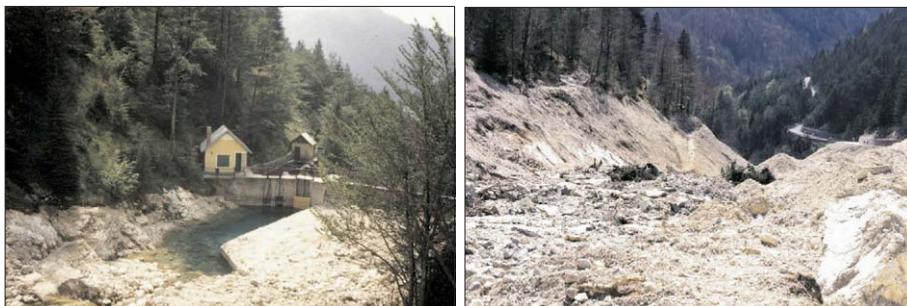
Fig. 3., 4: The hydropower plant object in the torrent Mangartski potok before and after the debris flow (Photo: archives of the PGD Log pod Mangartom)

The first landslide occurred on 15th of November 2000 at around 1 p.m. in the bed of the Mangartski potok torrent. The maximum inclination of the torrent bed is 15%. The bed rests on glacier and torrent deposits. Such material, even if it is totally wet, can not slide if the inclination is only 15%. The most probable cause of the landslide was a tremor that also occurred on the 15th of November. The tremor caused the liquefaction of the waterlogged material. The length of the landslide was 1 km, the width approximately 0,1 km, the volume approximately 600.000 m³. The speed of the landslide was less than 1 m/s. The landslide destroyed the Mangart hydropower plant ca 0,8 km downstream from the landslide source (Figure 3, 4) and the bridge on the road to the Predil boarder crossing ca 1,0 km downstream from the landslide source. In the Mangartski potok torrent gorge, due to a very steep inclination, the landslide changed the mode of movement into a debris flow. The debris flow stopped on the deposition area in the gorge of the torrent Predelica near the confluence with the torrent Mangartski potok. The debris consolidated and the mode of transport turned back to free flow of sediment (Horvat, 2001).

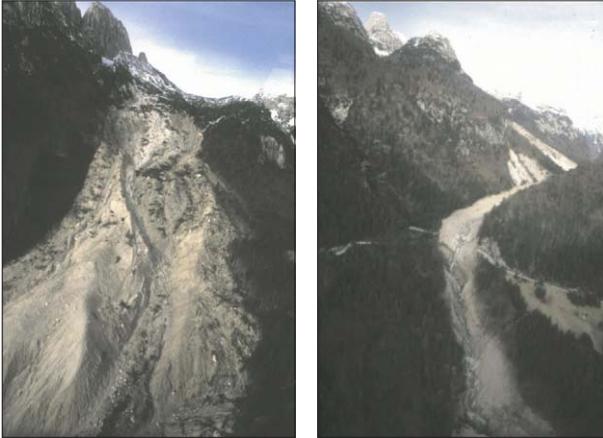
Fig. 5, 6: Second landslide source area and the Mangart potok torrent after the debris flow (Photo: B. Ušeničnik)
 Abb. 5, 6: Rutschungsgebiet und des Wildbachbett von Mangartski potok nach dem Murgangsergebnis (Foto: B.U.)

The second landslide (landslide area 200.000 m², landslide volume 1.000.000 m³) was released on the 17th of November on the Stože area, about 130 to 150 meters above the torrent bed of Mangartski potok (Figure 5). The triggering of the second landslide was not in direct connection with that of the first landslide. As the source area was very steep, the landslide immediately changed into a debris flow with an estimated speed of 8 – 10 m/s. (Majes, 2001). After about 500m the debris flow reached the bed of the Mangartski potok torrent (Figure 6).

As the first landslide caused the complete devastation of the middle and lower flow bed of the torrent Mangarstki potok and also of the middle flow bed of the torrent Predelica, there was practically no more place for the energy dissipation or the deposition of the debris. The second debris flow, with its high energy, destroyed the torrential beds of Mangartski potok and Predelica and part of the village of Log pod Mangartom (Figure 4). It also caused huge devastation in the bed of the Koritnica torrent where another small hydropower plant was damaged (Horvat, 2001).

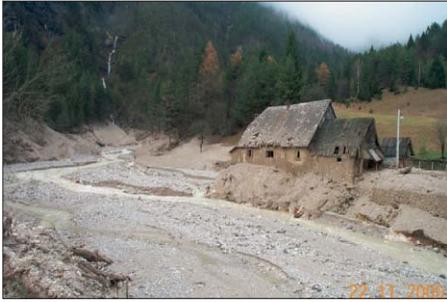
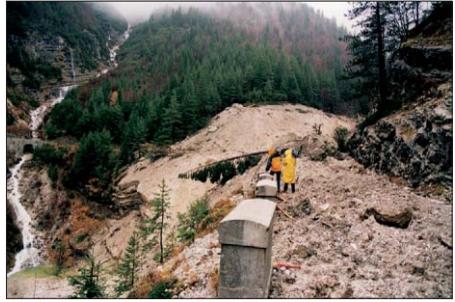
Fig. 7., 8: Damage in the village Log pod Mangartom – destroyed bridge on the road to Predil (Photo: A. Horvat)
 Abb. 7, 8: Die Schaden im Dorf Log pod Mangartom und zerstörte Brücke nach Predil (Foto: A. Horvat)

6 houses and 7 farm buildings were destroyed. Another 11 houses and 1 farm building in the village were damaged. The beds of Mangartski potok, Predelica and Koritnica torrents were destroyed on most of their length. Two bridges on the state road to Italy (Bovec-Predel_Tarvisio) were destroyed (Figure 7, 8); the important road connection to Predel was cut off. The important tourist road towards Mangart Col was cut off and destroyed on the length of ca 1km. Two small hydropower plants were damaged. There were great damages to electricity supplies and telephone connections.

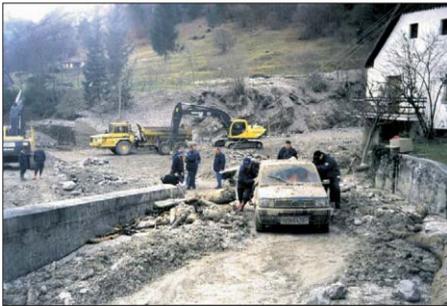
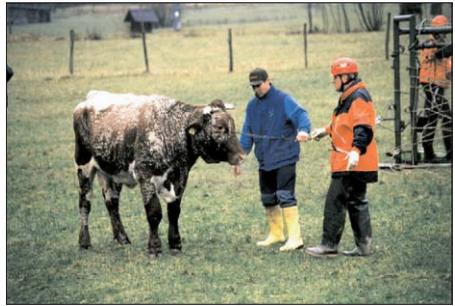
Fig. 9, 10: First intervention measures Care of the animals (Photo: PGD Log pod Mangartom and Bovec)
 Abb. 9, 10: Erste Intervention; Sorge tragen für die Tiere (Foto: PGD Log)

On the 25 November 2000 they examined the situation and proposed temporary measures for the affected area. The evacuated inhabitants should stay out of the village Log pod Mangartom until spring. The Municipal protection unit, the local fire brigade and some inhabitants from the village also took care of the animals and the property in the village (Figure 9, 10).

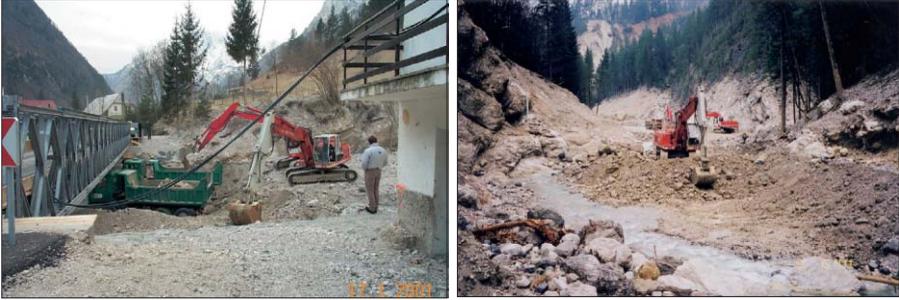
Fig. 11., 12: The Enterprise for Torrent Control removes debris from deposition area (Photo: A. Horvat)

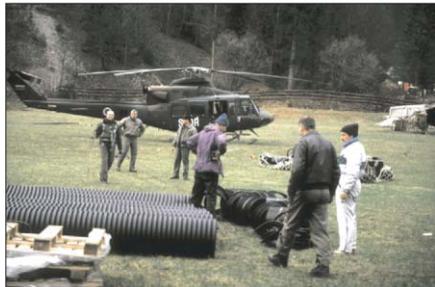
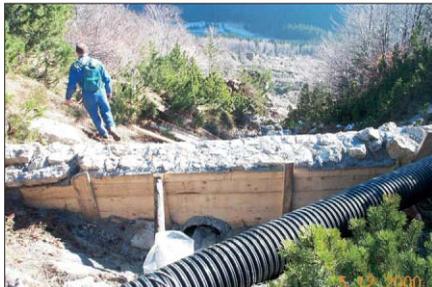
Fig. 13., 14: The Slovenian Air Force helped with helicopters; Draining of the landslide (Photo: B. Ušeničnik);
 Abb. 13, 14: Slowenische Luftkraft half mit dem Hubschrauber; Dränierung des Hinterlandwasser

The key rescue services and measures against this natural disaster were carried out by the local fire brigade, the Enterprise for Road Maintenance and the Enterprise for Torrent and Erosion Control. The latter started with necessary monitoring and torrent control measures (e.g. redirecting the torrent flow of Predelica in the area of Log pod Mangartom, draining of the landslide, etc.) in cooperation with the Slovenian Air Force's helicopters (Figure 13, 14).

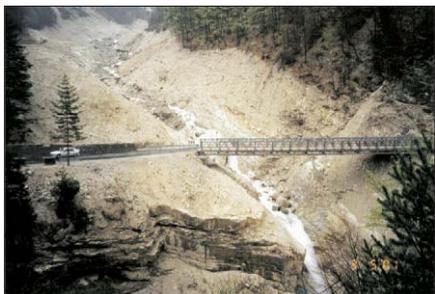
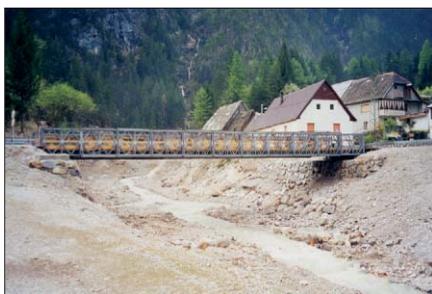
Fig. 17, 18: The two new bridges - on the road to Predil and in the village Log pod Mangartom (Photo: A. Horvat)
 Abb. 17, 18: Zwei neue Notbrücken auf der Straße Bovec - Predil und im Dorf Log pod Mangartom (Foto: A. H.)
