Internationales Symposion INTERPRAEVENT 2004 – RIVA / TRIENT

RIVER ENGINEERING MEASURES IN AN ALPINE RIVER AFTER A MAJOR DEBRIS FLOW EVENT

Matjaž Mikoš¹, Franc Rojnik² and Rok Fazarinc³

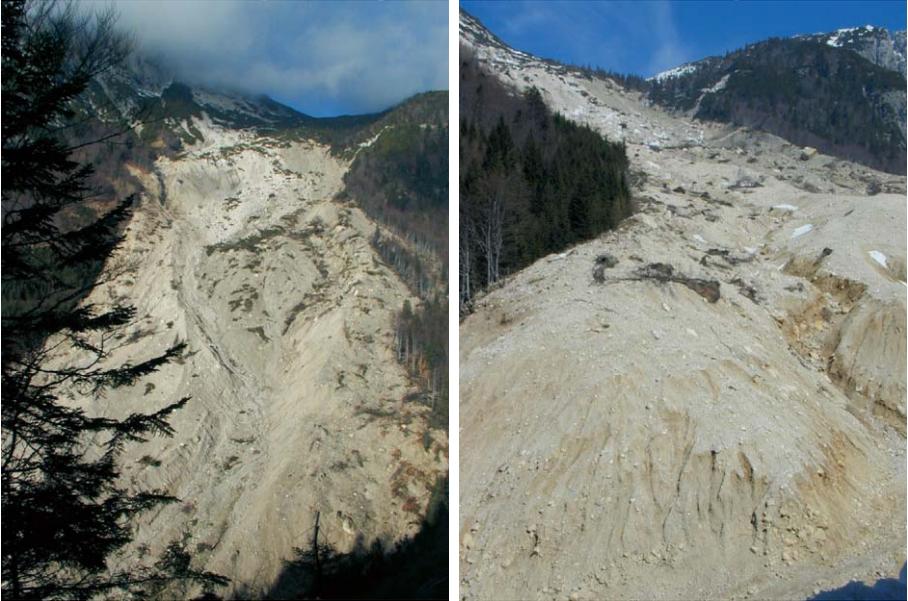
Fig. 1: A view towards the Stože slope after the event (on November 29, 2000).

The first landslide slipped on the Stože slope (Fig. 1) on 25 ha around 1 p.m. on November 15, 2000, after a long wet period of intensive rainfalls. The Stože slope, covered with beech forest with some pine trees, failed between 1200 m and 1500 m, and slipped masses of nearly 1 million m^3 turned to a dry debris flow. It destroyed the Mangart alpine road and a concrete intake structure for a small HPP, and stopped in the Mangart Creek's torrential channel with the 15 % longitudinal slope.

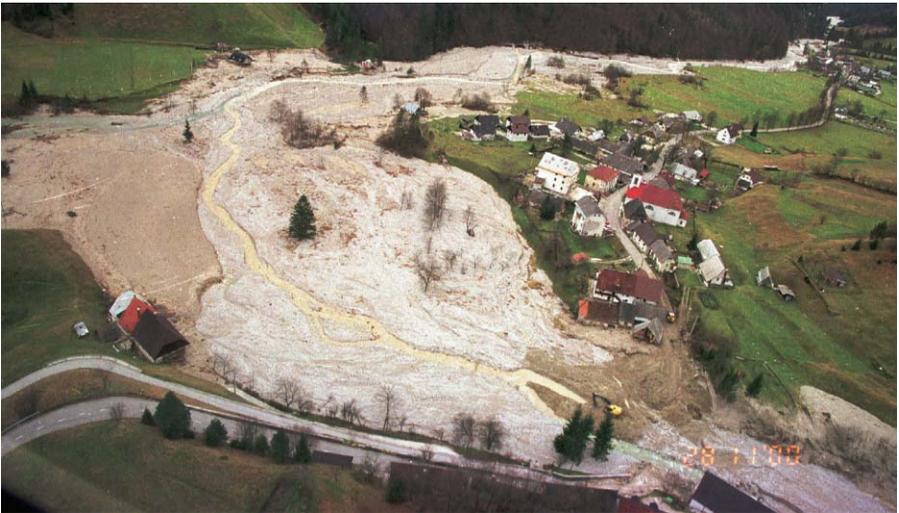
Fig. 2: Debris flow deposits in Log pod Mangartom (photo: November 28, 2000). The Predelica Torrent comes from the right and flows to the Koritnica River, coming from the left.

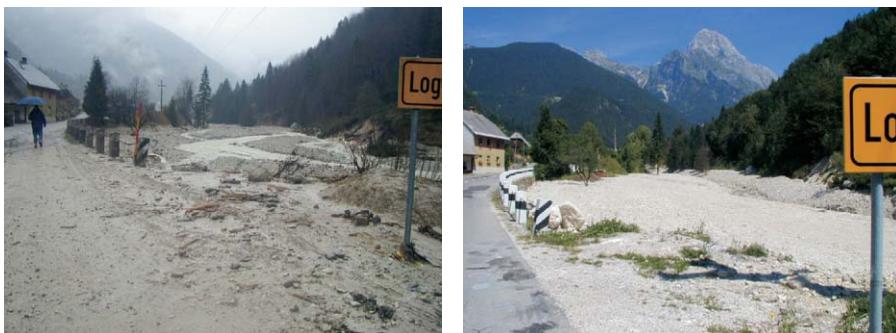
Fig. 5: A view towards the Koritnica River channel in Log pod Mangartom immediately after the debris flow event in November 2000 and after the completion of the first river engineering works in July 2001.

When forming a main channel to convey a 100-year flood the whole available potential in the area was used (no ground sill or similar structures were built). The channel width was chosen to be of less than 50 % of the normal channel width prior to the event. In 2001, the channel bottom of the Predelica was excavated to 3 m in width, and that of the Koritnica to 6 m at a longitudinal slope of 0.026 and 8 m at a slope of 0.022. The planned normal channel bed width (to be reached after the remediation will be completed) of the Predelica at a slope of 0.046 was 6 m, and that of the Koritnica River at a slope of 0.026 was 16 m. Temporary channels were formed with ungrouping of excavated debris flow deposits within the cross sections without any substantial transport along the channels. The surface of the ungrouped deposits was inclined towards the main channel (Fig. 5).
