## Monitored Behavior of Landslide at the Mid Niigata Prefecture Earthquake in 2004

Kazunori Fujisawa, Yasuo Ishii and Noriya Kamihara

Public Works Research Institute, 1-6, Minamihara, Tsukuba-shi, Ibaraki-ken, 305-8516 Japan

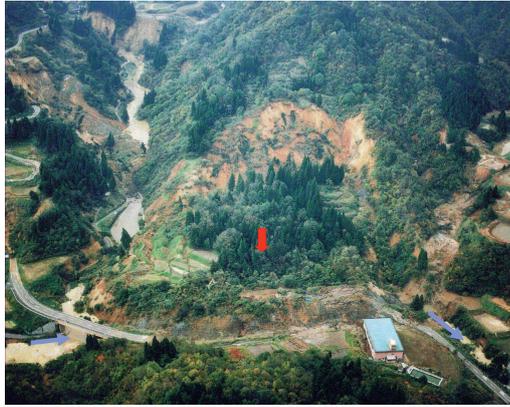
**Photo. 1.** Higashitakezawa

Soil masses that were found to have moved without deformation based on the aerial photographs were considered landslides (Photograph 1). Other types of soil movements were regarded as slope failures (Photograph 2). Landslides were further classified into two types as described below.

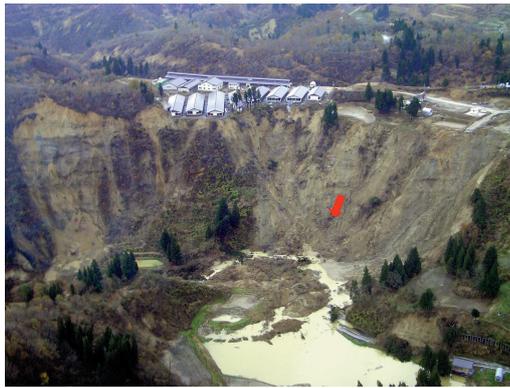
**Photo. 2.** Photograph-2 Naranoki
