Roadside Slope Failures in Nepal during Torrential Rainfall and their Mitigation

Abstract

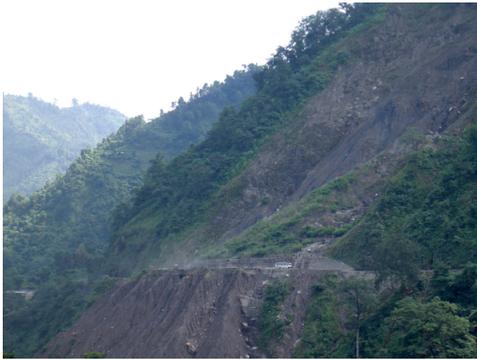
Fig. 4. Krishnabhir Landslide in October 2004

Crosta and Frattini, 2003; Xie et al, 2004; Aleotti, 2004; Wen and Aydin, 2005; Kim et al 2004) whereas most of the deep-seated landslides are affected by long-term variation of annual rainfall as well as daily rainfall which has to last at least some couple of years (Bonnard and Noverraz, 2001; Hong et al, 2005). In Himalayan context, shallow landslides are associated with monsoon brought torrential rainfall (Dahal and Kafle 2003; Poudel et al 2003; Gabet et al 2004; Khanal and Watanabe 2005). Not only shallow landslide, but also deep-seated landslides are also usually associated with the monsoon rainfall. Many roadside slopes along the highways consist of considerable numbers of deep-seated landslides which are in prolong creep during torrential rainfall. For example, a large and well known landslide of the Prithivi Highway, named as Krishnabhir Landslide (Fig 4), occurred after some days of intense precipitation, in the Trishuli River valley (Lesser Himalaya) at the beginning of mid of August 2000 and blockade the Prithivi Highway, main entry route of Kathmandu, total 11 days. Because of low cost mitigation measures and “wait and see” principle, the highway was blocked many times since 2000 and it was stabilized in 2005. Better to say, in 2005, there was no blockade report from the Krishnabhir Landslide.

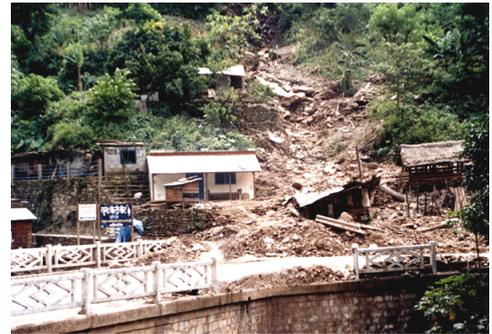
Fig. 11. Debris flow in Mugling Narayanghat Road at Jalbire village

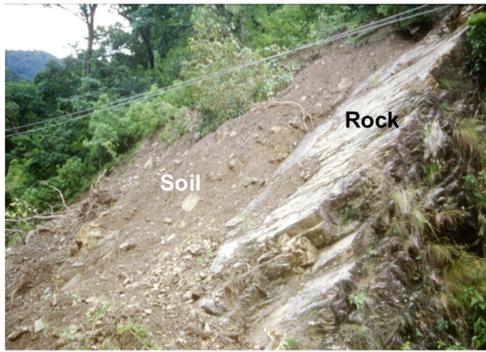
Fig. 13. Translational slides observed in Chatara-Barahchhetra rural road

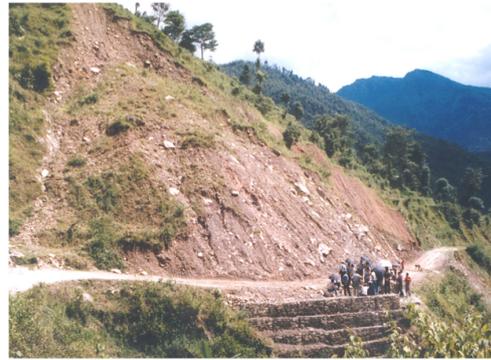
Fig. 14. Rotaional slides observed on cut slope at chainage 1+250, Balephi-Jalbire rural road

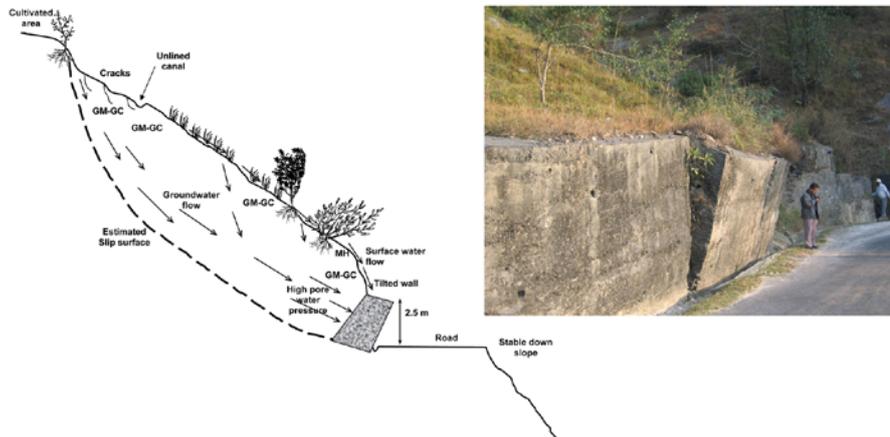
Fig. 16. Schematic diagram of Kattike Mool landslide and damage concrete masonry wall at km 1+200, Sidhartha Highway, Pumdi Vumi, Pokhara, Kaski

displaced and damaged in 2004 (Fig 16). Only one problem on this site is ground water but there is not any structure which can manage groundwater. So proper understanding of geological problems is essential. Detailed topographic survey is necessary at landslides area. An engineering geological survey is also necessary along road. But such surveys are not in practice in district and rural roads. Even in highways, such surveys do not consider as a prime investigation works.

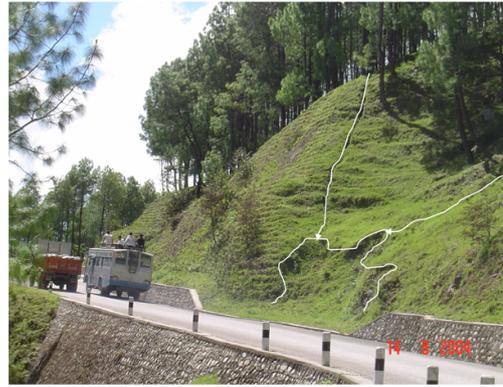
Fig. 18. Improper use of unlined catch drain and generation of shallow failure after rainfall at km 4+000, Banepa-Nepalthok Road
