Landslides and Landscape Change Induced by Heavy Rainfall and Intensive Earthquake in Mid-Niigata, Japan: GIS Analyses and Interpretation of Aerial Photographs

Hiromitsu Yamagishi,¹⁾ Toko Takayama²⁾ and Junko Iwahashi³⁾

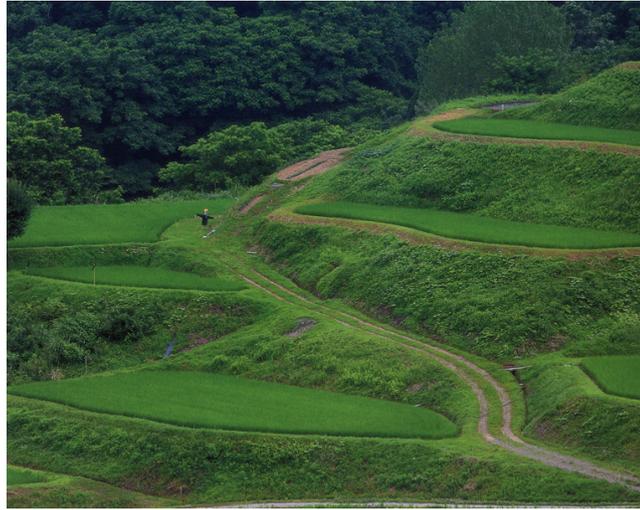
Fig. 7. Paddy field in the hilly area of Ojiya, Niigata (taken by Yamamoto, H)

Mid-Niigata areas is known for its fertile rice fields. Gentle slope areas between hills, which are mostly sites of old deep-seated landslides, are used as paddy fields (Tanata) for producing delicious rice such as Koshihikari. These rice fields also display beautiful landscape changes in colors from spring to winter (Fig. 7). However, because of the July 13 heavy rainfalls and October 23 intensive earthquakes, the paddy fields and the landscape, are highly affected and destroyed (Figs. 7 and 8). Air-photos taken just after the destruction were important to describe the damage patterns of the paddy fields. Particularly, images of high resolution airborne digital mapping camera (DMC) were very useful to analyze landscape failure in a GIS and to provide faster mapping techniques. We have analyzed the damage patterns using the DMC images combined with GIS.

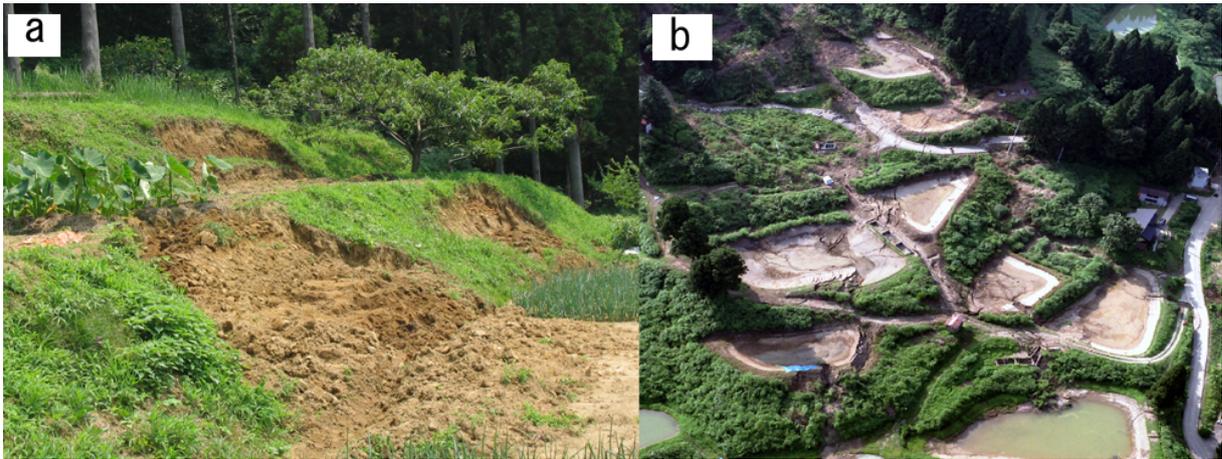
Fig. 8. Photos showing collapsed paddy fields by the 7.13 heavy rainfalls. a: Shallow sliding from the rims of the paddy fields (Izumozaki area), b: Cracks crossing the paddy fields (Minami Nikoro, Yamakoshi area. Taken by Nakanihon Air Service Co., Ltd.)

Most of the July13 landslides took place on natural steep slopes, and the displaced materials covered the paddy fields. However, in some places, failures originated from the edges of the paddy fields themselves (Fig.8a). In some other places, landslide cracks crossed the rim of the paddy fields (Fig. 8b).
