Soil Erosion Problems In Northeast Thailand: A Case Study from the View of Agricultural Development in a Rural Community Near Khon Kaen

Kosit Lorsirirat¹⁾ and Hideji Maita²⁾

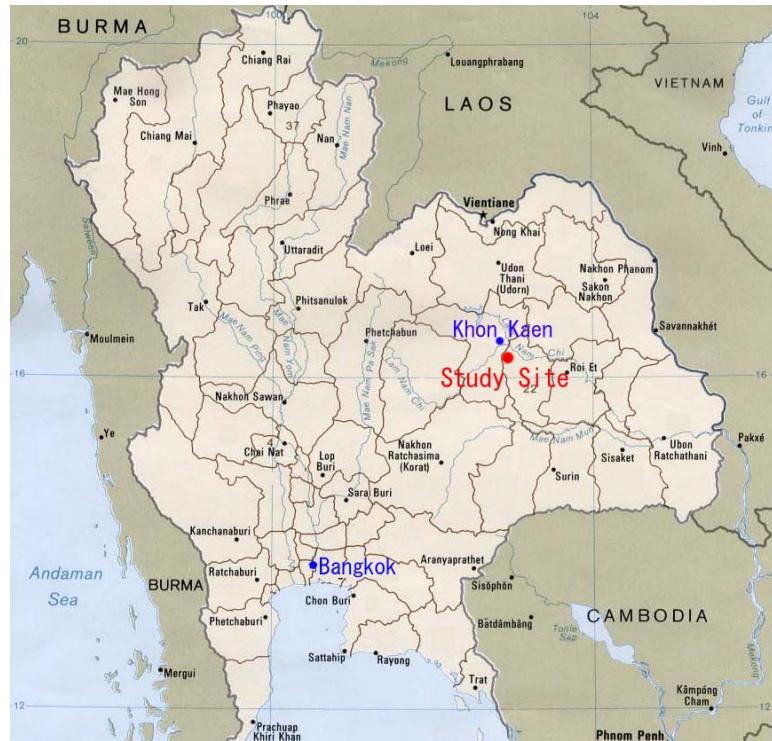
Fig. 4. Changes in the cultivation area of cassava and sugarcane in the whole of Thailand (Map showing study site (Khon Khwang and Non Jalern villages near Khon Kaen City)

The Khon Khwang and Non Jalern villages (Lat.: N $16^{\circ}14.6'$, Lon.: E $102^{\circ}54.9'$) near Khon Kaen city were selected as the study site that belongs to the Kosum Phisai district of Maha Sarakham Province (Fig.4) to conduct a case study. The geology of the study site consists of Mesozoic sedimentary rocks overlaid by Quaternary deposits composed of sandy loam in the surface layer (Imaizumi et al., 2002). The topography is classified as rolling hills, which undulate with a relative height of about 10 m in the study site and neighboring area. Elevations range from 170 m to 200 m above sea level. The region has a tropical monsoon climate characterized by a rainy season from May to October and a dry season from November to April. The mean annual rainfall in Kosum Phisai near the study site is 1150 mm: 1005 mm (87%) falls during the rainy season,

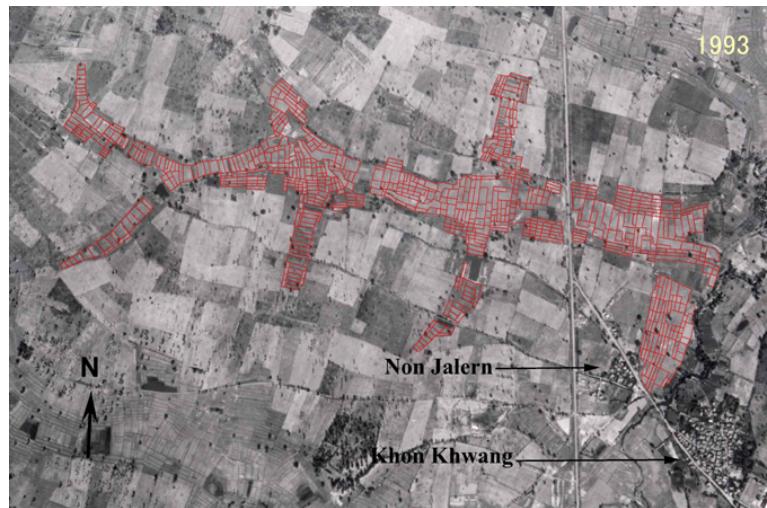
Fig. 6. Aerial photo showing the landscape of the study site that consisted of upland occupied by crop fields and lowland occupied by rain-fed paddy fields in 1993. A solid quadrilateral shows a section of rain-fed paddy fields.

site must have remained at almost the same level from around 1940 until 1973, and the site's upland forests remained stable until the early 1970s. However, the introduction of cash crops into the upland in the mid 1970s changed the forests into crop fields and effected the evolution of a new landscape where crop fields covered the upland, while rain-fed paddy fields still occupied the lowland (Fig.6). At the same time, the increased income obtained from the cash crops made the village people wealthy and resulted in the population increase in Khon Khwang village (Fig.9). The growth in Khon Khwang village led to the establishment of the new Non Jalern village in 1993 (Figs.8 and 9). To support this population growth, rain-fed paddy fields in the study site were somewhat expanded (Figs.5 and 6). However, there is a limit to the size of the population that can be fed by the production obtained from its own paddy fields because rice cultivated areas are constrained by the topographical condition even though the efforts to expand the areas are made. If the population exceeds the limitation, additional rice must be introduced from the outside. Judging from the aerial photos, the village people must have abandoned their dependence on their own fields to provide all their subsistence rice since 1996. Unsteadiness of the rice production due to the drought-prone weather must have accelerated the abandonment. From this view, maximum efforts to increase the amount of the rice production might be made in around 1993 (Fig.6). However the efforts could not be maintained because of the pressure of population growth of the study site. Once the abandonment starts, cash crop cultivation is further stimulated and continues to invade wherever possible. This is why the rain-fed paddy fields of the study site decreased considerably in 2002 and were distributed only at the valley bottom (Figs. 6 and 7).

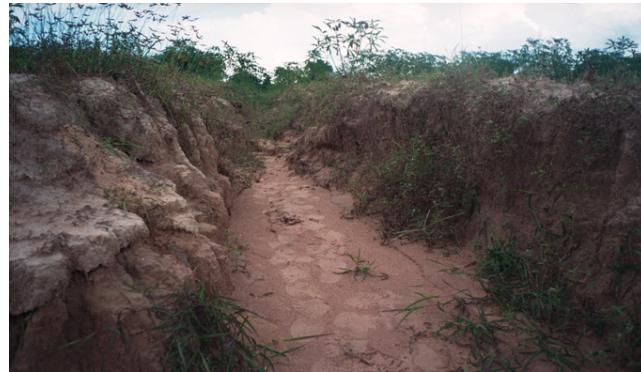
Fig. 10. Severe soil erosion in the cassava field of Khon Kaen Province (taken in October 1999)
