Disaster Monitoring and Warning System by the Niigata Prefectural Government after the Mid Niigata Prefecture Earthquake

Abstract

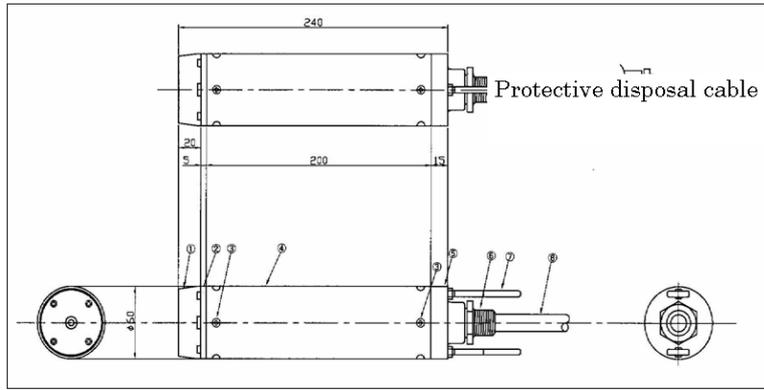
Fig. 4. Crystal water gauge structure

Crystal water gauge (the sensor of pressure system by oscillator) was used for observation of water

level. When the sensor is pressured, the frequency of the oscillator changes. By pressing on the lower part of the sensor, the pressure is transmitted to the crystal oscillator. The material of the sensor is made of stainless steel (SUS316). It weighs about 2.5kg and is 240mm long and 60mm in diameter. The range of measurement is about 0 to 20 meters. It is powered by a solar battery (Fig.4). In order to carry out construction works by the Ministry of Land, Infrastructure and Transport, the measuring system was removed. We newly installed a radio water level gauge at Juunidaira Bridge in the downstream area in November, 2005.

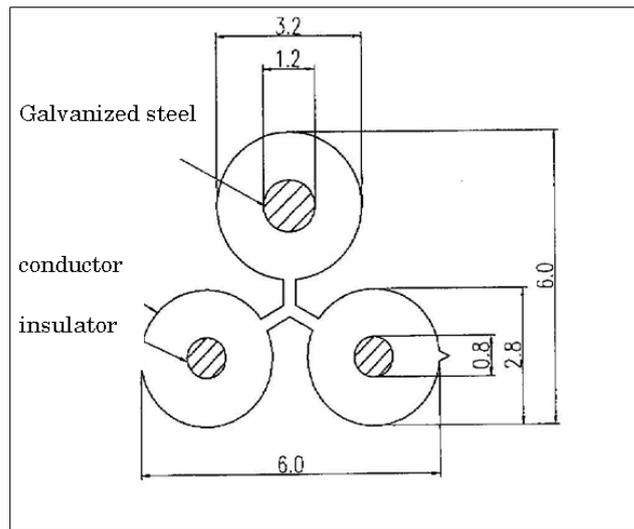
Fig. 5. The structure of wire

This system is used for detecting mudflow and sediment movement on the wire-cable that is made of conductor. This wire-cable is set on check dams and bridges. The cutting off of this wire signals occurrence of a sediment disaster. The wire is rapped with polyvinyl chloride of 1mm thick and the wire itself as conductor is made of galvanized steel line which has a diameter of about 0.8mm (Fig.5). This wire-sensor installed at the

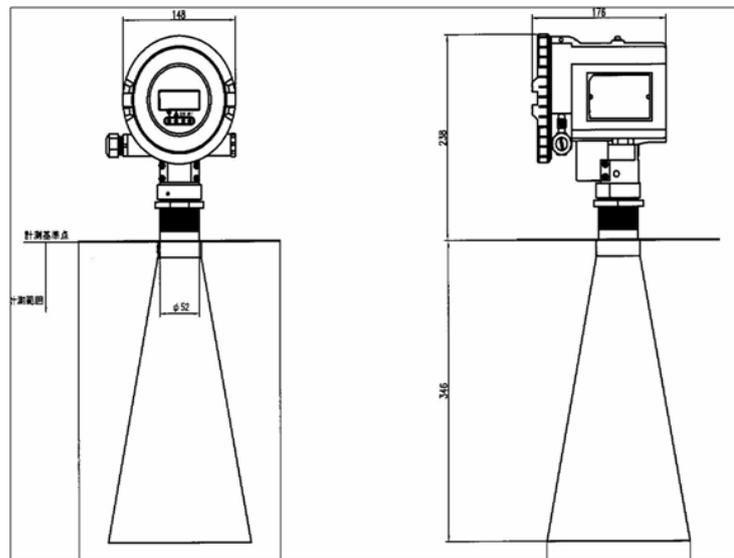
Fig. 8. Structure of microwave water level gauge

This instrument is a microwave water level gauge (Fig.8), and measures the distance between the gauge and the surface of the water. It is made of aluminum and its range of measurement is about 0 to 20 meters. The warning message will be signaled, when the water level measured by this gauge exceed the critical level

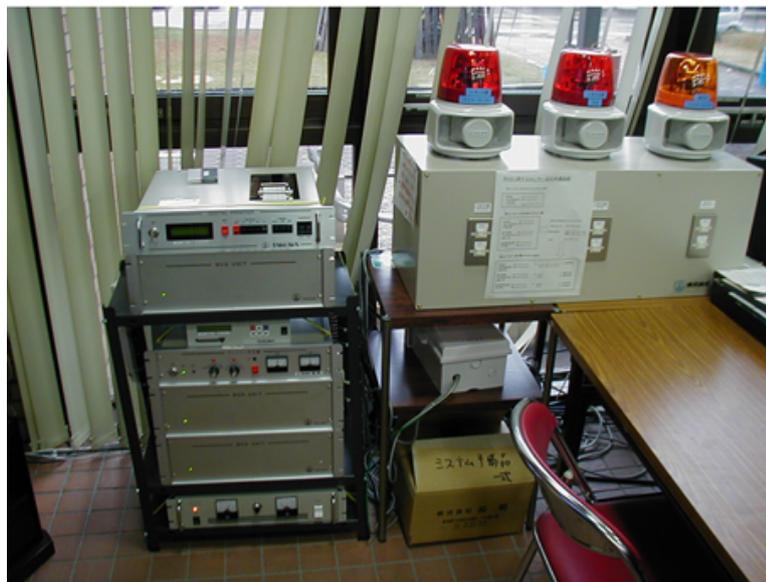
Fig. 10. Revolving lights set up at the Ryuko Community Hall

When debris flow occur, as signaled by the rupture of the wire-sensor, sirens are sounded and revolving lights are turned on reporting to the residents of Ryuko area the occurrence of the disaster. The lights set at Juunidaira Bridge and Koimo River Bridge are yellow and red, respectively.

③ Master station of the Ryuko hall (Fig.10)

The main monitoring system was set in the hall of the community of Ryuko because it was the most important public hall and the strongest building in this area. All information and data gathered by the monitoring instruments set in the Imo-river basin are collected here for analysis by local government staffs.
