ACID TEST OF JOINT TECHNICAL AND BIOLOGICAL MEASURES IN SLOPE STABILISATION AND GULLY CONTROL – IMPACT ANALYSIS OF THE HEAVY RAINSTORM EVENT IN AUGUST 2005

Frank Graf¹, Albert Böll²

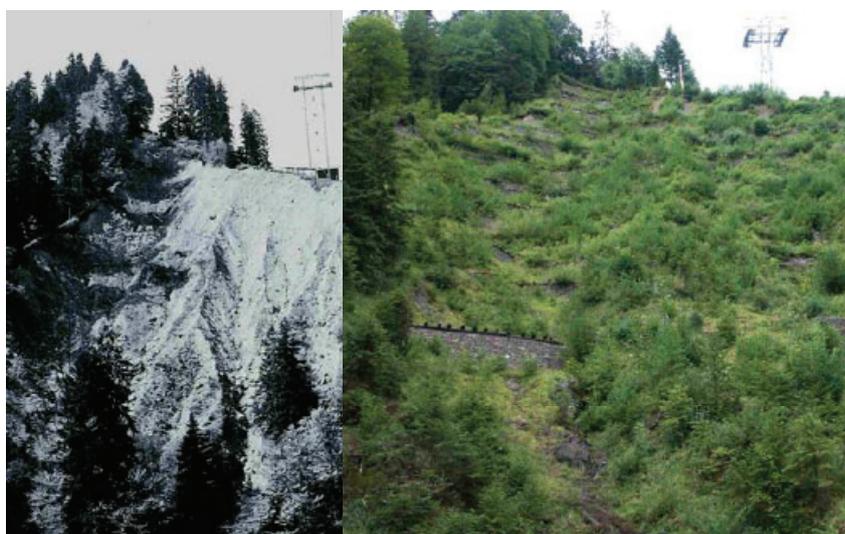
Fig. 1: The “Schwandrübi” area. left: in 1974 prior to the application of joint technical (gabions) and biological (*Alnus incana*, *Salix purpurea*, hydroseeding) measures conducted during 1981 and 1982 and right: in 2005 after the heavy rainstorm event in August

In the context of a joint project financed by the Federal Office for the Environment (FOEN) the ancient sliding area “Schwandrübi” in Dallenwil (Central Switzerland) providing joint technical and biological measures (Fig.1) was chosen to address the following aspects:

The “Schwandrübi” is a steep and amphitheatre-like gully on moraine material and part of a larger catchment. Until 1980 it was a steady source of bed load of the outlet channel and, therefore, a potential danger for the ski resort “Wirzveli” above (Fig. 1) as well as the adjacent villages.

The development of the biological measures that consisted of cuttings of *Salix purpurea* and rooted plantlets of *Alnus incana* combined with a conventional seed mixture (hydro-seeding) was most satisfactory (Fig. 1 right). The natural re-establishment of *Salix appendiculata* – rarely used in eco-engineering due to the low vegetative reproduction – reveals the underestimated potential of this species. The rainstorm left hardly any destructive marks neither on the vegetation nor on the soil surface. Root excavations in the field and laboratory investigations confirm a high rooting degree. Furthermore, plant association analysis yielded in considerable diversity and a species composition close to natural succession stages.
