ANALYSIS OF THE RECULTIVATION OF THE EXTENSIVE CALCIT QUARRY

Dr. Aleš Horvat¹, Jože Papež²

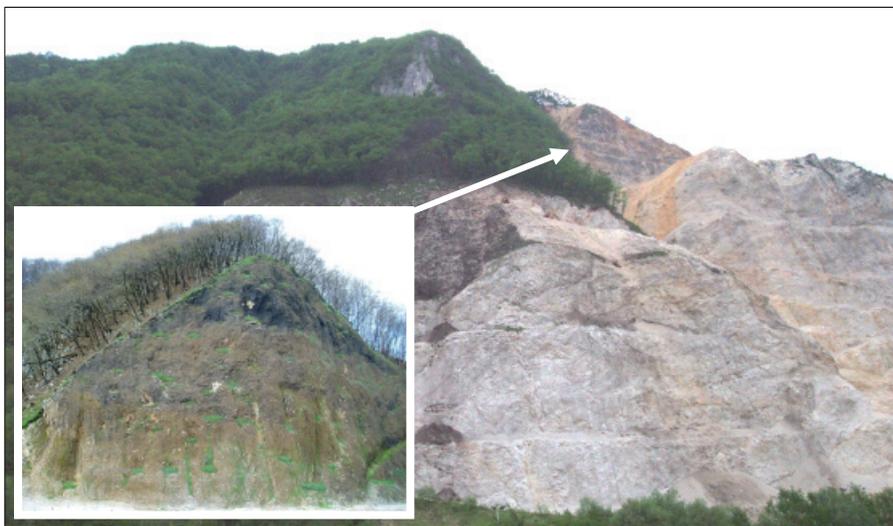
Fig. 1: Recultivation works are carried out from top down and follow the dynamic of quarry exploitation

Calcit quarry is situated on the SE slope of the Kamniška Bistrica torrent valley, next to the settlement Stahovica. In the year 1996 a new »from up to down« method of excavation was introduced. From the ecological point of view this method is more appropriate, because it allows immediate recultivation of the upper, already exploited levels, while the calcit is still being excavated on the lower levels. On the other hand, the recultivation itself is much more difficult, since the reduction of the slope is not possible. Therefore the slope was very steep and surface stony and almost without fertile substratum. Company PUH d.d. which carried out the recultivation, had to carry out the necessary rockfall control measures for the safety of the workers that were continually working on the lower levels, and simultaneously carried out the recultivation by using different soil bioengineering techniques (mulchhydroseeding, plant cores technique, planting on terraces,...)

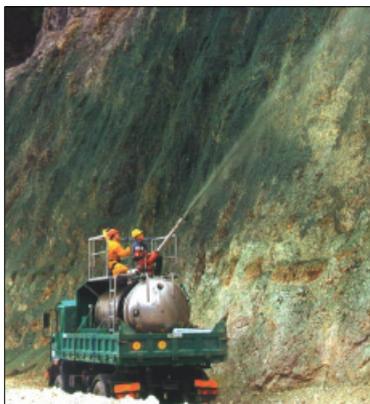
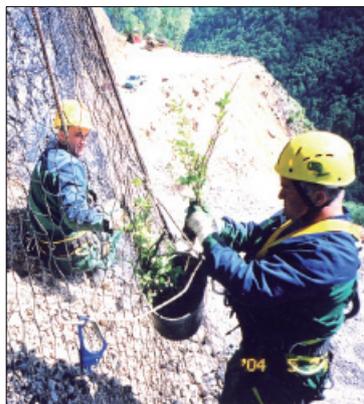
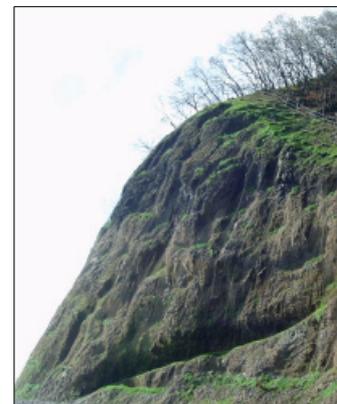
Fig. 2, 3, 4: Mulchhydroseeding and planting in plant cores technique gave satisfying results

Though the conditions for carrying out the recultivation works and for the growth of the vegetation as well were extreme, the techniques proved to be successful. With the combination of different soil bioengineering techniques the successive processes of natural overgrowing can be crucially accelerated also in extreme conditions, where these processes are otherwise running very slowly or they have no chance at all. It is important to stress out that beside the applied techniques, the final success depends very much on the cooperation between the quarry management and the performer of the recultivation works. While excavating calcit, the quarry workers have been simultaneously removing all labile rocks, have been avoiding the creation of overhang parts on the slope and, according to the instructions, have been already designing special niches and shelves, necessary for later preparation of plant cores and thus enabled successful use of bioengineering measures.
