SEDIMENT DISASTER CAUSED BY THE TYPHOON “RUSA” FOLLOWING FOREST FIRE IN THE EAST COASTAL REGION, THE REPUBLIC OF KOREA

Masanobu Kimura¹, Kun-Woo Chun², Tomomi Marutani³ and Suk-Woo Kim⁴

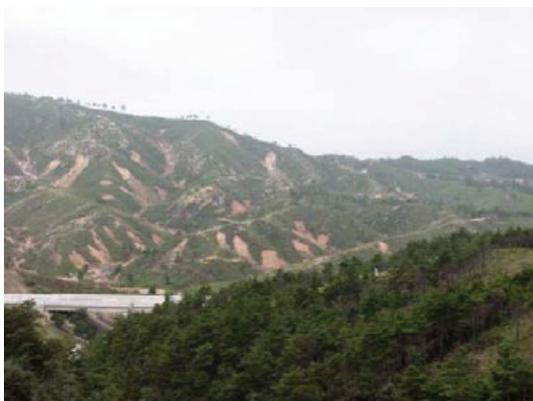
Photo 1: Landslides by the typhoon “Rusa” in the fire damage area

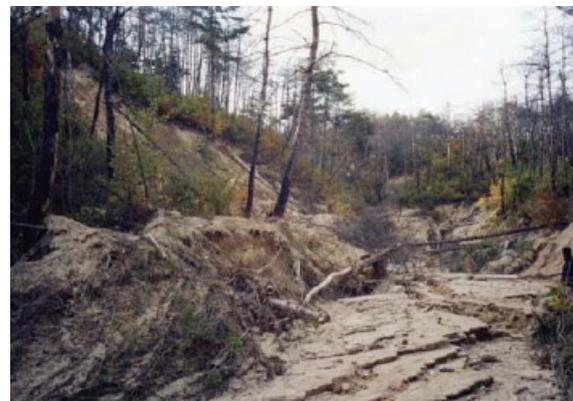
Photo 2: Deposition of fine sediment and degradation of stream bed
