IMPLEMENTING THE RESULTS OF AN EVENT-ANALYSIS

FLOODS 2005 IN THE DIEMTIGTAL VALLEY

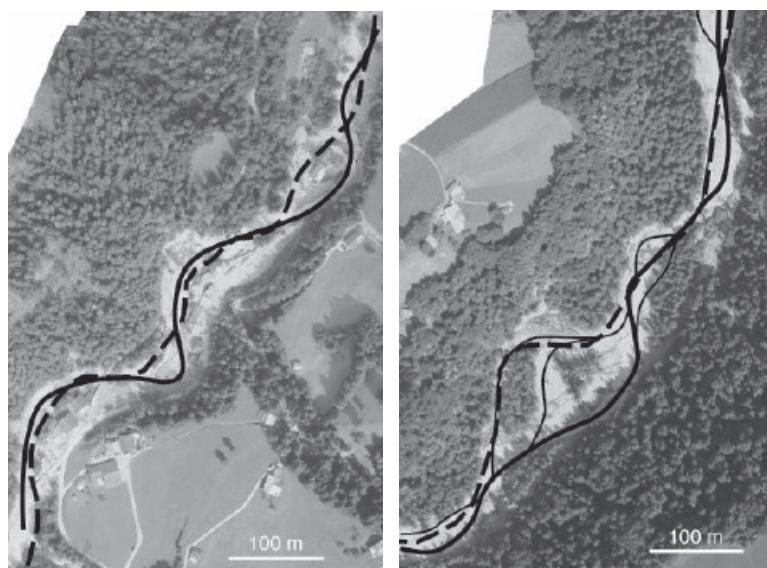
Fig. 1:
Morphological changes during the
2005 flood event in the River
Chirel: formation of meanders
(left) and braiding (right).
Existing channel dotted, new
channels solid. Flow direction
from bottom to top.

- In reaches with a relative deficit of bed load, the channel migrated forming meanders and mobilised bed load through bank erosion in the outer bends. (Fig. 1, left).
- In reaches with a relative excess of bed load, solids were deposited and the channel enlarged itself, forming a braided river bed (Fig. 1, right).
- On the alluvial fan, bed load was deposited, because the sediment yield of the River Chirel exceeded the transport capacity of the receiving stream.
