# THE LANDSLIDE SOUTH OF IMMENSTADT/ALLGÄU

## A COMBINED LANDSLIDE CAUSING DANGERS TO THE TOWN AND INFRASTRUCTURE FACILITIES

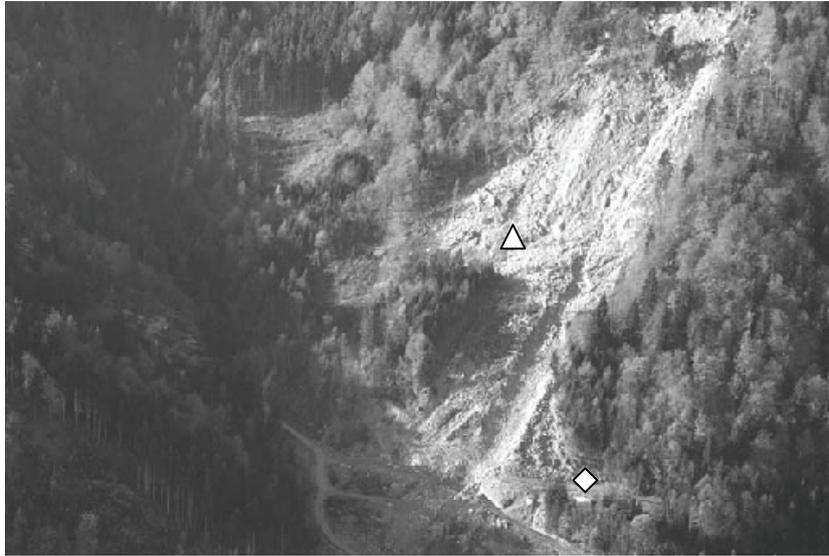
**Fig. 1:** View from the north to the landslide area. The white triangle shows the position of the morphological terrace which divides the primary and the secondary landslide area. The white square indicates the position of the water supply of Immenstadt

The landslide area can be divided in two parts. The upper part above the morphological terrace is the primary landslide; the lower part is the secondary landslide. From March 2006 until January 2007 the activity has not ceased.
