ASSESSMENT OF DEBRIS-FLOW HAZARD IN NW SLOVENIA

FIELD WORK IN HEADWATERS OF THE UPPER SAVA RIVER AND INVESTIGATIONS ON FAN SEDIMENTS

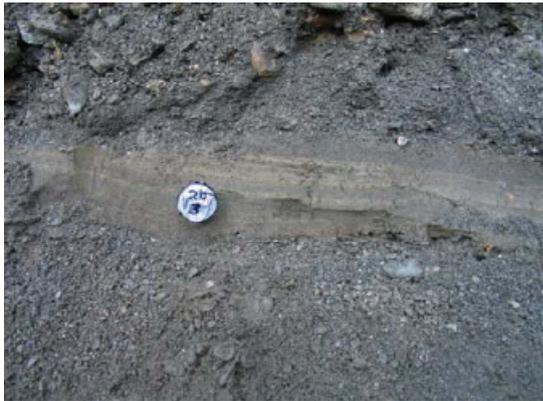
Fig. 1 The OSL age-dating sampling detail within the stream sediment portion of the sequence in the proximal trench on the Trebiža torrential fan.

For some of the torrential fans under investigation, several distinct debris-flow events were recognized within the sediment profile, while the importance and meaning of further internal stratification was also analyzed in situ. Generally, a typical sedimentary sequence of each of the recognized debris-flow events comprises of a succession of fining-upward non-sorted coarse gravel diamicton that gradually passes into better sorted stream sediments (gravel and/or sand and/or silt). The sequences are separated by erosion surfaces of which none show signs of significant pedogenesis. Furthermore, sediment samples were taken for laboratory lithological analyses and some more samples for OSL age dating (e.g. from the silt-rich layer, see Fig. 1), as the main aim of this field work was to get evidence of historical debris-flow events and to try to estimate the time of their occurrence.

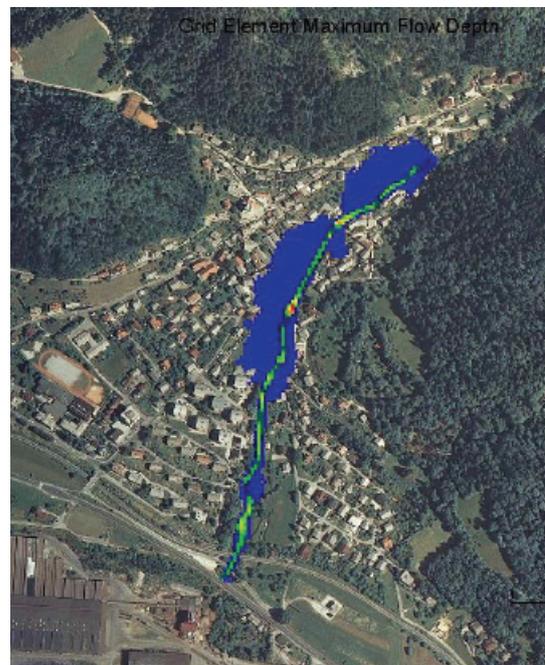
Fig. 2 Maximum flow depths for clear water hydrograph with the return period of 100 years on the Koroška Bela fan, using Flo2D mathematical model.

The results gained through this field and laboratory work are currently used for two-dimensional mathematical modelling of debris flows on torrential fans. In order to determine hazard maps on these fans, a digital elevation model (5 x 5 m) has been used together with the two-dimensional mathematical model Flo-2D (see preliminary results on Fig. 2).
