SEDIMENT DELIVERY FROM THE LATTENBACH CATCHMENT TO THE RIVER SANNA BY DEBRIS FLOODS AND DEBRIS FLOWS

Johannes Huebl^{1*}, Roland Kaitna²

Key Words: Debris flow, Debris flood, Monitoring

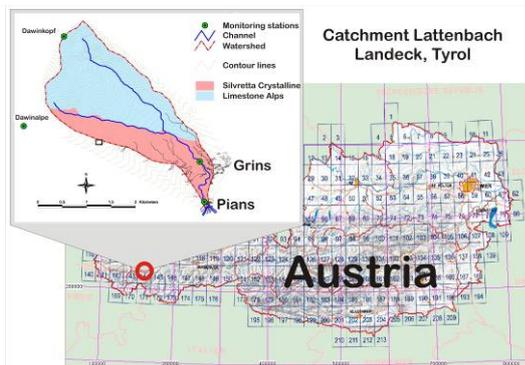
Fig. 1 Location and geologic sketch of the Lattenbach catchment in the western part of Austria

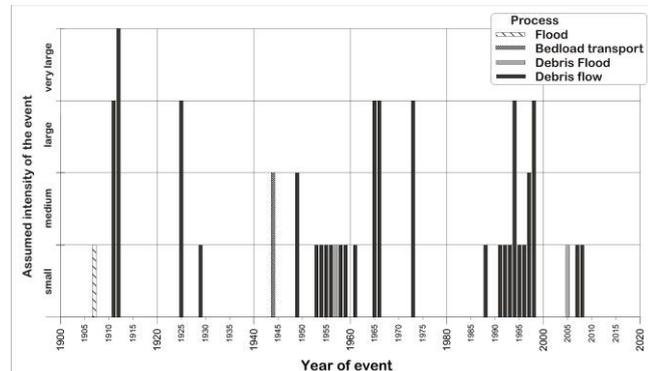
Fig. 2 Frequency and estimated magnitude of flow events in the Lattenbach catchment based in historic reports

Severe events of debris flows and debris floods causing remarkable damage are reported in the years 1911, 1912, 1925, 1944, 1949, 1965, 1966, 1973 and 1998 (Fig. 2). The type and the intensity of the processes have been assessed based on the description of the damages and deposition in the villages Grins and Pians (Huebl *et al.*, 2008). Analyzing the chronicle of debris flows, the most probable triggers resulted from short-term thunderstorms.

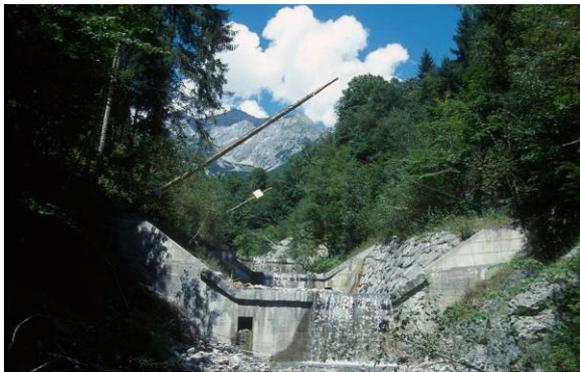
Fig. 3 Flow depth sensors at the monitoring station Grins (middle reach)

One channel monitoring station is located in a reach of a series of check dams close to the village Grins in the lower part of the middle section of the Lattenbach. This monitoring station comprises two flow depth sensors installed at 5 m above two check dams 47 m apart where basal and lateral erosion is not to be expected (Fig. 3). Until 2007 the mean flow depth over ten minutes has been recorded. After an upgrade of the measurement system in 2007 the sampling frequency was set to 1 Hz, triggered by a threshold of flow depth of 0.3 m.

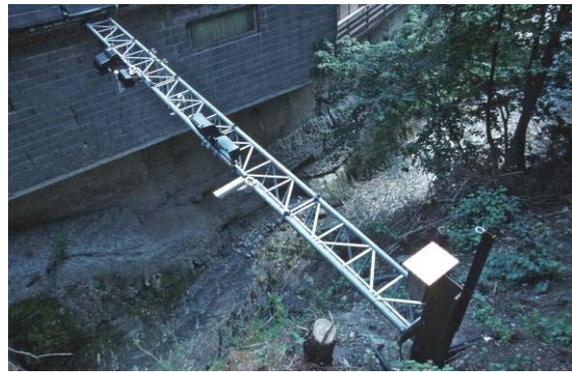
Fig. 4 Video and flow depth monitoring station Pians (lower reach)

A second monitoring station has been installed in the vicinity of the confluence with the river Sanna in a short bedrock reach within the municipality of Pians. The site is equipped with one ultra sonic flow depth sensor and two digital video cameras, one looking vertically down onto the flow surface and one recording the flow arriving from upstream. The resolution is 720 x 576 pixels, with a frequency of 1 frame every 2 seconds. The video system is triggered when both upstream flow depth sensors register a threshold depth of 1 m.

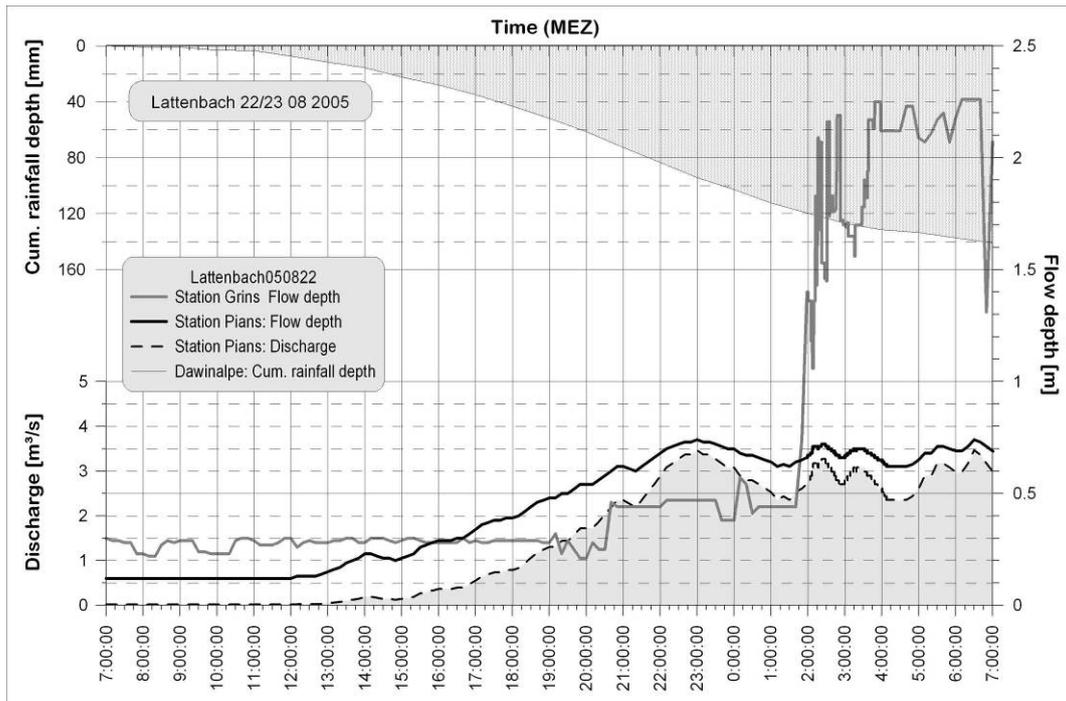
Fig. 5 Cumulative rainfall measured at ‘Dawinalpe’ (top) and flow depth records of the monitoring stations Grins and Pians (bottom)

The flow event on August 23rd 2005 occurred after a long wet period. The rainfall event which finally triggered the mass wasting process delivered 150 mm within 24 h, according to the high altitude climate station at Dawinalpe. Fig. 5 shows the cumulative rainfall registered at Dawinalpe and flow depth recorded at the stations Grins (upstream) and Pians (downstream). The sampling rate was set to 10 min, so we have only rough information about the deposition process at station Grins.

The peak discharge at the outlet of the watershed at the station Pians (above the confluence with the river Sanna) was estimated with around $3 \text{ m}^3/\text{s}$ (Fig. 5), and no comparable amount of sediment was transported through or deposited in this section. Based on a rating curve derived from hydraulic modeling assuming only clear water flow, the maximum possible volume of water that could have passed through the bedrock reach at Grins within 27 hours (duration of the hydrograph) was about $150,000 \text{ m}^3$. Considering that the flow also transported at least some bedload, and sediment deposition at the upstream reach took place within a shorter period of time than the total duration of the hydrograph at Pians (cf. Fig.5), the sediment concentration must have been significantly higher than expected during a “typical” bedload transport event. However, due to the described deposition pattern and due to the lack of evidence of debris flow activity we suggest to classify this event as debris flood.

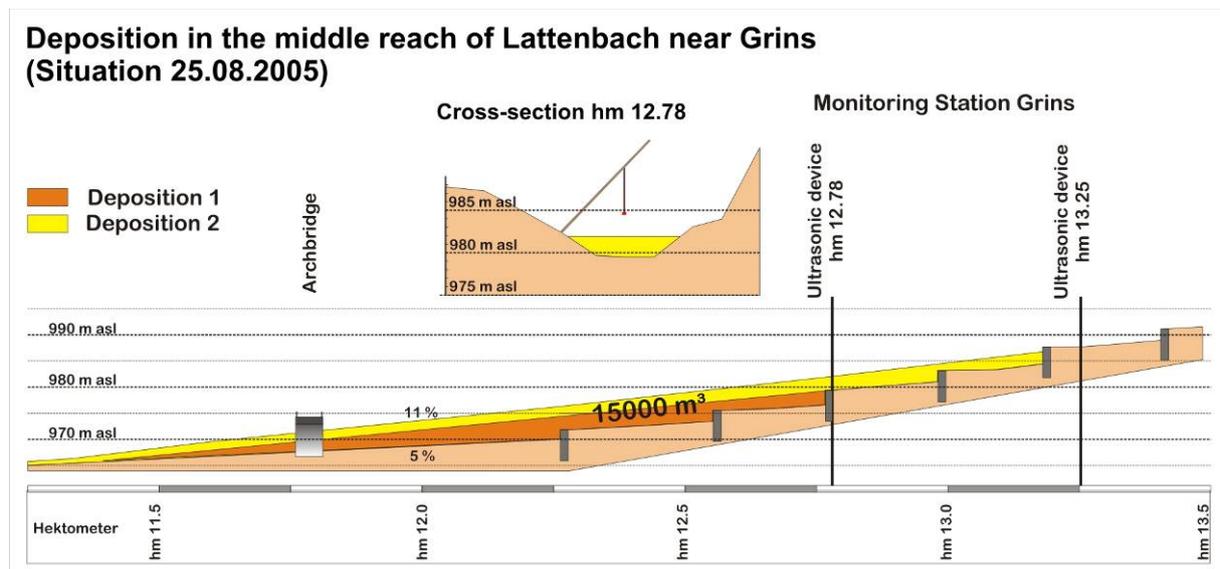
Fig. 6 Sketch of the monitoring site Grins within the sequence of check dam and the simplified deposition pattern after the debris flood event of 2005

Field investigations have been carried out on the 25th of August, two days after the event. It was found, that most of the sediment was mobilized from the channel bed and transported to the middle reach (station Grins), where around 15,000 m³ of sediment was deposited (Fig. 6&7). Deposition was presumably favored partly due to a reduction of slope downstream of the series of check dams where the flow depth sensors are located, and also due to a reduction of width by an arch bridge crossing the channel 100 m downstream of the flow depth sensor.

(from 1:45 am to 3:45 am). Assuming a gradual deposition backwards from the arch bridge we refer to this sediment volume as Deposition 2 in Fig. 6. Deposition 1 most likely has been deposited during this time, too. However, an increase of flow depth is already registered at 8:30 pm (20:30).

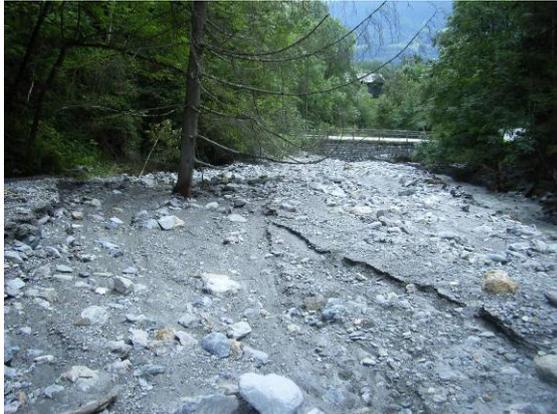
Fig. 7 Downstream view to the arch bridge.

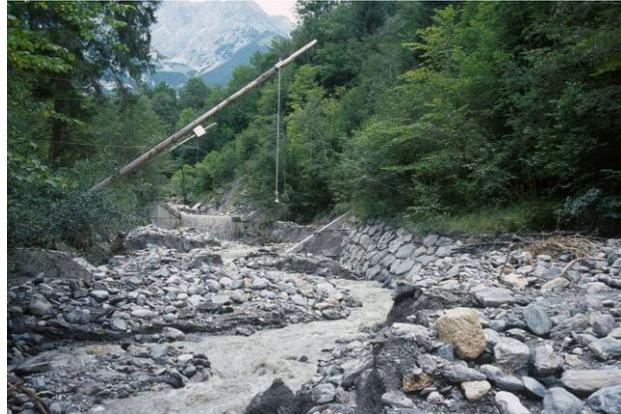
Fig. 8 Upstream view to chain of check dams at the monitoring station of Grins

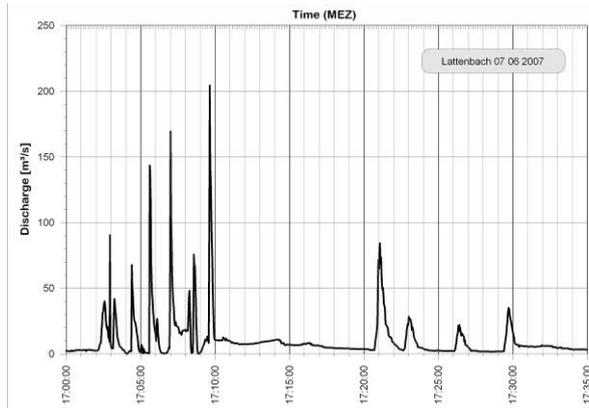
Fig. 9 Hydrograph of the debris flow event 2007 at the station Pians, based on Video analysis

Fig. 9 shows the hydrograph derived from video analysis. The calculation of discharge is based on the observed flow depth and estimated surface velocity from particle tracking.

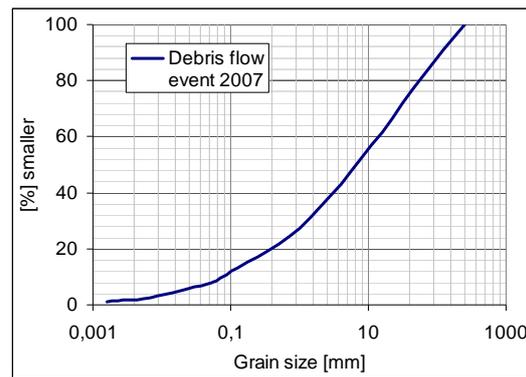
Fig. 10 Grain size distribution curve of a sample taken from deposits close to the arch bridge at the station Grins

The mobilized debris resulted from several landslides of different type in the headwaters. They are spatially distributed in the catchment, many of them supplying directly the channel. Samples were taken from debris flow deposits some weeks after the event occurred. A grain size analysis was carried out (Fig. 10) and showed that the material was very fine (9% silt and clay) and was mainly composed of sediment smaller than 63 mm (82 % by weight). Several big boulders (diameter around 1 m) could be identified only at the front of the first surge from the video (Fig. 11), but not in the deposits in the investigated lower channel reach of the Lattenbach. The event left the monitored reach between the flow depth sensors at Grins and the arch bridge without any considerable deposits within the channel (Fig. 12, cp. with Fig. 7), indicating a high inertia and mobility of the material mixture travelling through this reach. At the narrow section at the arch bridge some material was deposited at the side and even on the road. Along the channel clear limits of mudlines and no evidence of flowing water could be observed. Based on these observations we identified this event as a debris flow with a high content of fines.

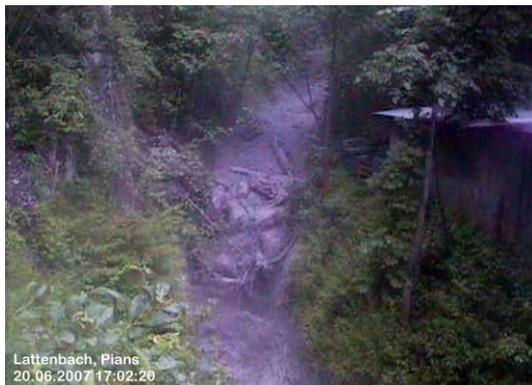
Fig. 11 Single frame of the arrival of the first surge of the debris flow event from 2007 (from video)

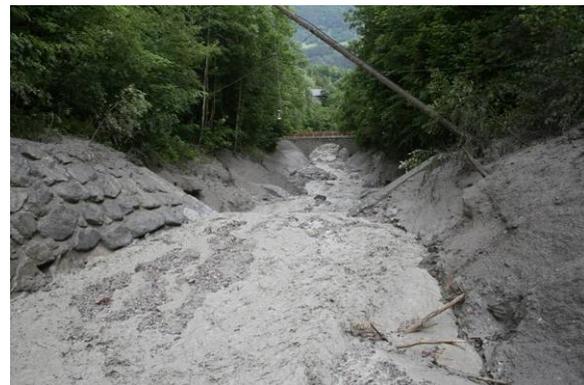
Fig. 12 Downstream view at the monitoring station Grins.

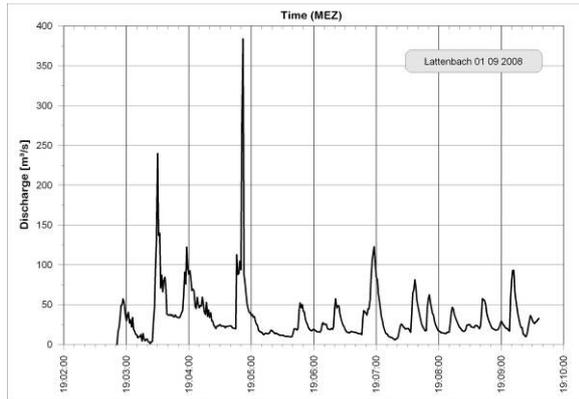
Fig. 13 Hydrograph of the debris flow event 2008 at the station Grins
