# APPLICATION OF GROUND-PENETRATING RADAR METHOD TO DETECT HIDDEN DEFECTS IN BANK REVETMENT

Yumin V. Kang<sup>1</sup>, Hui-Chi Hsu<sup>2\*</sup>, Kun-Fa Li<sup>2</sup>, Ming-Chih Lin<sup>2</sup>

**Keywords:** Flood mitigation, Revetment, Hidden defects, Ground Penetrating Radar (GPR)

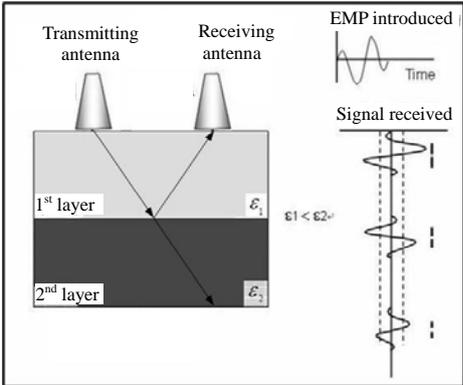
**Fig. 1** Principle of GPR

Ground penetrating radar (GPR) is one of the newer geophysical methods. It has been used for the past 20 years for a variety of applications to investigate many civil structures, such as pipe line, pavement, bridge, rock field, and vadose zone. Early utilization of this method for engineering applications were given by Morey (1974), Annan and Davis (1976), and Ulriksen (1982). An extensive overview of the method is given by Davis and Annan (1989). The principle of GPR is that an oscillatory electromagnetic wave (EM wave) of 10~2500 MHz is launched from the transmitting antenna into the structure under examination. The electromagnetic waves interact with features inside the structure. The waves are reflected, transmitted, absorbed and refracted. When a certain interface or object changes the conductivity or dielectric constant, a partial radar wave is reflected to the ground surface

(Fig. 1). The image is then displayed on the screen and, after processing, the signal can be plotted into a Distance-Time diagram which can be used to determine the position of abnormal underground electromagnetic waves as well as to estimate the relevant stratum interface. By exploiting the wave propagation characteristics of electromagnetic fields, GPR provides a very high resolution sub-surface mapping method.

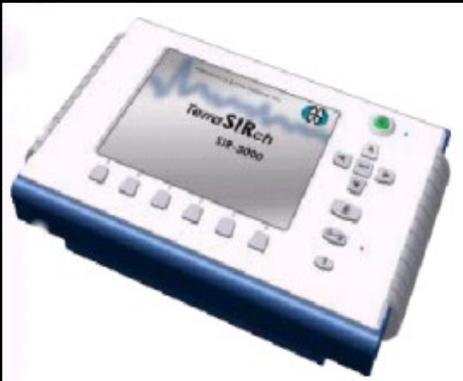
**Fig. 3** GPR data acquisition system used

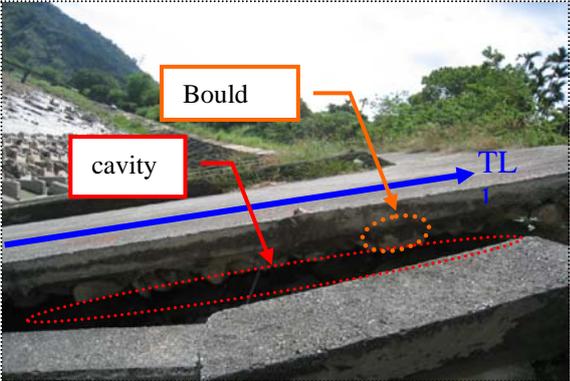
**Fig. 4** Cavity and boulder under concrete revetment

Fig. 13 and Fig. 14 are the raw data and processed image of TL3, respectively. Similar signatures of three interfaces can be observed. The missing interface is now longer than that of TL2. As compared to TL1, there is less soil erosion in TL2 and the least soil erosion occurs in TL3. This results consist with the visual observation in the test site where the concrete plate is at the end of the whole bank revetment and TL1 is the test line closest to the edge of the bank revetment as shown in Fig. 4.

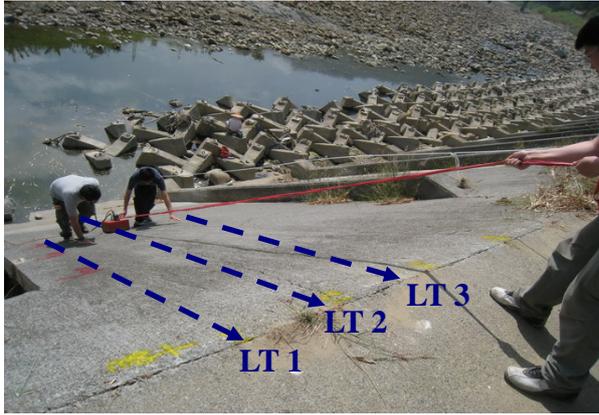
Fig. 5 Test site and three test lines

In this article the results from a field investigation of the bank revetment (Fig. 2) located in the downstream of the Pin-Lin stream at Chungliiao Township of Nantou County in Taiwan are presented and discussed. The bank revetment consists of concrete plates and vertical concrete beams between two plates. There is no steel reinforcement in the structure. The width of each plate is 4 meters, its height is 8 meters, and the thickness of each plate is in the range of 20~25 cm. The slope of revetment is about 55° measured from the horizontal line. A SIR-3000 GPR data acquisition system (Fig. 3) manufactured by GSSI (Geophysical Survey System, Inc., USA) with 400 MHz bistatic antenna was used. Three test lines were undertaken to examine the GPR images for a concrete plate under which there is a existing cavity (Fig. 4). Their line codes are LT1, LT2, and LT3 (Fig. 5) with their lengths equal to 8 meters. The distance between each test line is one meter. For the easy of conducting the GPR test, each test line was undertaken by moving antenna from the bottom to the top of the concrete plate. It is noted that in addition to a cavity under the concrete plate, there is a surface crack at the top of the plate with its length about 1 meter (Fig. 6) which is located between test lines LT1 and LT2.

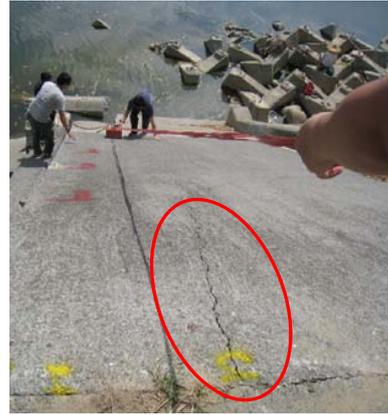
Fig. 6 Surface crack at test site

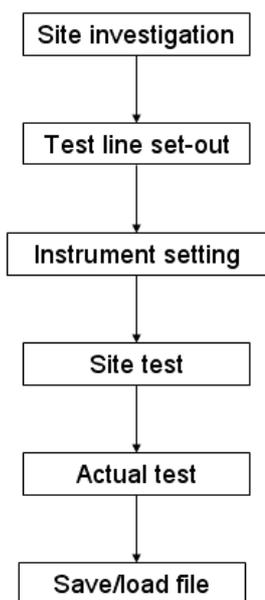
Fig. 7 Flowchart of pre-processing

In order to effectively and rapidly detect the target, a successful GPR test must be undertaken with adequate settings and the in-situ pre-processing steps were taken as shown in Fig. 7. The influence of factors such as method of GPR recording, selection of monitoring system, type of underground interface and characteristics of wave transmission would generate differences between data and geotechnical space. In addition, diagrammatic distortion often occurs in the GPR raw data due to in-situ noise, so it may be difficult to make effective interpretation directly from the raw data. Therefore, post-processing was used to assist the diagrammatic interpretation as shown in Fig. 8. In this test, a low-pass boxcar FIR (Finite-duration Impulse Response) filter was applied, with which it passes low-frequency signals but attenuates signals with frequencies higher than the cut-off frequency which equals to center-frequency multiplied by 2. A high-pass boxcar FIR filter was also applied, with which it passes high-frequency signals but attenuates signals with frequencies lower than the cut-off frequency which equals to center-frequency divided by 6. Since some reverberation packets occur at the last portion of the raw data, some gain control was conducted to suppress them.

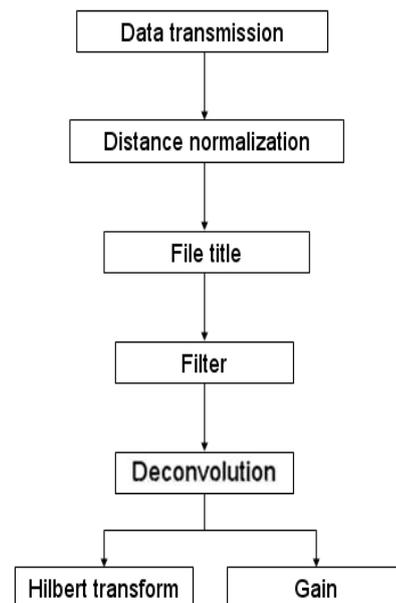
Fig. 8 Flowchart of post-processing

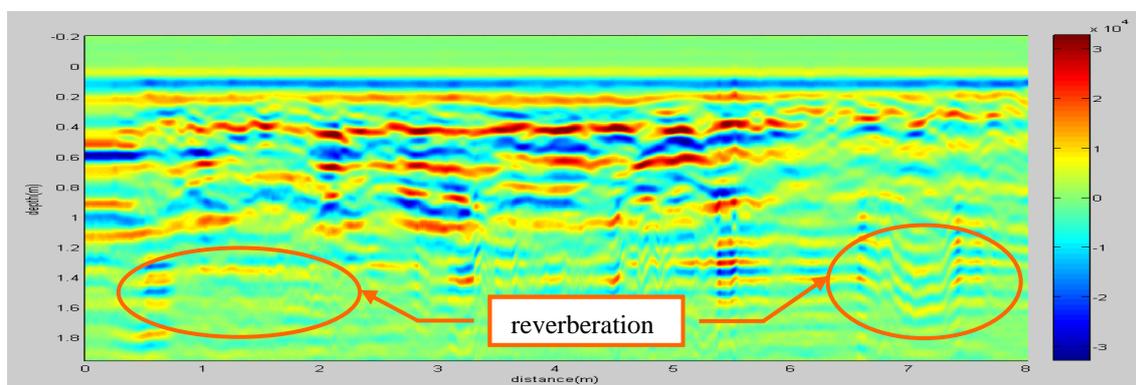
Fig. 9 shows the colormap diagram of raw data for test line TL1, where the horizontal axis is the tangential distance along the surface of the concrete plate. The distance of zero indicates the GPR data at the lowest side (water side) of the revetment and the distance of 8 meters indicates the data at the topmost side of the revetment. The vertical axis of raw data is the depth measured from the surface of the plate. After filtering and gain controlling mentioned beforehand, Fig. 10 is the processed image in grayscale mode of Fig. 9. By comparing raw data with processed data, there are three crucial perspectives can be drawn. First, due to multi-color display, more pseudo reflected interfaces can be found in colormap mode than in the grayscale mode. Second, the post-processing conducted in this study is robust regarding effectively suppressing the noise. Third, two strong interface reflections can be easily found in the processed images other than in the raw data.

**Fig. 9** Raw data of TL1

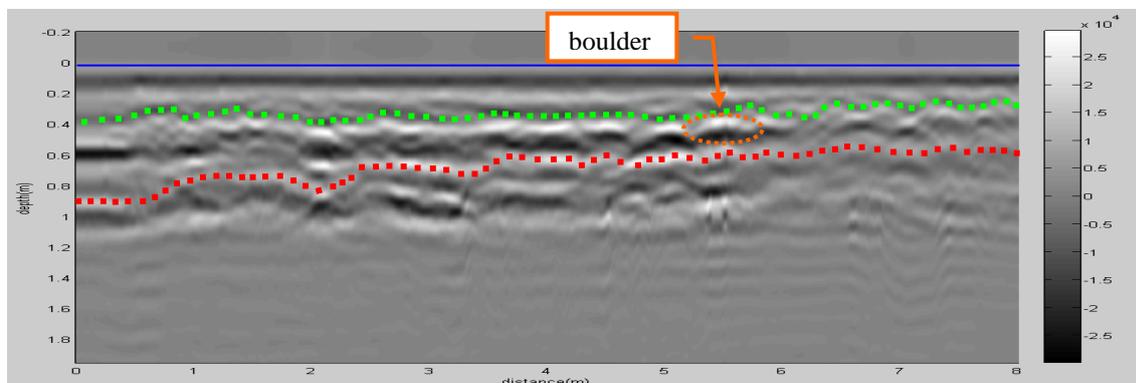
**Fig. 10** Processed image of TL1, which indicates concrete surface (in blue), concrete-air interface (in green) and air-soil surface (in red)

A GPR reflection will be produced at a boundary between two different materials, where the dielectric constant suddenly changes. Higher dielectric contrast between the two materials, results in a stronger reflection. Davis and Annan (1989) reported typical dielectric constants for some geological media. In this study, the GPR antenna was placed directly on the surface of the concrete plate, instead of leaving an air gap. The signature of concrete plate at TL1 consists three portions: the first positive peak (white band at the depth of zero in Fig. 10), followed by a negative peak (black band), and then another positive peak. Thus, the blue line depicted in Fig. 10 represents the location of concrete surface which is inclined about  $55^{\circ}$  measured from the horizontal line in the test site. When the EM energy reaches the bottom of the concrete, a phase inversion occurs at a concrete-air interface because of the low dielectric

of air (a value of one) as compared to the dielectric value of concrete (6~11). So instead of a positive/negative/positive (white/black/white) peak, the phase inverted sequence will be negative/positive/negative (black/white/black) for the concrete-air interface as shown by the green line in Fig. 10. Due to soil erosion under the concrete, there is a cavity beneath the bank revetment in the test site (Fig. 5). Consistently, some boulders stuck by cement to the bottom of the concrete plate can be seen as shown in Fig. 4. The signature of a boulder looks like an inverted V hyperbola as shown by orange circle in Fig. 10. The signature of an air-soil interface should be positive/negative/positive (white/black/white) peak because of the low dielectric of air (a value of one) as compared to the dielectric value of soil (3~30) as shown by the red line in Fig. 10. Hence the region between the green line and the red one in Fig. 10. represents the air-filled zone under the bank revetment. The cavity found in this article extends from the down side of the bank revetment to its top, and its height ranges approximately from 0.3m to 0.6m.

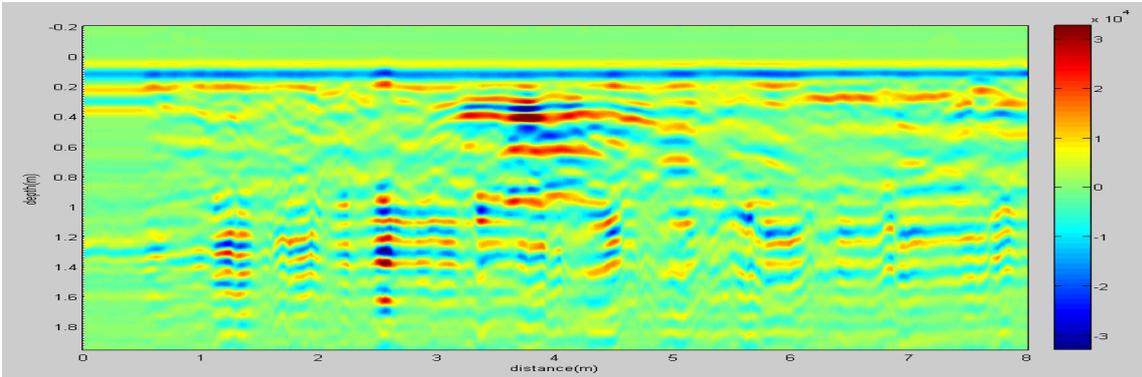
Fig. 11 and Fig. 12 are the raw data and processed image of TL2, respectively. Similar trends can be observed in the GPR image (Fig. 12) after processing: the blue line represents the concrete surface, the green line indicates the concrete-air interface of the concrete bottom, and the red line refers to the air-soil interface. The region between the green line and the red line represents the cavity under the bank revetment. It is noted that the signature of air-soil interface should produce white/black/white peak but it disappears at the left corner of Fig. 12 with a question mark. The missing interface may indicate the soil erosion stops at this point and the soil directly contacts with the bottom of concrete plate, so that weak reflection can no longer be detectable due to low dielectric contrast between the concrete and the soil.

**Fig. 11** Raw data of TL2

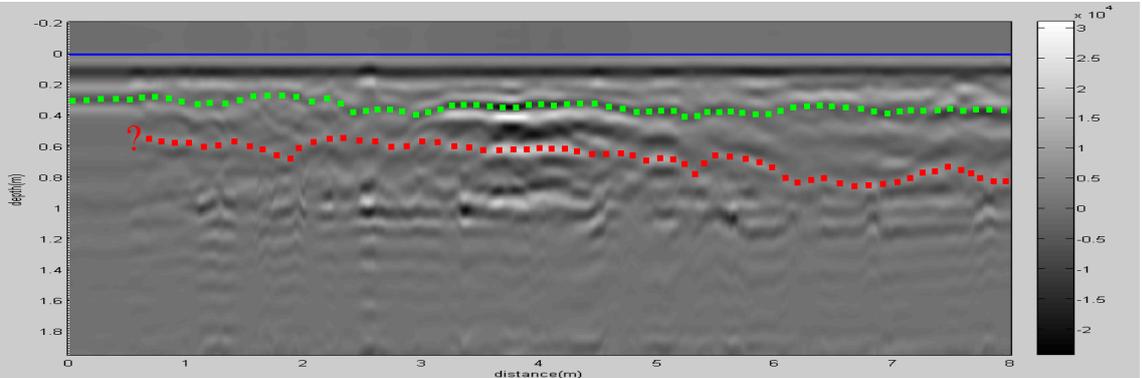
**Fig. 12** Processed image of TL2, which indicates concrete surface (in blue), concrete-air interface (in green), air-soil surface (in red), and missing interface (within question marks).

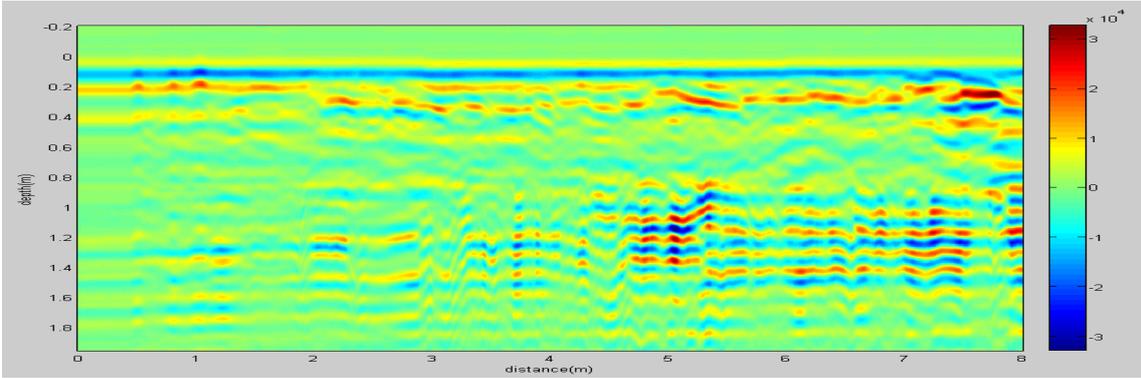
**Fig. 13** Raw data of TL3

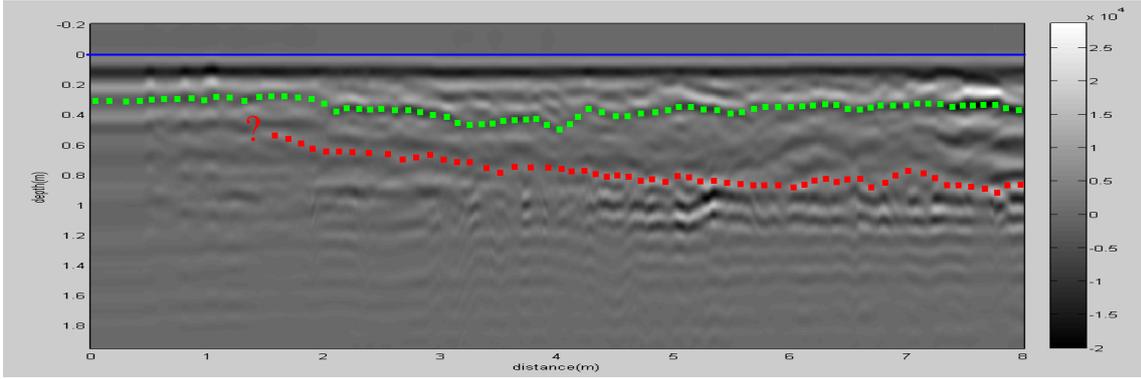
**Fig.14** Processed image of TL3, which indicates concrete surface (in blue), concrete-air interface (in green) air-soil surface (in red), and missing interface (with a question mark).

The possible cause of the large cavity under the concrete plate of the test site is mainly due to river flow vortex, since this section under investigation is the last section of the whole bank revetment. The structure type of bank revetment like the test site is a common type of revetment in Taiwan. According to the experience of authors, in addition to surface crack at the top of the concrete plate, there are hidden defects under the bank revetment which may not be necessary located at the last section of bank revetment. For instance, Fig. 15 is a typical broken concrete plate which is located midway of a bank revetment in Taichung, Taiwan. Fig. 16 shows the cavity under the plate at that site. It is noted that both concrete plates located closely next to the broken plate, the soil under the plates may be subject to river flow vortex and some cavities may already occur. These hidden defects may not be identified simply by visual inspection, unless some large broken plate had occurred in the near section. Therefore, developing a systematic and non-destructive technique, such as GPR, is extremely important

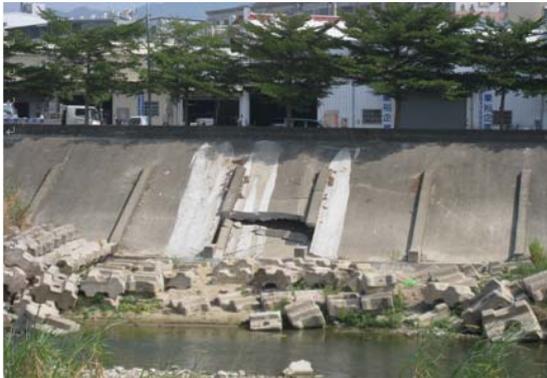
**Fig. 15** Concrete plate broken at other site

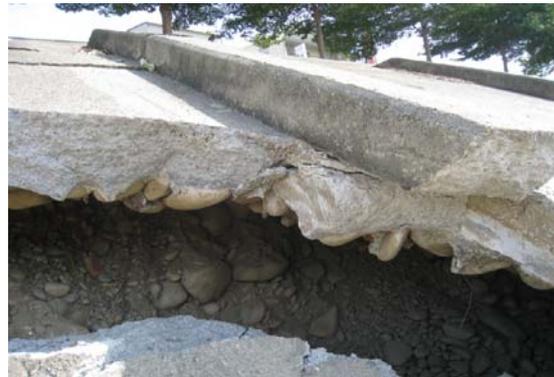
**Fig. 16** Cavity under concrete plate at other site
