# **SURFACE DEFORMATION AND MASS MOVEMENTS CAUSED BY THE 2005 KASHMIR EARTHQUAKE, NORTHERN PAKISTAN**

## **ABSTRACT**

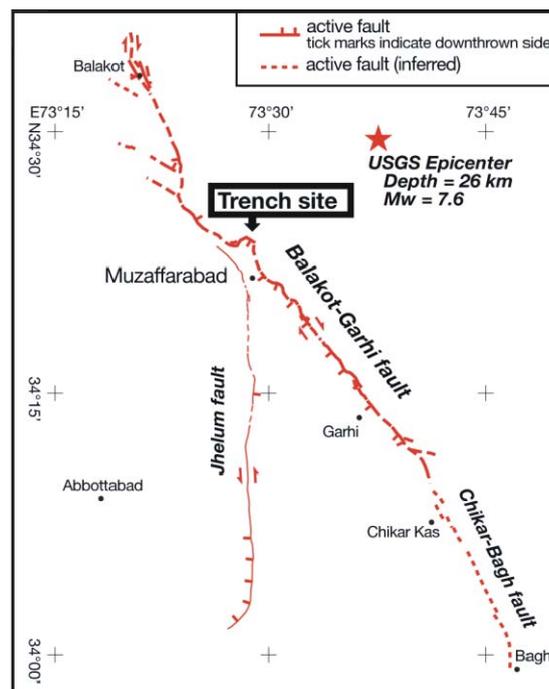
**Fig. 1.** Location of the active faults in the source area of October 08 2005, Pakistan Earthquake (modified from Kumahara and Nakata, 2005).

Several lines of evidence suggested that the earthquake had produced surface ruptures along the Balakot-Bagh fault. Mapped surface rupture trace shows that neither the Main Frontal Thrust (MFT) nor the Main Boundary Thrust (MBT) is responsible for the earthquake, but three active faults or fault segments within the Sub-Himalaya, collectively called the Balakot-Bagh fault make up the causative fault. Using satellite data and fault modelling, various researchers found that high crustal deformation has occurred along the known active faults stretching northwest and southeast from epicenter (Nakata et al. 1991), with northeastern part moved upward.

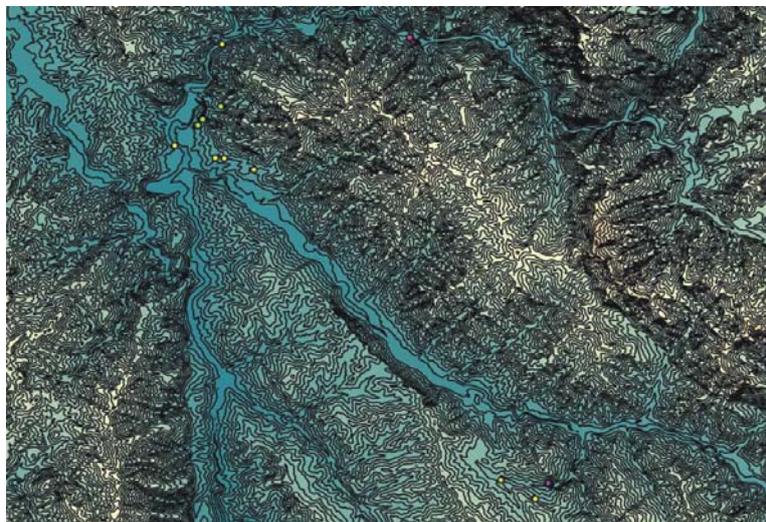
**Fig. 2.** Digital elevation map of the Neelum, Jhelum and Kaghan valleys derived from NASA SRTM data.

The mountains reach elevation  $> 3000$  m a.s.l between the Jhelum and Neelum river valleys with high values  $> 5000$  m. The landscape is deeply incised by the river network giving topographic relief of c. 3000 m that reflects fluvial erosion with landslides forming an important geomorphic component of sediment flux and landscape development (Figure 2). The intense fluvial incision by the Jhelum River has produced steeper low valley slopes that exceed  $50^{\circ}$  and is observed along its left bank. Above these lower steep valley slopes, the hill slopes become less steep ranging from  $10$  to  $20^{\circ}$  before being replaced by steeper ( $> 50^{\circ}$ ) high glaciated summit slopes (Kamp et al. 2008). Elevation of river floor in the upper stream from Naushera ascends from 800 to 1000 m a.s.l. The river terrace of the last glacial age develop as if it had once buried the Jhelum Valley, however, it has been incised deeply and the relative height from the river floor is about 100 m. Lower river terraces of several levels are observed below the last glacial terrace.

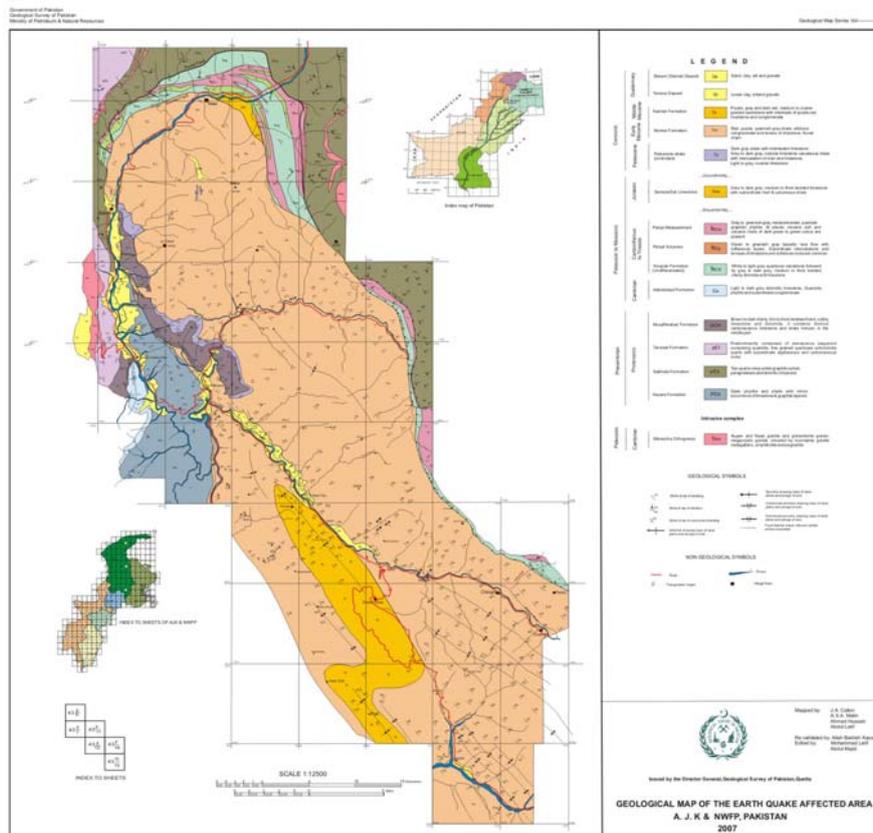
Fig. 3. Geological map of Hazara Kashmir Syntaxis and its surroundings.

Structurally, the study area forms a major anticline termed the Hazara-Kashmir Syntaxis (Calkins et al. 1975) reflecting part of the complex structural situation which defines the western termination of the Himalayan arc. This is a place where the MBT veers by about  $170^{\circ}$ , surrounding a “finger” of strongly folded, Miocene, red sandstones of the Murree Formation. The outer parts of the syntaxis are formed of older Pre-Cambrian metasedimentary rocks and metamorphic rocks of the Indian Shield and which are now in fault contact with the younger Murree Formation (Figure 3). The western side of the syntaxis is complicated by the existence of the Muzaffarabad anticline (Calkins et al. 1975). The Balakot-Bagh fault has an opposite sense of movement to the MBT and has moved south-westwards brining Neo-Proterozoic Muzaffarabad Formation dolomites over the Murree Formation. Along the thrust fault, these rocks are highly fractured with many discontinuities.

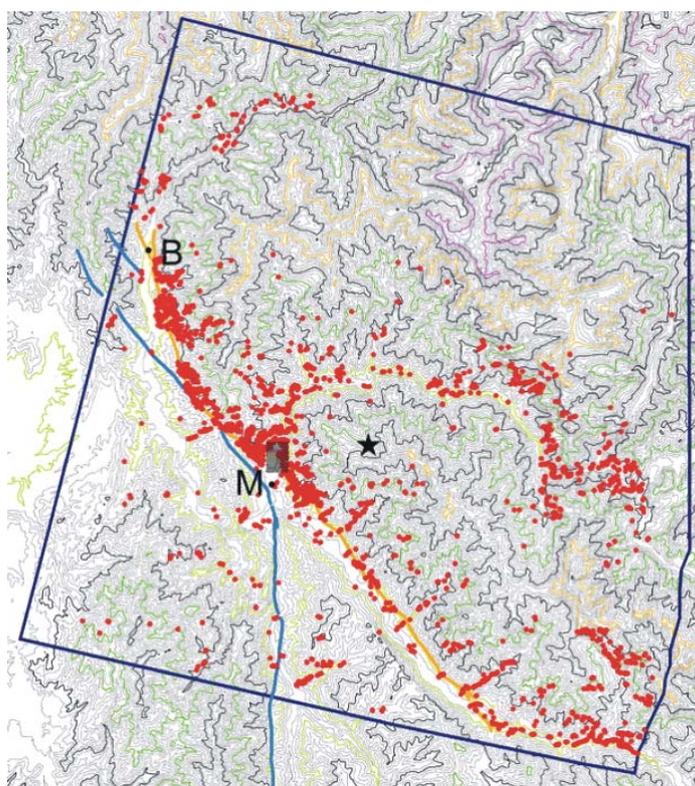
**Fig. 4.** Landslide distribution of coseismic landslides interpreted from SPOT-5 imagery (Sato et al. 2006).

from mapping from 1 m IKONOS and 2.5 m SPOT imagery resulted in approximately 2,424 landslides over an area of 55 x 51 km (Figure 4). This total does not include slopes showing signs of progressive failure. However, based on our's own visit we consider that this total needs to be revised upward to over 3000 landslides. The distribution of landslides is not clustered around the epicentral point, but instead appears related to proximity to the surface expression of the fault rupture, particularly hanging wall slopes of the northwestern half of the fault trace. This seems due to hanging walls comprising highly of fractured dolomite and limestone above the Balakot-Bagh fault. Landslide types included deep-seated failure; shallow, disrupted landslides; rockfalls; and cut-slope failures. The Kashmir earthquake involved slope failures in both bedrock and superficial deposits, with landslides occurring on many natural slopes and artificially cut slopes, particularly along transport routes (Owen et al. 2008; Petley et al. 2006). Kamp et al (2008) observed nearly 90 % of all landsliding occurred at elevations below 2000 m a.s.l., with nearly half of all landsliding being at elevations from 1000-1500 m a.s.l. Only 10 % of the landsliding occurred at elevations between 2000 and 3000 m a.s.l. Furthermore, landsliding was scarce at high elevations above 3500 m a.s.l.

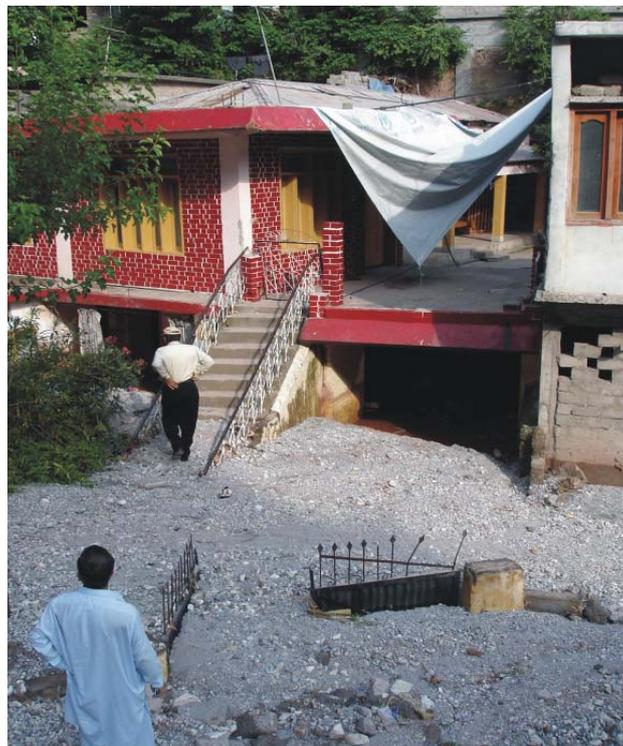
**Fig. 5.** Houses half burried in debris flow.

High resolution satellite imagery show that most slopes failed by rock fall and shallow failure on steep slopes leading to the formation of numerous talus cones. Field observations have however shown that it is not simply a matter of plotting the fault trace from a colour of the landslide debris. There are thick colluvial gravels composed of white dolomite clasts overlying the red Murree sedimentary rocks on many slopes due to previous slope processes, particularly debris flows. These plus the in situ fragmentation of the slopes has resulted in a high increase of available sediment which . During heavy rains of monsoon, this loose material combined with water moves as debris flows in the deeply incised creeks and hit the in habitants. These creeks directly pass through the Muzaffarabad city and feed the Neelum River flowing southward immediately at the western end of the city. People living in the valley along these creeks are seriously effected by the debris flow with there houses half or full buried (Figure 5).

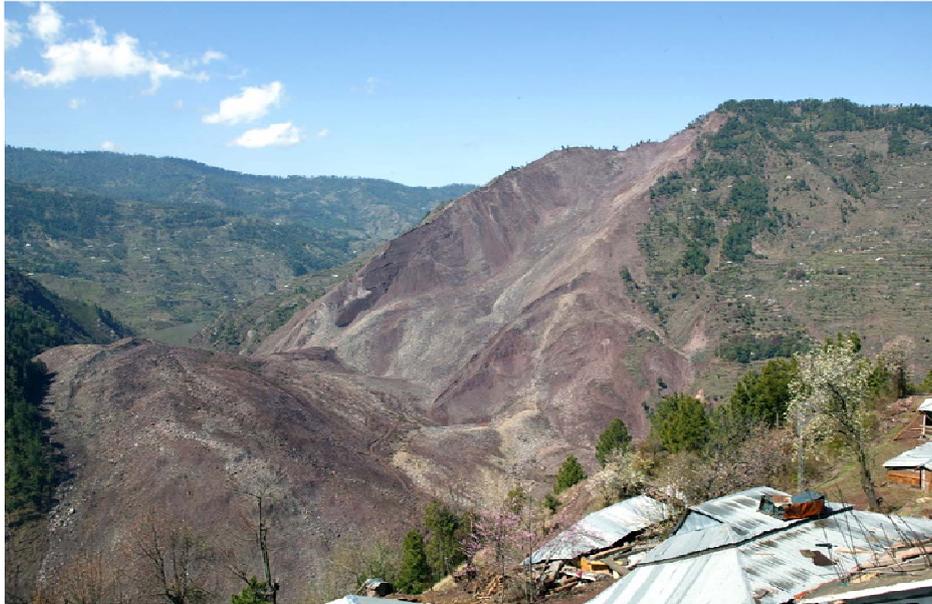
**Fig. 6.** Hattian Bala landslide on the left bank of Karli stream.

The largest landslide, known as the Hattian Bala Landslide, as it is close to the town of Hattian Bala, is located in a tributary of the Jhelum Valley in the Murree Formation, approximately 3 km from the fault trace (Harp and Crone, 2006; Owen et al. 2008). Its scar is  $> 1$  km long,  $> 200$  m wide, and  $> 20$  m deep and sloping northwards between  $60\text{-}70^{\circ}$  (Owen et al. 2008). Here, about 80 million  $\text{m}^3$  of material slid in the form of a debris avalanche over a total crown to toe distance of about 2 km (Figure 6). The landslide was clearly structurally controlled, with the slide plane being defined by a plunging syncline. The debris crossed the valley, was  $\sim 130$  m thick, and two lakes subsequently formed. By 2008, both lakes have increased in size and depths, and in both cases mitigation was undertaken through the construction of spillways, both of which have since had flow across them. Trommler et al. (2008) modeled the clear-water peak discharge of such a flood to be  $8000 \text{ m}^3/\text{s}$  causing a 12 m high flood wave immediately below the dam and 9 m high wave at the confluence of the Karli and Jhelum rivers near the village of Hattian.

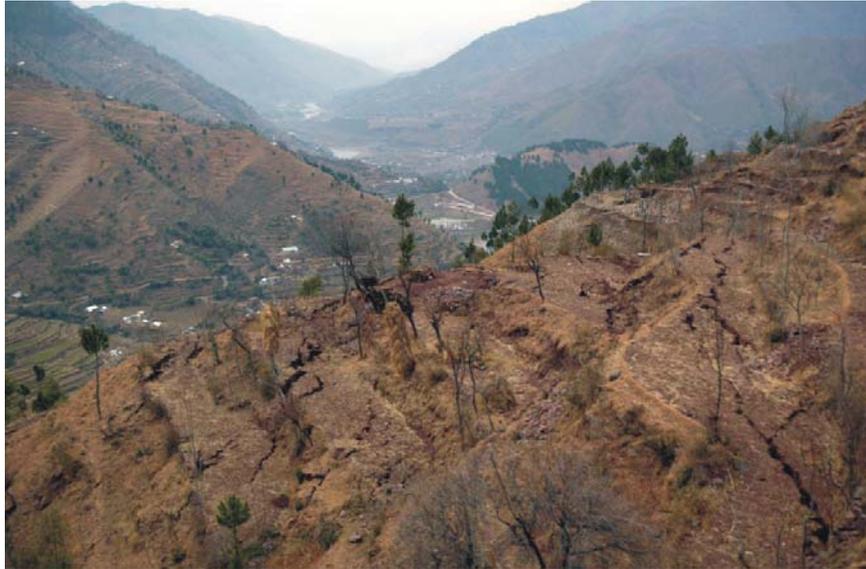
**Fig. 7.** A cracked slope in colluvium in the Jhelum River valley. The orientation of the cracks varies according to local topographic controls.

Most extensive slope failures are also likely to occur as existing landslides continue to enlarge by retrogression of back and lateral scarps. The presence of tension cracks on many slopes with a pattern that mirrors the configuration of the scarp allows the pattern of development to be proposed. However, there are other areas of hillslope that have not failed but have a high density crack array (Figure 7). These cracks occur on both the hanging wall and footwall blocks, but with the highest concentration occurring on the footwall side. It is suggested that these two are likely to fail as a series of deep seated failures on parts of slopes. It is more difficult to determine whether whole hillslopes may fail, such as the Botha-Khilla slope. However, should this scenario arise, this would be a major disaster affecting this part of the Jhelum valley.
