LANDSLIDE RISK INCREASING CAUSED BY HIGHWAY CONSTRUCTION

Željko Arbanas^{1*}, Sanja Dugonjić²

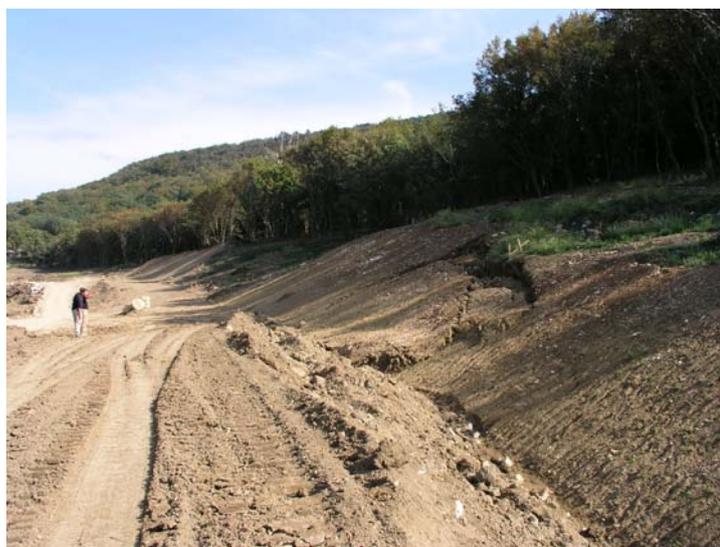
Fig. 2 Instabilities in Draga Valley during the highway construction

Flysch rock mass is subject to chemical weathering, which is particularly expressed in the fine-grained members, especially varieties of silts and shale. Due to the mentioned processes flysch rock mass gradually increases in volume, disintegrates and dissembles into clay and silt components (Fig. 2). By gradual degradation it becomes clayey-silty completely weathering rock mass zone, whose physical-mechanical properties are more like engineering soil (Arbanas *et al.*, 1999; Benac *et al.*, 2005, Dugonjić *et al.*, 2008). Typical geotechnical profile (Fig. 3.) of the slopes in Draga Valley consists of three layers: clay cover made after disintegration of flysch rock mass (residual soil) or brought by gravitation from hypsometrically higher parts of the slope, layer of weathered flysch deposits with variable weathered characteristics, which decrease with depth and fresh flysch zone (Arbanas *et al.*, 2008).

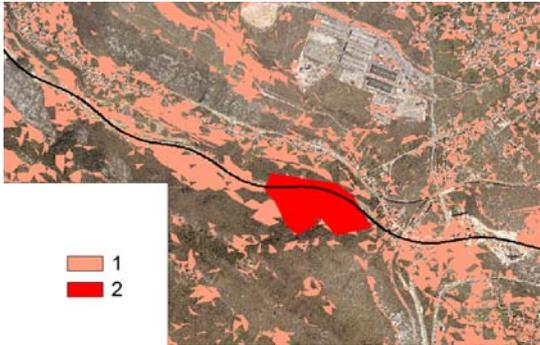
Fig. 10 Spatial hazard distribution map shown in ortho rectified photography of Draga Valley after highway construction: 1) High hazard areas; 2) Very high hazard areas

Level of moderate risk was assigned to the areas where instabilities are possible under adverse conditions. High risk was established in the potentially unstable areas which have slopes between 15 and 37% (Fig. 10), and the cover layer is usually relatively thick (3-10m). Very high risk level dominates in the terrains with bedrock surface slopes between 20 and 35%, and locations at where landslide instabilities already occur, or in the areas where the instability event is almost certain. The most of occurred landslides in the area of highway were caused by construction. Analyzing of all influent factors, zones of extra landslide risk are determined caused by slope cutting and increment of steps.
