# **A NUMERICAL ANALYSIS OF SLOPE FAILURE IN WELDED TUFF CAUSED BY THE IWATE-MIYAGI NAIRIKU EARTHQUAKE IN 2008**

**Key Words:** Earthquakes, Slope failure, Distinct element method

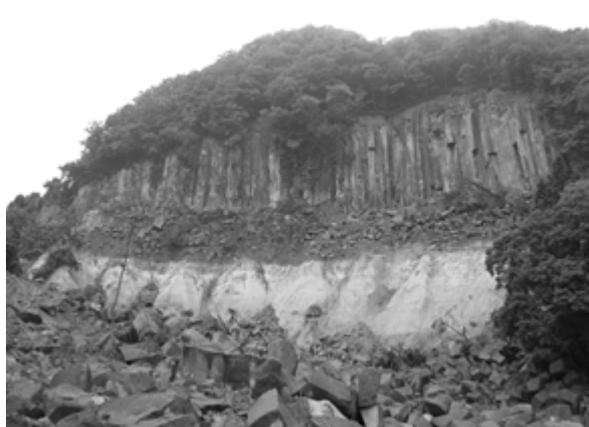
**Photograph 1** Slope failure at the site A

Fig.1 shows the location of investigation. Photographs 1 and 2 show the slope failure at the site A and the site B, respectively. At the site A, the slope failure occurred due to the

earthquake. The dimensions of slope failure are about 120 m in height and about 250m in width. The upper part of the slope consists of stiff welded tuff with well-developed columnar joints and lower part consists of soft pumice tuff. The collapsed rock masses were near the geologic boundary and the river indicated as Sanhazama River in Fig. 1. A similar geological structure was discovered at the site B. In both cases, the rock mass has reached the opposite bank of the river.

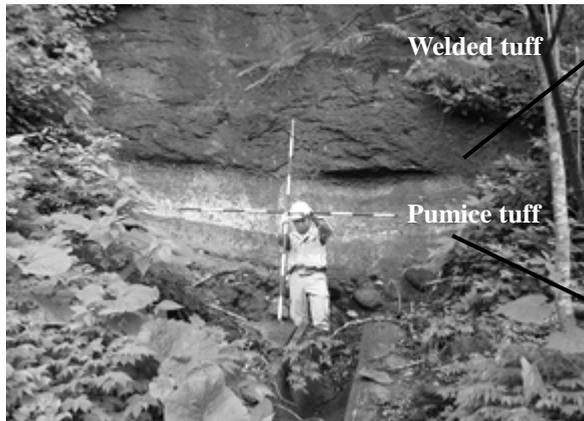
**Photograph 3** Outcrop nearby the site B

Photograph 3 shows the outcrop near the site B. Photographs 4 and 5, show the steel wedge that was hammered in to the two types of rocks, in order to illustrate difference in the stiffness and strengths of the welded tuff and pumice tuff. These photographs show that the wedge could not be hammered in to the welded tuff for more than 1 cm, whereas the wedge could be easily hammered into the pumice tuff for more than 5 cm. The differences in the mechanical properties of welded tuff and pumice tuff were examined by uniaxial compression and ultrasonic tests of samples obtained from the site B.

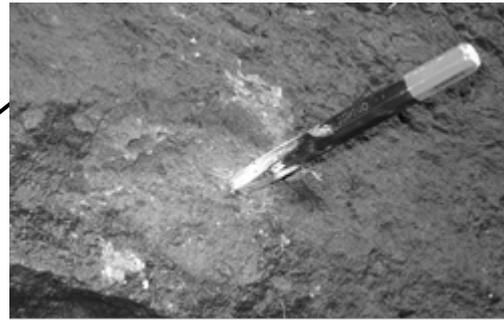
**Photograph 4** Welded tuff. The wedge penetrated less than 1 cm

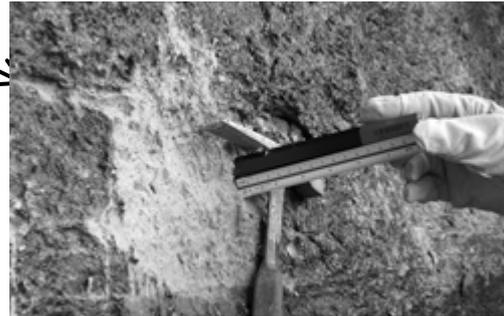
**Photograph 5** Pumice tuff. The wedge penetrated more than 5 cm

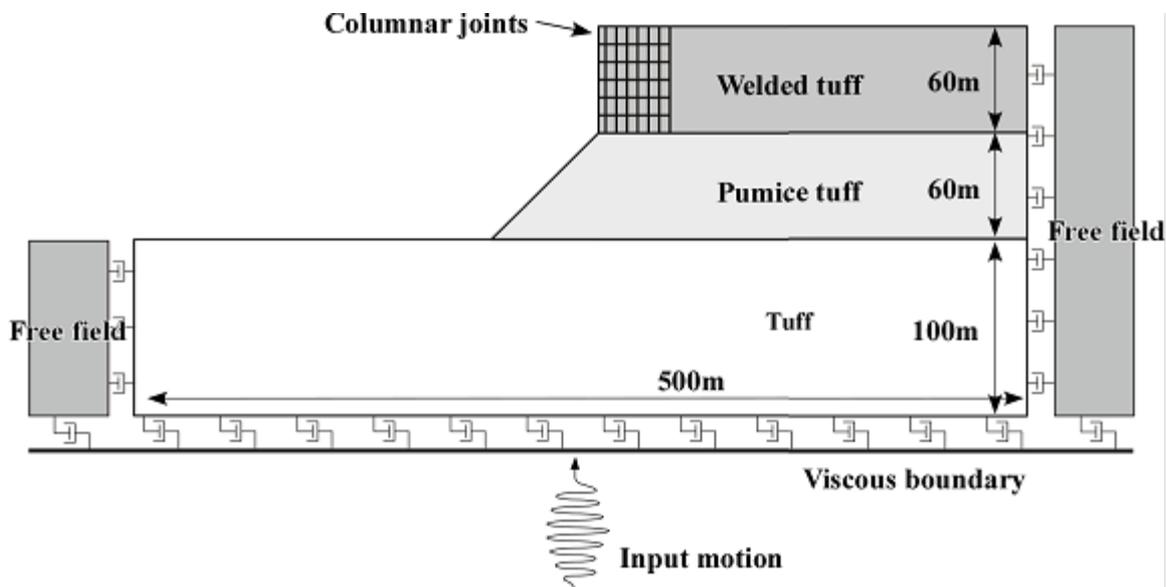
Fig. 2 DEM model for the dynamic simulation

Fig.2 shows the distinct element method (DEM) model for the dynamic simulation. In case of jointed rock masses, DEM is based on discontinuum approach and is therefore suitable to simulate behaviors exhibiting large movements such as rockfall.

There is no detailed profile of the slope, and the similar slope failure was discovered in several sites. Hence, the simplified model was made for the dynamic simulation based on the simple measurement using handy laser distance meter.

The model consists of the following three layers: welded tuff, pumice tuff, and tuff. The columnar joints were generated in the front region of the welded tuff. On bottom and both sides of DEM analysis model, boundary conditions are as follows:

Bottom: Vertical: fixed boundary, Horizontal: viscous boundary

Side: Vertical: fixed boundary, Horizontal: viscous boundary with free field

All the rock mass were modeled as elastic model. In the analysis, physical properties of rock mass were determined from laboratory tests. The joint strength parameters were used typical small value given in Table 2. A Rayleigh damping was used to get more reliable results.

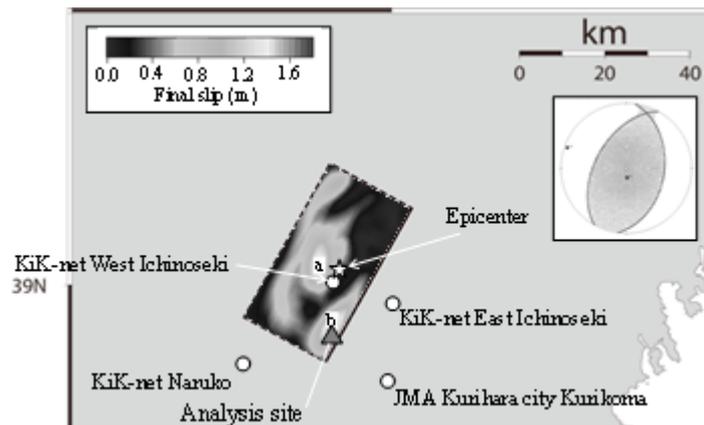
**Fig. 3** The characterized source model for strong ground motion prediction

There is no station that has recorded the strong motion near the targeted site. Hence, in this study, strong earthquake motion in the site was estimated using the stochastically simulated Green's function method (Kamae *et al.*, 1991). The characterized source model for strong ground motion was generated by the waveforms inversion method (Nozu, 2008; Hata *et al.*, 2009) that is based on the seismic slip distribution. The ground shaking characteristics in the site was based on the subsurface structural model by the National Research Institute for Earth Science and Disaster Prevention (NIED). The theoretical waveform by numerical calculation of strong ground motion was adopted as input earthquake motion for the DEM model.

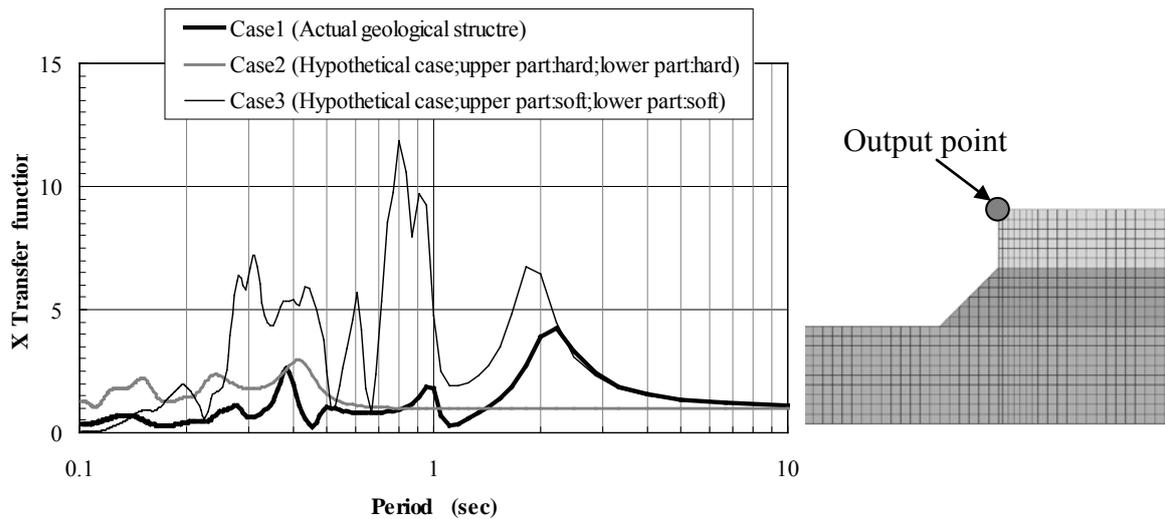
Fig. 6 Result of frequency response analysis

Table 4 shows results of eigenvalue analysis. Fig. 6 shows result of frequency response analysis. Predominant period of case 1 (actual geological structure) appear at 0.4 seconds, 1.0 seconds, and 2.0 seconds. On the other hand, predominant period of case 2 is shorter than 0.4 seconds. Predominant period of case 3 appear at similar period of the case 1. It is assumed that the slope response is amplified at 2.0 seconds therefore, due to the soft pumice tuff.

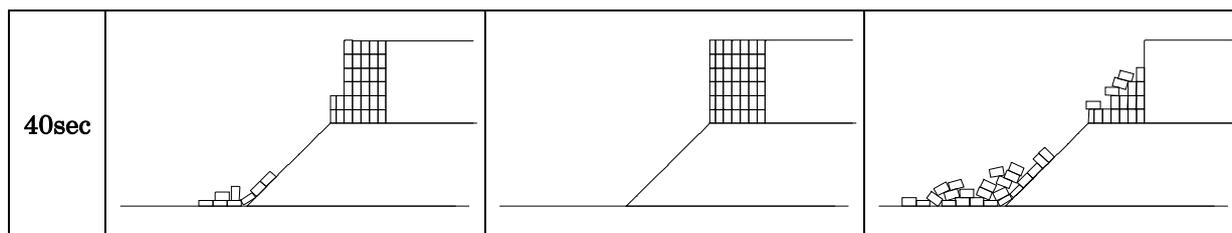
Fig. 7 DEM analysis results at 20 seconds and 40 seconds

Fig.7 shows DEM analysis results at 20 seconds and 40 seconds. In case 1, the columnar joints clearly opened after 20 seconds and the rock masses started to incline toward the river, followed by toppling failure, where broken rock pieces fell up to the toe of the lower layer. The travel distances of the broken rock pieces were similar in the field.

In case 2, the columnar joints started to open approximately 20 seconds after the initiation of excitation. However, the jointed rock mass did not fail. In case 3, while the behavior of the rock mass is similar to that of case 1, more rocks have fallen than in case 1.

<b>Case 1</b> <b>Actual geological structure</b> <b>Upper part: Welded tuff</b> <b>Lower part: Pumice tuff</b>	<b>Case 2</b> <b>Hypothetical case</b> <b>Upper part: Welded tuff</b> <b>Lower part: Welded tuff</b>	<b>Case 3</b> <b>Hypothetical case</b> <b>Upper part: Pumice tuff</b> <b>Lower part: Pumice tuff</b>
20sec	Vector scale — 5m

These simulated results, such as the toppling failure and the amplitudes of the displacements, are thought to be consistent with the behaviors that are expected from the observation of the spreads of debris and joint systems. Hence, it is assumed that the slope failure is affected by the existence of soft pumice tuff and the columnar joints.

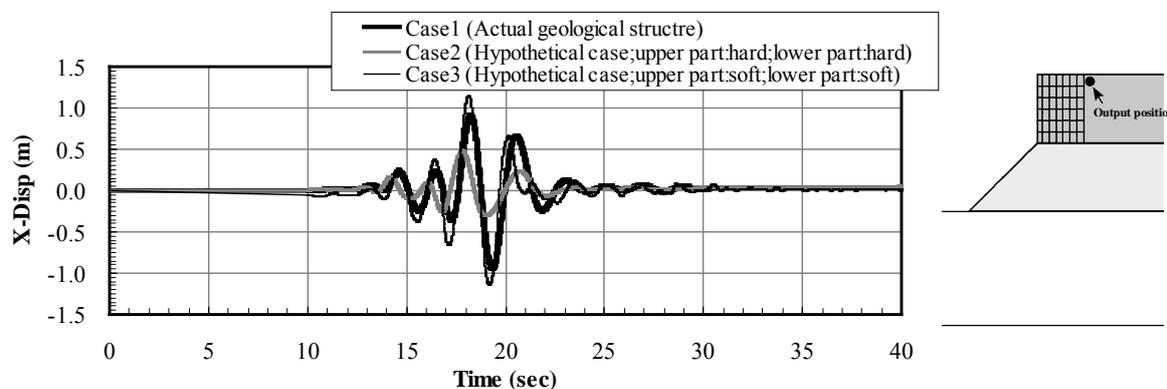
Fig. 8 Horizontal displacement time history of top of the slope

Fig.8 shows horizontal displacement time history of top of the slope. The maximum displacement was about 1.0 m in case 1 and case 3. By contrast the maximum displacement was about 0.5 m in case 2.
