EFFECTS OF DEBRIS-FLOW CONTROL WORKS ON ENVIRONMENT AND CONSEQUENCES FOR LAND-USE PLANNING CASE STUDY “MURBACH”, TYROL, AUSTRIA

Joerg Heumader^{1*}

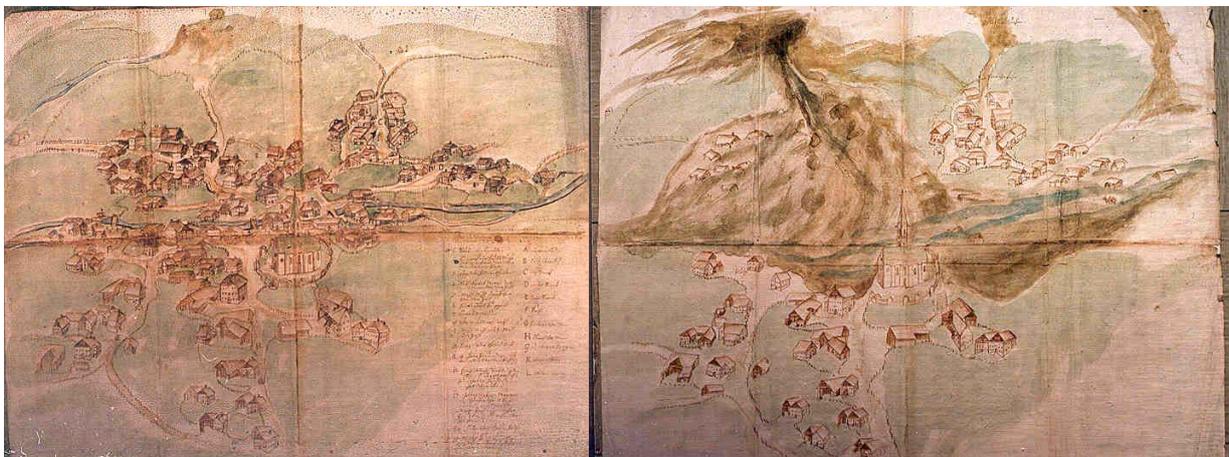
Fig. 1 and 2: The village of Umhausen before and after the catastrophe of 1762.

In the period from the 9th to the 11th of July in the year 1762 a series of debris flows, coming down from the basin for 40 hours damaged 68 houses and farm buildings, which had been built on the southern sector of the debris cone. Only one house in this part of the village "Umhausen" has withstood this catastrophe. 9 persons and a lot of livestock were killed (Fig. 1 and 2).

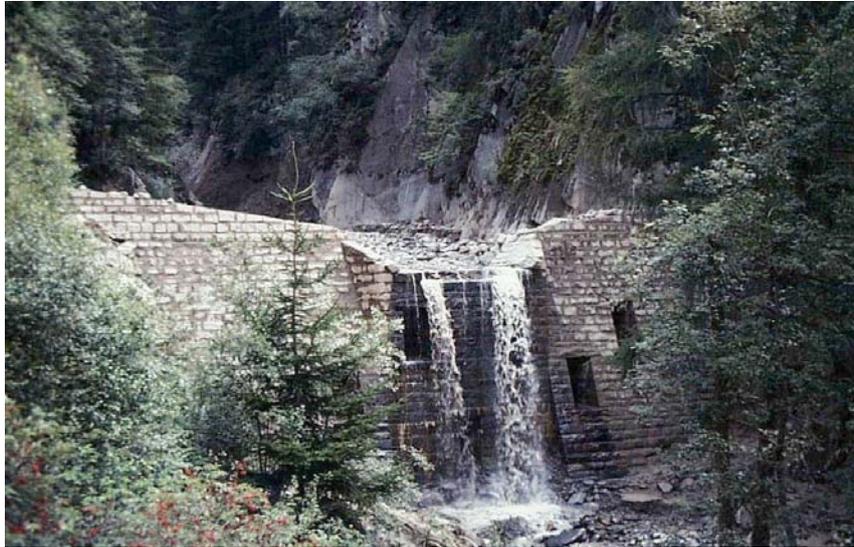
Fig. 4: At the valley outlet a gravity dam, made of concrete masonry, functions as a debris-flow breaker.

At the valley outlet a gravity dam with large holes made of concrete masonry functions as a sort of debris-flow breaker; its storage capacity is 5.000 m³ (Fig. 4).

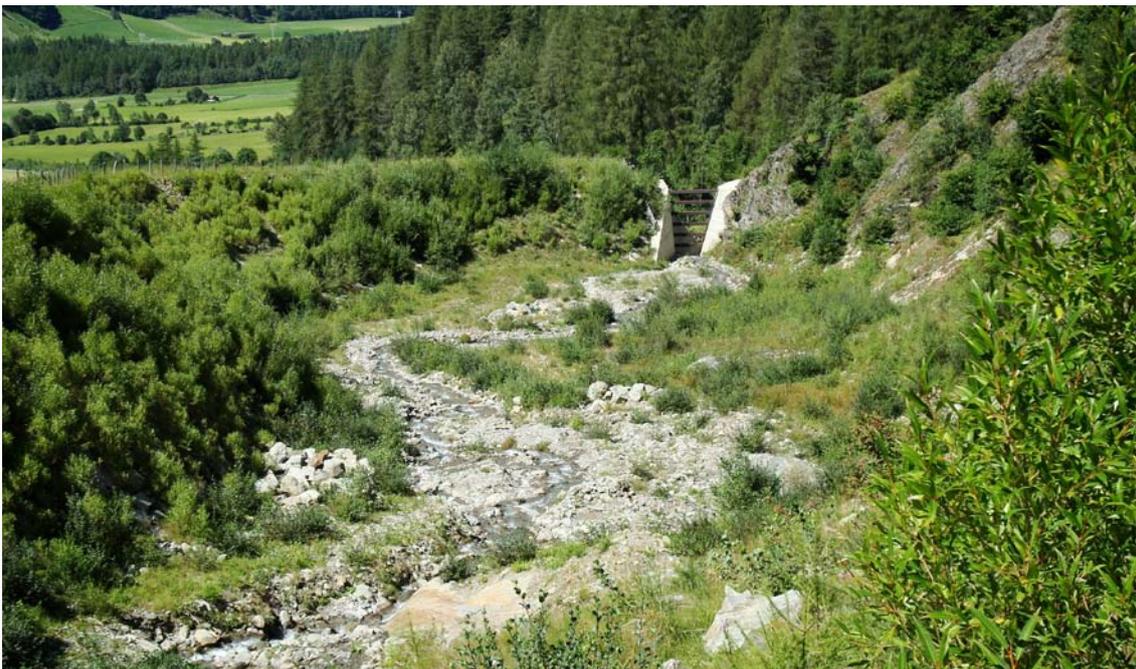
Fig. 5: The debris-retention basin has been structured, but otherwise left to natural regeneration.

On the northern sector of the uppermost part of the debris cone a debris-flow retention basin has been built. It reaches upstream almost to the debris-flow breaker, it is bordered to the north by the mountainside and to the south by an earth dam, whose waterside slope is protected by dry-laid boulders. The basin's outlet is a dam, made of reinforced concrete with steel bars closing its opening, supported on the left by an angular retaining wall and fixed on the right to a natural rock outcrop by prestressed anchors. The retention capacity of the basin is 40.000 m³ at minimum, depending on the aggradation grade (Fig. 5).

Despite the fact, that the retention basin will be filled up by the next debris-flow, nature-orientated planning has been done for the period before that event. Considering environmental and landscape aspects the dam's outer slope has been afforested with groups of conifers (*Larix decidua*) and some broadleaf tree species. Willow cuttings (*Salix sp.*) and alder plants (*Alnus*

sp.) have been planted into the gaps between the dry-laid stones of the revetment of the inner slope. The basin's bottom has been structured and left to natural revegetation (Fig. 5). The basin's outlet's opening reaches down to the torrent bottom and is no barrier for migrating fish. Because of the special outlet construction of the basin only the earth dam can be seen from the opposite mountainside.

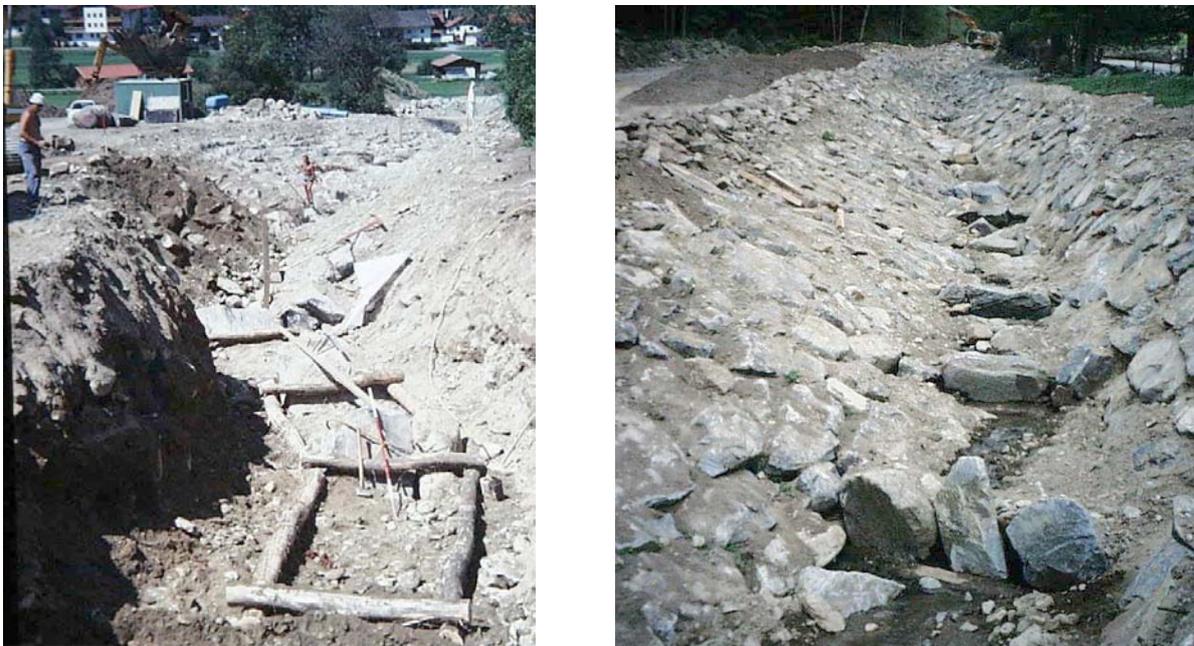
Fig. 6 and 7: Near-nature channel under and just after construction without water running.

Planning had to take into account the energy surplus of the water runoff downstream the retention basin, which would have resulted in severe depth and lateral erosion problems. When setting out the channel's centerline it was tried to integrate existing stone rows, bush and tree groups etc. The channel has an open, natural bottom with varying width fixed by low sills made of boulders founded on timber logs. The banks with varying slope inclinations, steeper in the outer curves, gently inclined in the inner curves, are protected by revetments of dry-laid stones, founded on timber logs (Fig. 6 and 7).

The gaps in the stone pavement were planted with willow cuttings (*Salix sp.*), the upper edge and strips of varying width on both banks with groups of bushes and trees.

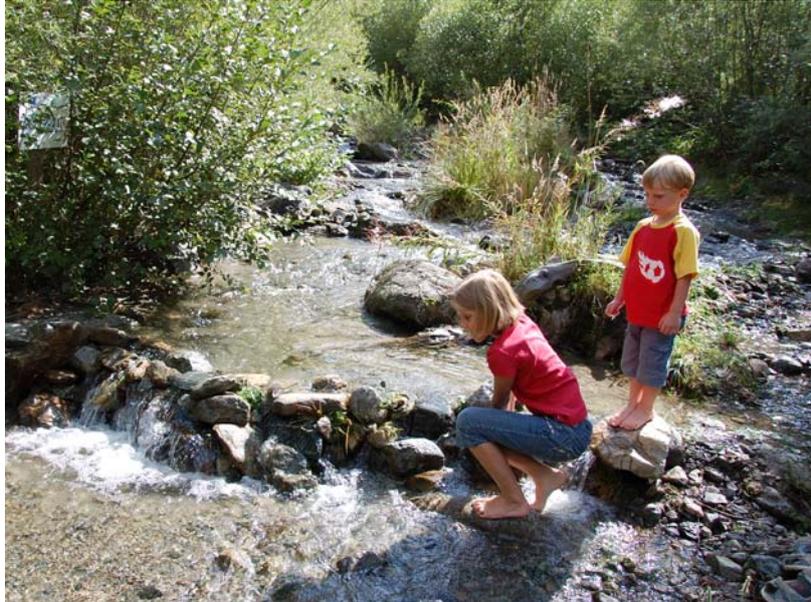
Fig. 8: Channel widenings as playing grounds for children.

Three channel widenings with gently inclined slopes have been designed as water-playgrounds for children, several picnic places and information boards have been installed (Fig. 8).

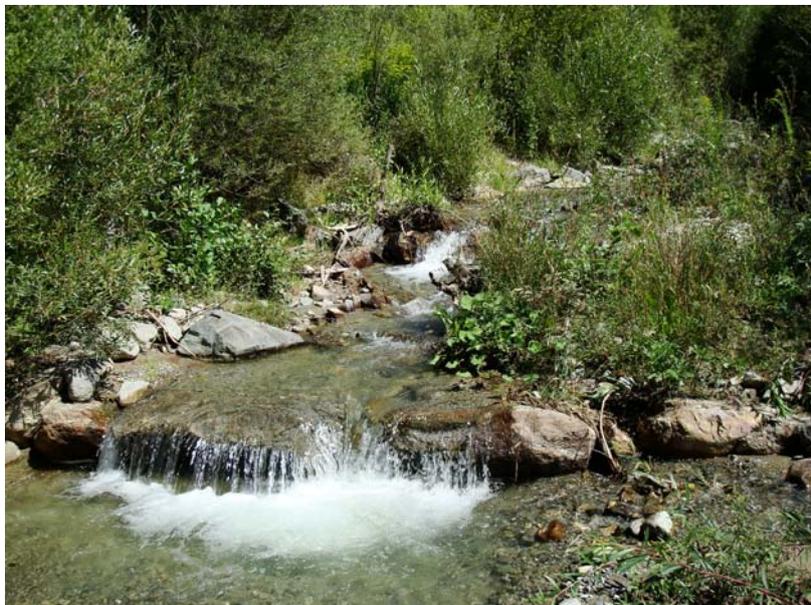
Fig. 9: Step-pool-structures and densely planted banks as good habitats for life inside and outside the water.

The step-pool-structure of the new channel is very positive for water-life, even two fish species (*Salmo trutta f. fario* and *Salvelinus fontinalis*) live here now (Fig. 9).
