THE DEVELOPMENT OF SABO TECHNOLOGY TO MITIGATE DISASTER CAUSED BY DEBRIS FLOW IN INDONESIA

Agus Sumaryono^{1*}, Evrilia Hildasari²

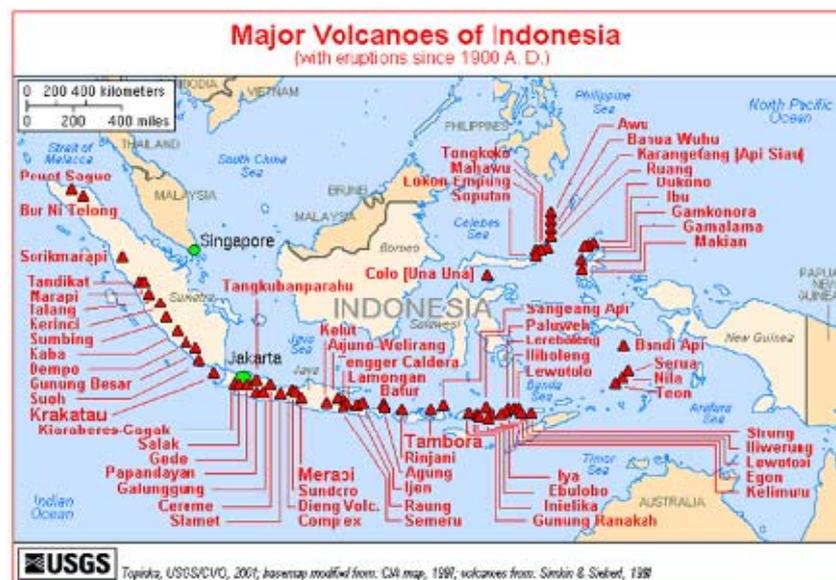
Fig. 1 Mayor Active Volcanoes of Indonesia

There are some conditions which trigger the occurrence of debris flow in Indonesia such as topography, geology, rainfall, and environment. The mountainous topography condition of the islands in Indonesia, heavy rainfall, steep slope of river bed, and the steep slope of land surface are the main causes of debris flow occurrence in the country. The geological condition where Indonesia has 129 active volcanoes, (see Fig. 1) and located at the confluence point of three tectonic plates i.e. Eurasia, Pacific and Australian plate are also plays important role to the occurrence of sediment disaster.

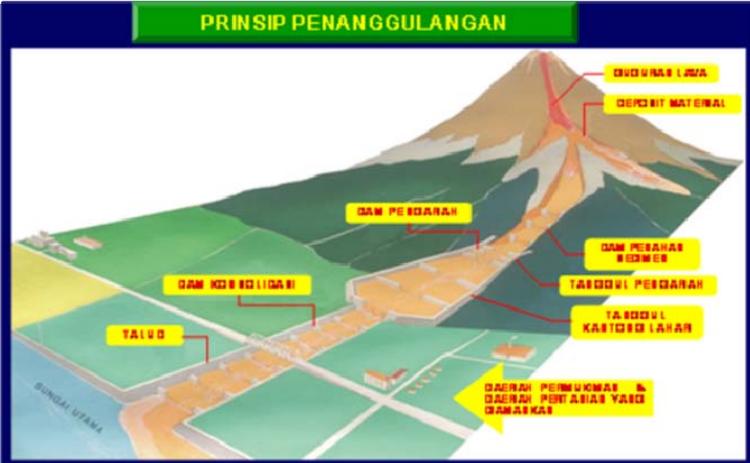
Fig. 4 Debris flow disaster countermeasure model in a volcanic area (source: Mt. Merapi Volcanic Debris Control Project, Yogyakarta.)

In order to mitigate the disaster caused by debris flow, sabo technology has been introduced by Japanese engineers since 40 years ago through the technical cooperation between Indonesian and Japanese Government. The Indonesian engineers have been cooperated with the Japanese engineers to solve the problems of debris flow countermeasure not only at the lahar rivers in the volcanic area but also at the torrent rivers in non volcanic area. Sabo structures such as sabo dams (check dams), consolidation dams, groundsills, training levees, spur dykes and the other structures have been constructed at a number of rivers. Fig.4 shows the model of debris flow countermeasure in a volcanic area.

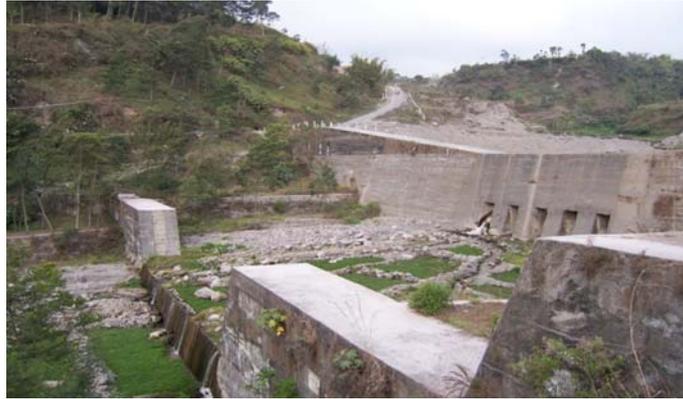
Fig. 5 One of the check dams in Mt. Merapi area has another function as a submerged bridge (Photograph taken by Agus Sumaryono)

In the beginning of 1970, sabo works has been implemented by constructing check dams made of stone masonry. After that, some sabo structures were made of concrete and the others were made of the combination of stone masonry and concrete. In 1990 decade, steel double wall check dams have been introduced in Mt. Merapi area. There are some various type of chek dams which were constructed both in volcanic and non volcanic areas such as open type check dams, close type check dams and culvert type check dams. Besides have the function to trap and control sediment discharge, the sabo structures have been developed as multipurpose sabo dams. The other purposes of sabo structures are to divert water for irrigation, domestic water and micro hydro power plant, as the foundation of bridges, and as the submerged bridges. Fig 5 shows a sabo dam in Mt. Merapi area which has another function as a submerged bridge.
