Assessment of soil erosion and flood control measures in a small Siwalik Hill catchment of Nepal Himalaya

Key words: Land use change, channel change, bank erosion, mitigation, Siwalik Hills

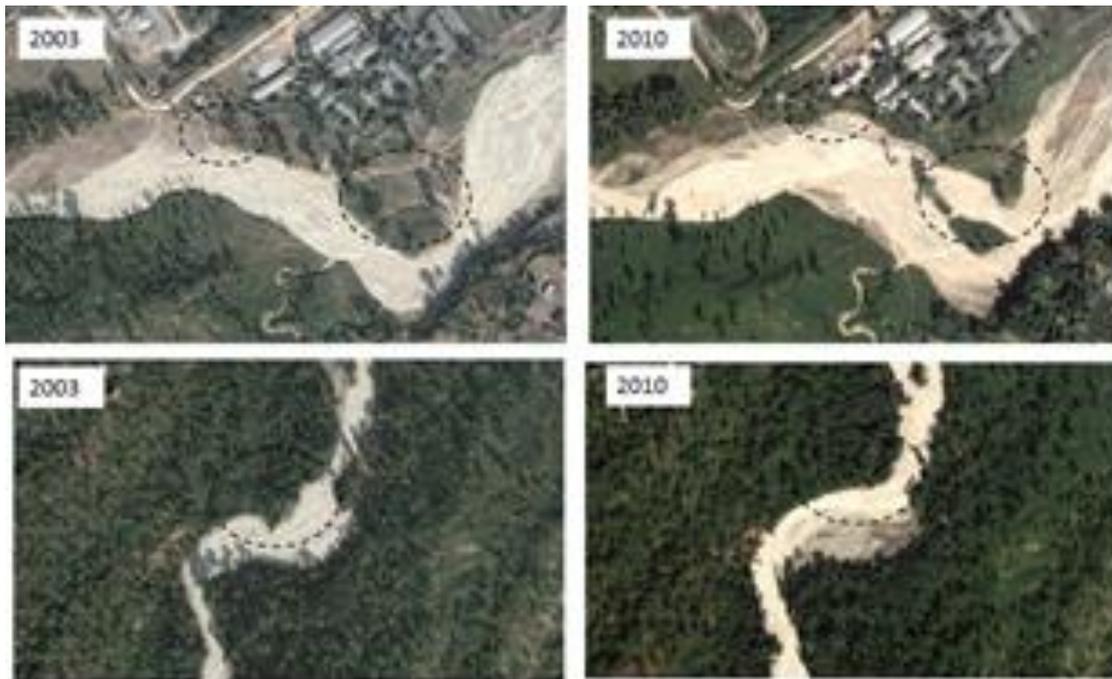
Fig. 4 Widening of an active channel of Khajuri Stream from 2003 to 2010 traced from Google images.

Analysis of the Google images indicated various types of morphological changes from 2003 to 2010 especially within the middle reach (Figure 4). A few abrupt changes in stream planform were also noticed possibly as a result of the catastrophic events, such as a dramatic channel widening in response to a large storm event. Also, several cases of progressive change in channel width were observed which led to many types of morphological changes, for example, a meander growth leading to a meander cut-off (Figure 4). There were also several cases where an active channel course deviated from its normal course resulting in side bank erosion and stream widening. The assessment of the long-term trends showed that the channels had undergone active erosion, alteration of channel flow paths and lateral movement over the last few decades.

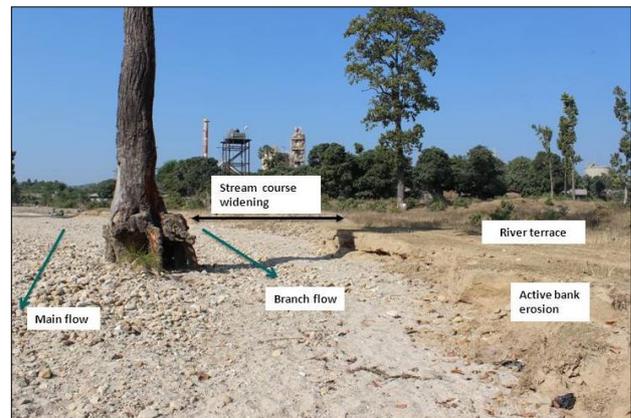
The streams were characterized by extremely movable boundaries mostly associated with channel widening and in some occasion complete channel course migration (Figure 5).

Increase in width varied from a few meters up to 300 m. The bed materials were composed of a combination of coarse sand and gravel. The extent and pattern of these morphological changes widely varied both in space and time.

Fig. 5 A recent occurrence of bank erosion and course widening in the middle reach of Khajuri Stream.

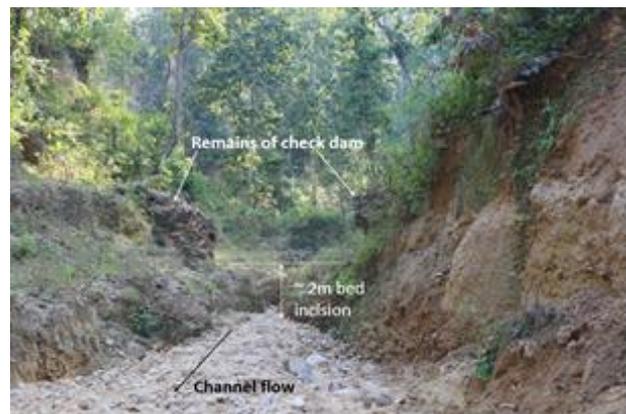
Key morphological changes identified in the field as a consequence of these measures are shown in Figure 7. In the upper reach, none of the check dams for gully erosion control which were adopted in early 2000's existed during the 2012 field survey (Location B in Figure 7). Significant channel bed incision (up to ~2m) was noticed along the gully channel bed (Figure 8). It was noticed that these structures could not survive against the incision process on the alluvial cone due to riverbank erosion along the Khajuri stream (Figure 9).

Fig. 8 Failure of a check dam as a result of channel bed incision along a gully channel (Photo: Dec 2012).

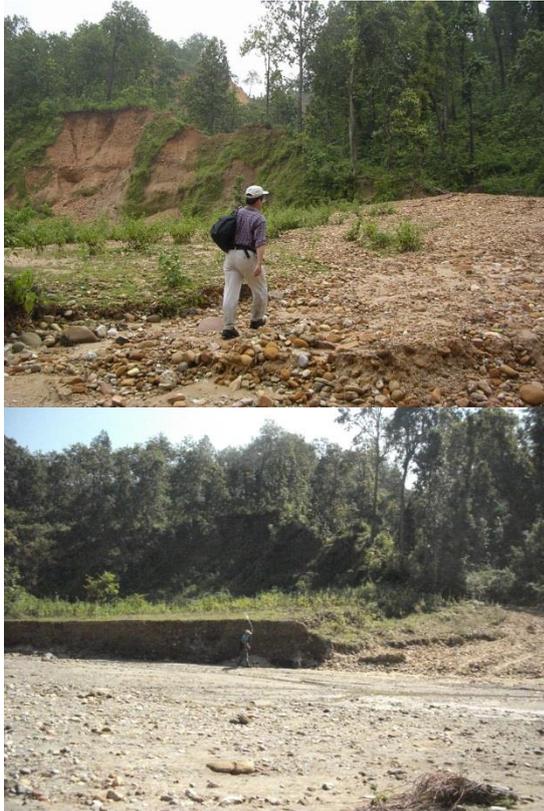
Fig. 9 Upper: Alluvial fan of an active gully. Lower: Bank erosion of the alluvial fan by the Khajuri main stream (Photo: Oct 2013).

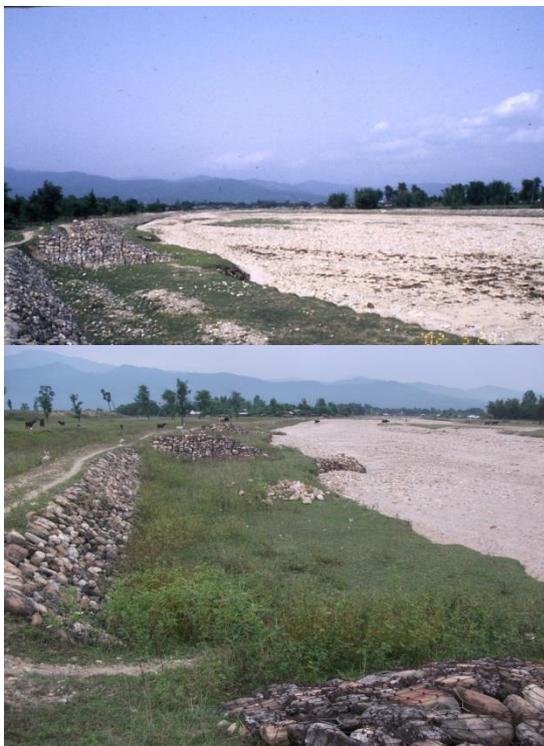
The embankments with gabion launching aprons to protect against scouring erosion have been well functioning without significant riverbed aggradation and degradation in the upstream half of the Lower reach for 15 years since 1998.

Fig. 10 Embankment with series of spurs and aprons (Photo: upper; June 1998, lower; Oct 2013)(Location C).

In this segment, the river width was designed same as that of natural river course before the channel works, and the height of the embankment was decided from the discharge designed from the slope-area method and expected rate of riverbed raising within five years based on the interview to local people [*Water induced Disaster Prevention Technical Centre, 1999*] (Figure 10). This positive effect for flood control is possibly due to maintaining the channel width same as the width in natural condition.
