Successful hazard prevention using flexible multi-level barriers

Key words: Debris flow prevention, multilevel ringnet barriers, shallow landslides

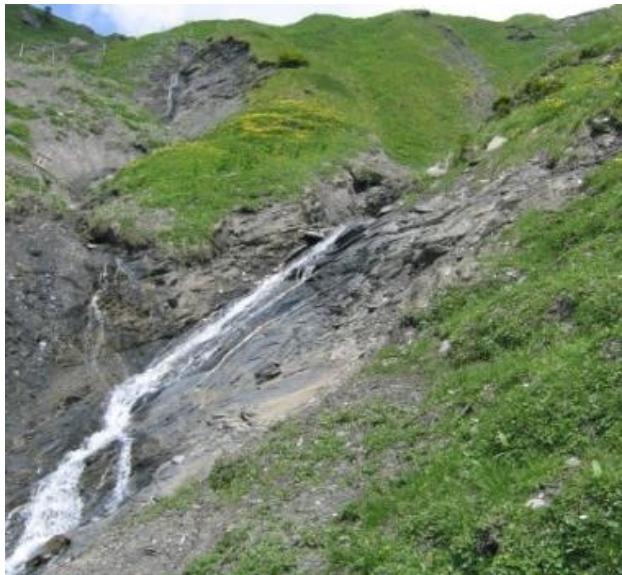
Fig. 2 Catchment area with the Milibach in the Gummen region

The valley of Gummen is made of slope parallel black clay rich alénien schist (Alénienschiefer). Sometimes there are some parts of sandstone in between. The slope parallel schist is very sensitive to weather and acts as aquiclude (Wenger, 2006).

This formation is overlaid by a weathered, several meter thick debris layer. This layer forms the origin for the debris flow material and consists of weathered part of the upper Doggers. Parts of moraines are only infrequently within the debris.

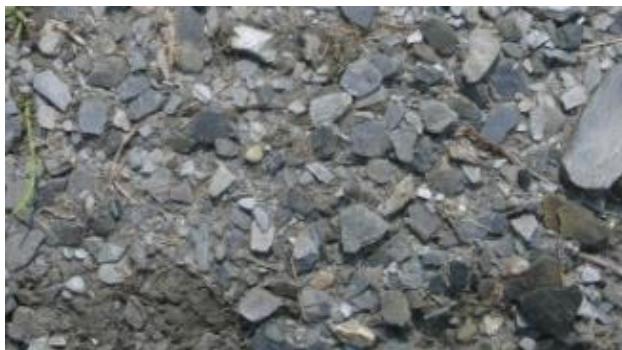
Fig. 3 Alénien schist material.

The debris is a very clayey, silty and also sandy with a lot of bigger stones and boulders. If the material is dry its internal friction angle ϕ' lies between $25\text{--}28^\circ$ with an apparently cohesion of $c' = 0\text{--}3 \text{ kN/m}^2$. If the material is saturated with water, these values rapidly get lower, even the internal friction angle reach values of 15° . After wet periods with a lot of rainfall these packets of granular soil are mobilized as hillslope debris flows and transport the debris into the river. Very particular is the low plasticity of the material. The part of clay and silt is 15-20 %. This fact is a very big problem for the disposal construction because they have to be built very flat with retaining walls (Wendeler et al. 2008).

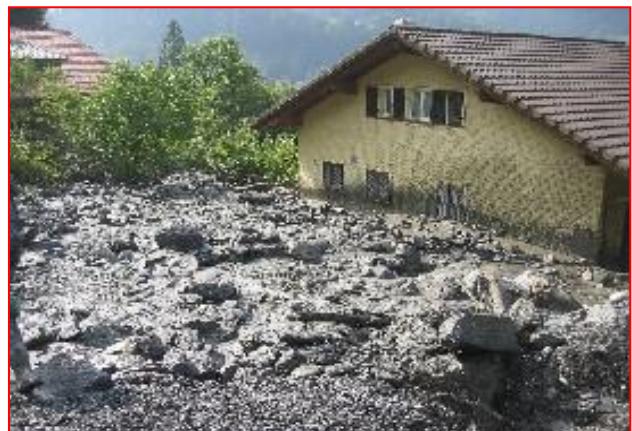
Fig. 4 Caused damages in Meiringen in 2005.

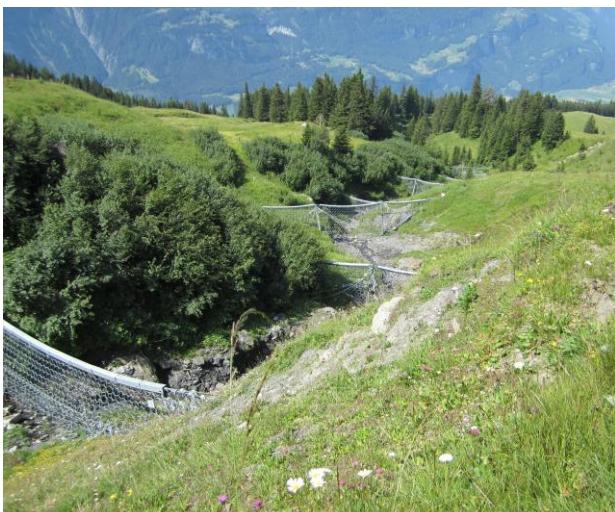
Fig. 7 Final project realization of the 13 flexible barriers in line.

The final installation of the 13 barriers in line was finished in 2009. Since that date regular inspection

visits of the “Schwellenkooperation” (regional community for water engineering) are done to maintain the system in regular frequencies. Small blockage of the basal openings are cleaned out and height measurements of them are performed.

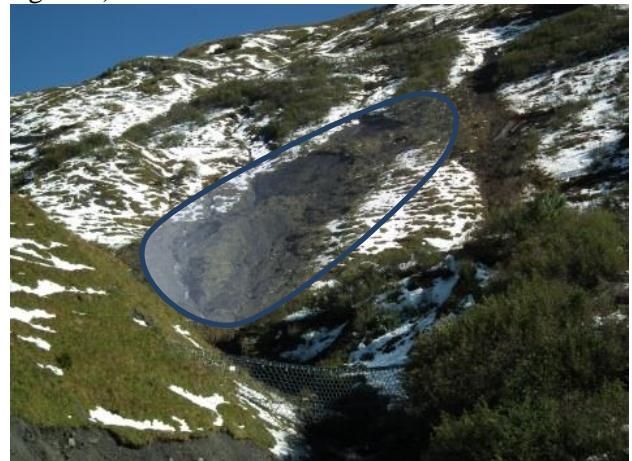
Fig. 9 Shallow landslide close to flexible barrier No 2 caused the filling of this net.

Around 2,000 m³ of material got mobilized 10th of October, most of the material by a shallow landslide close to flexible net No 2 from the top (see figure 9).

The customer as well as the geologist of this project decided to leave first net No 2 filled in the torrent to stabilize the foot of the shallow landslide at the slope to the right view river upstream. Net No 5 will be cleaned with normal water flow, some maintenance work will be required caused by eroded

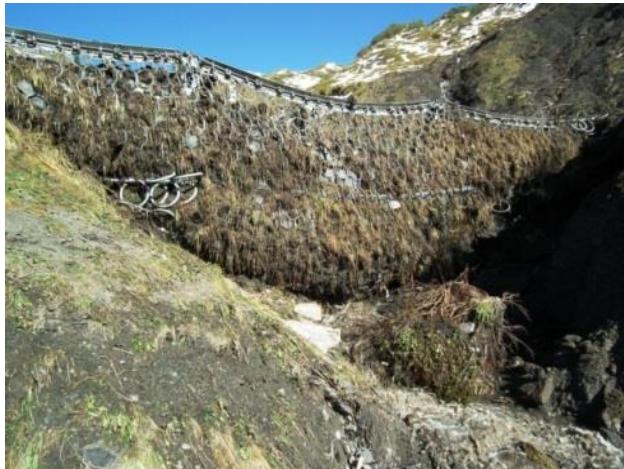
Fig. 10 Stopped material behind net No 2

Flexible net No 2 got filled up to the max. level and flexible net No 5 filled up to half net height (see figure 10 and 11). The nets in between did not filled up because of their higher basal opening, the gap between the lower support rope and the river bed.

Also the complete developed design concept of the dimensioned barriers was proven by this event. No failure of the directly impacted barrier No 2 was happening even the shallow landslide brought a total volume of around 2,000 m³ at once impacting the barrier. The material retained behind the barrier look dense with an estimated density of the slide of around 2,000 kg/m³. To recalculate the impact forces of the slide to the barrier the velocity plays an important role. In that case for 30° inclined slope it can be estimated to max. 10 m/s. Flow height of the slide are much harder to estimate and cannot be declared thus impact pressure acted on the barrier No 2 unluckily cannot be back calculated precisely.

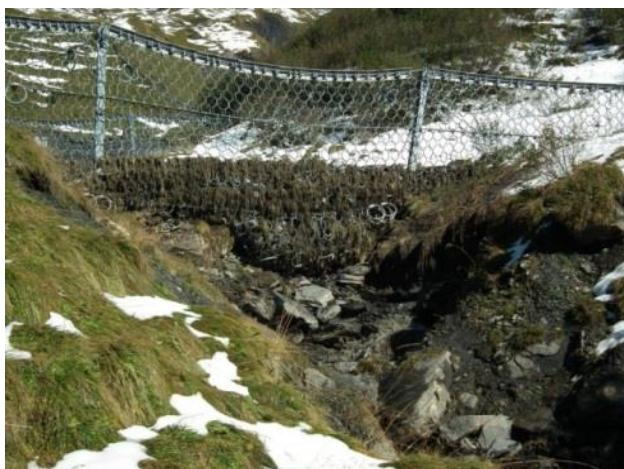
Fig. 11 Stopped material behind net No 5
