# Landslide and flood hazards consequences and community based management initiatives in Nepal Himalaya

Key words: geo hazards, steep slope, land use, community based management

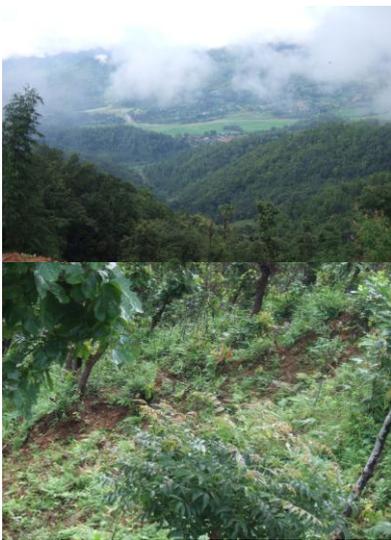
**Fig. 1** General glimpse of study area (land use and slide view)

The area mainly consists of forest, cultivated land, barren area and settlement. It is usual practice that the local communities are dependent upon the agriculture system and farmers grow varieties of products (rice, wheat, maize and cereals crops) even if in steeper slope (> 30 degrees) as shown in **Fig. 1**. Usually farmers are depending upon the subsistence agriculture farming for their daily life. The rural villages are residing into the foothill slopes which are very prone for landslide No proper land use planning is practiced.

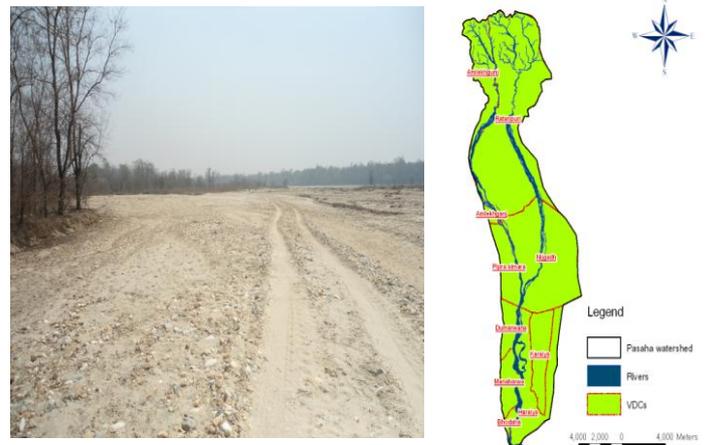
**Fig. 2** Glimpse of Siwalik region site (River bed view, catchment shape)

The study area is located in central Nepal, Bara District and is one of the major River originating from the fragile Siwalik/Churia landscape as shown in **Fig. 2**. The watershed area comprises both steep slope (northern part) and flat (southern part) where

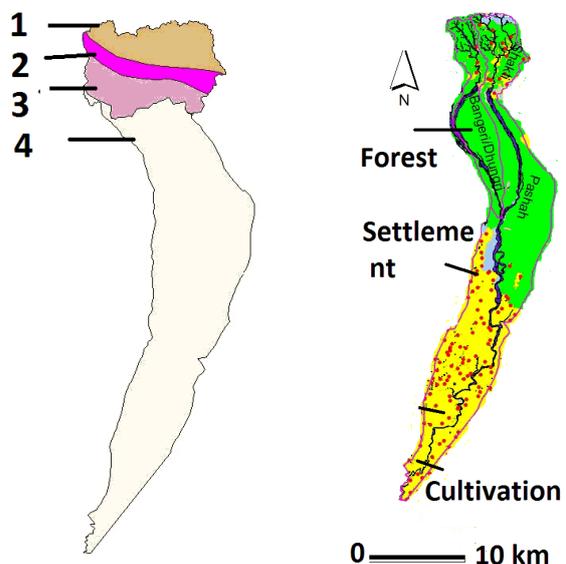
**Fig. 3** Geology and land use maps  
Geology (1: Upper siwalik group, 2: Middle siwalik group, 3: Lower Siwalik group, 4: quaternary deposits).

In the northern part, there is steep dissected topography with abundantly distributed unconsolidated loose materials originating from mudstone, sandstone, siltstone and shale. The general geological distribution and land use pattern are shown in **Fig. 3**.

The fertile agriculture lands, settlements, are located along the both side of the River course. Geologically comprises, three distinct units, in upper, middle, and lowland parts. In upper part, coarse boulder, sandstone, sandy clay and

conglomerate are more dominant. In middle parts, fine to medium grained sandstone and mudstone are common. In the lowermost part, medium to coarse grained sandstone, clay and conglomerate. The land use types include, sparse and poor quality forest, degraded land, with steep topography. In lowland sites, fertile agriculture area is abundantly distributed.

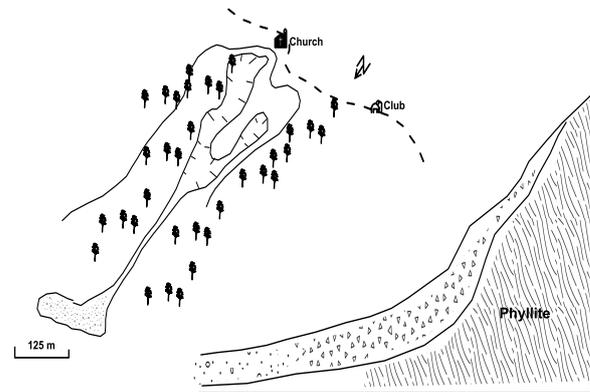
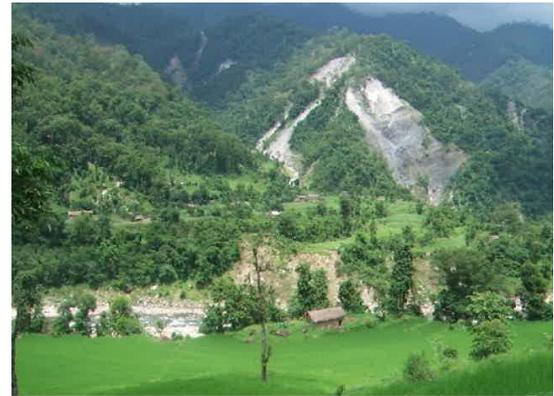
**Fig. 4** View of slides underlying above phyllite

(Underlying topographic situation and photographic view)

The landslides are mainly shallow translational type, and the scarp surface is covered by the regenerated vegetation. About 50% (15 slides) of total slides were occurred on the slopes ranging from 30° to 40°. No slides are observed in the slope less than 25°. According to land use pattern, about half of the slides are located in the forested land and remaining are either on the cultivated or over barren/bushes sites. About 70% of the total slides were observed over the slopes underlying with schist, and phyllites dominated landscape, **Fig. 4**. The causes of the landslide can be attributed to the highly fractured and highly weathered weak phyllite with the addition of concentrated precipitation and steep slope. The road construction along the unstable slope was triggered the slides. The thin soil mass located immediately above the bed rock is slid and bed rock is exposed. The exertion of pore water pressure might have also the important role for sliding. The root of the species *Alnus nepalensis* and *Shorea robusta* are not providing the sufficient strengths/reinforcement to control the sliding. Besides the bedding and foliation, discontinuities are found in the rock mass. The discontinuities are responsible for the development of failure by forming wedges and plane failures. Plane rock failures are especially common on the dip slopes, whereas wedge failures are observed mostly on the counter dip slopes.

Further, improper land use on the steep slope has contributed in this slope failure (irrigating paddy field on very steep slope). Rural road construction without slope assessment was another important causes. In some locations, groundwater seepage can be seen and underlying water might have created the lubricating effects. In addition, small gullies are abundantly distributed and it can be assumed that such small sized gullies might have developed into the slides during the course of time.

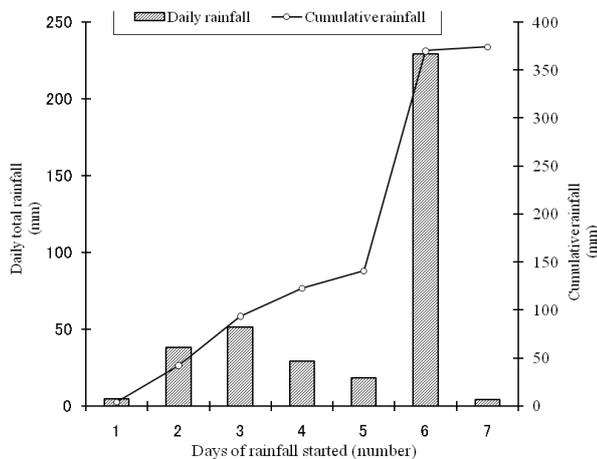
Fig. 5 Rainfall condition during sliding

Continuous antecedent rainfall for about 7 days has triggered the slides in Sisneri watershed areas. A daily total of 370 mm (Fig. 5) rainfall was observed. It was difficult to relate with the intensity duration because of unavailability of intensity data. The local community has established the digital rain gauge station and local people are taking the daily records. If excess rainfall is observed the operator warns by producing the large sounds so that local communities may aware of sliding events. It is the just initiation on Early Information system rather than the Early Warning System. It looks to be good initiation to disseminate the idea of landslide management.

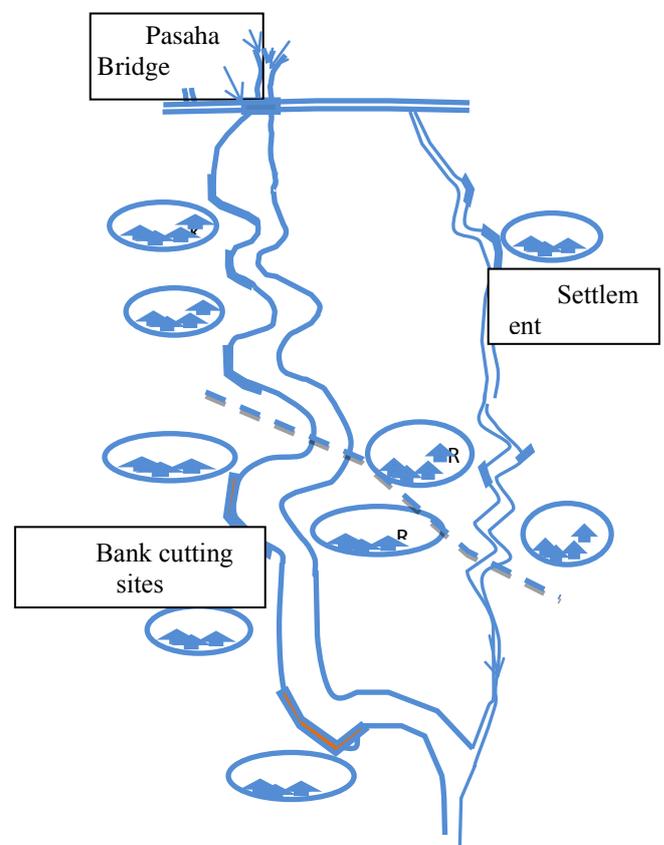
Fig. 6 Settlement and bank cutting view along the River path

seasons (May-July). The general settings of the river flow path and location of the settlements is shown below in Fig. 6. The area receives an average annual rainfall of about 2500-3500 mm and is concentrated during monsoon seasons. There is sharp slope gradient change within the span of 2-5 km (from hill to down gentle slope) span along the landscape and flow velocity is also changes suddenly. This sudden change in landscape gradient affects the water flow and ultimately influences on bank cutting, and debris deposition along the River bed. Hence River avulsion (branching) was become prominent. The flood severity zone is most severe for those people living very adjacent to the flow path. About 50% of total population of the catchment are residing along the River path and are supposed to be flood affected every year.

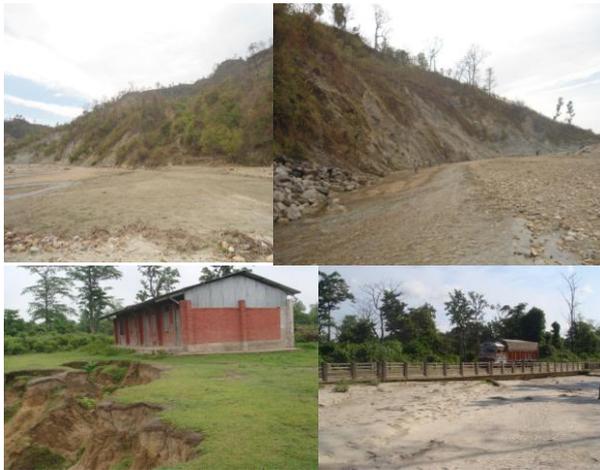
**Fig. 7** Bank cutting, and other damaging effects

The sediment originated from the hill slope flows with the high velocity and because of high energy destroyed everything along the path. The general glimpse is shown in Fig. 7. The school,

electric poles, agriculture lands, bridges were damaged.

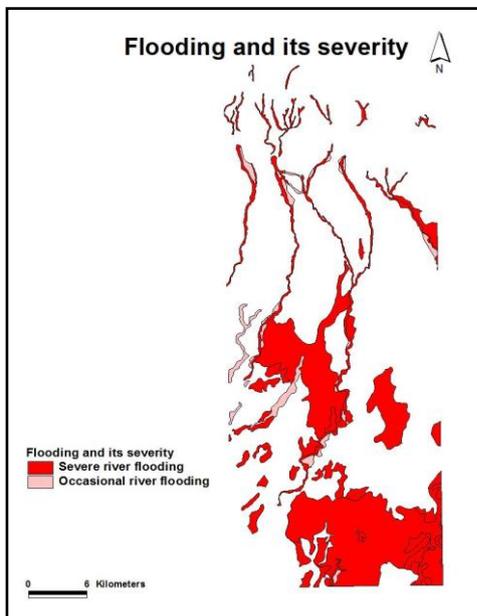
**Fig. 8** Flood severity map

Despite the annual loss due to flooding still majority of people are living under the adjacent to the severe flood prone sites as shown in **Fig. 8** and still effective preventive measures are not implementing.

The flood severity map indicates that still majority of the people (about 500 no) are living around the flood prone areas. This indicates that people still prefer for their easy agriculture practice rather than safety.

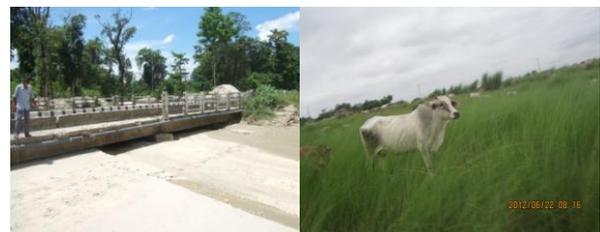
Sediment near bridge

land damage (conversion from cultivated land into grass cover)

**Fig. 9** Upstream (cause) and downstream (effect) linkages

1. About 200 hac, of fertile cultivated land was damaged,
2. Annual flooding and inundation have threatened about 500 Households along the River course,
3. Major Infrastructure like road, bridge, school, electric poles are under constant threat,
4. Mass wasting have caused forest cover depletion/degradation.
5. Forest biodiversity was severely affected
6. It is estimated that there is annual loss of about one billion US dollar..
7. There is strong upstream and downstream linkages. In the upper catchment there is causes (sediment source) and in the downstream side the is effect (damaging effects) as seen in **Fig. 9**. The agriculture land is now converted into grass land cover (covered by *Saccharum* as seen in photo right hand side).

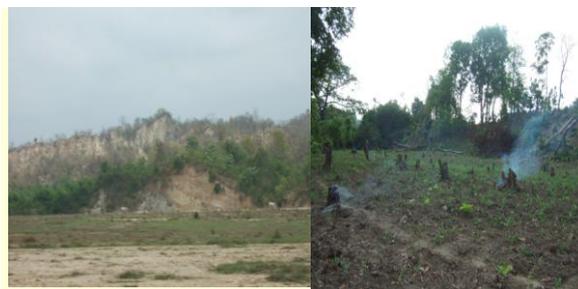
**Fig. 10** Glimpse of highly eroded slope and sediment origin zone deforestation

In mid hill region of Nepal, mainly surface failure events are common. The extent of damage is greater compared to deep seated slides (rarely seen). Both inherent characteristics (steep slope, loosely consolidated rock soil mass) and external factors (improper land use pattern, deforestation) are responsible for recurrent sliding. In the Siwalik/Churia region, there is large scale deforestation and massive erosion is at the upper catchment as can be seen in **Fig. 10**. The illegal (encroacher) people enters into the forest and cut down the trees. Gradually after firing, they people converts the forested land into the agricultural lands. After few years (when the productivity declines) they again shift into the another area and adapt the

similar practice. Hence gradually large area of the landscape is converted into the agriculture land. The area is steep and surface soil erosion is very prominent. The natural setting is disturbing by anthropogenic activities (settlement, firing etc.) and supporting for the flash flood and debris generation.
