# Distribution and Characteristics of Sediment-related Disasters Induced by the Great Kanto Earthquake in 1923

The Great Kanto Earthquake (M7.9), which occurred in the Kanto Region on September 1, 1923, cost the lives of 105,000 people, including the dead and missing, as a result of the direct seismic impact and ensuing fires. Among the earthquake damage, sediment-related disasters alone occurred at 167 locations and produced at least 1,056 victims, including the dead and missing, though this fact is less known among the general public. The characteristics of the distribution of sediment-related disasters caused by the Kanto Earthquake was the subject of a report that focused mainly on the survey results of the most devastating sediment disaster. It was a deep-seated landslide that presumably started on a mountain slope named Obora and struck a hamlet called Nebukawa in Kataura village, which is the southern part of today's Odawara City, Kanagawa Prefecture, and went down the Shiraito River as debris flow. In Yokohama City, 27,000 people were killed due to the collapse of buildings and the ensuing fires. I trailed the escape route in Yokohama taken by O.M. Poole, the Japan regiona

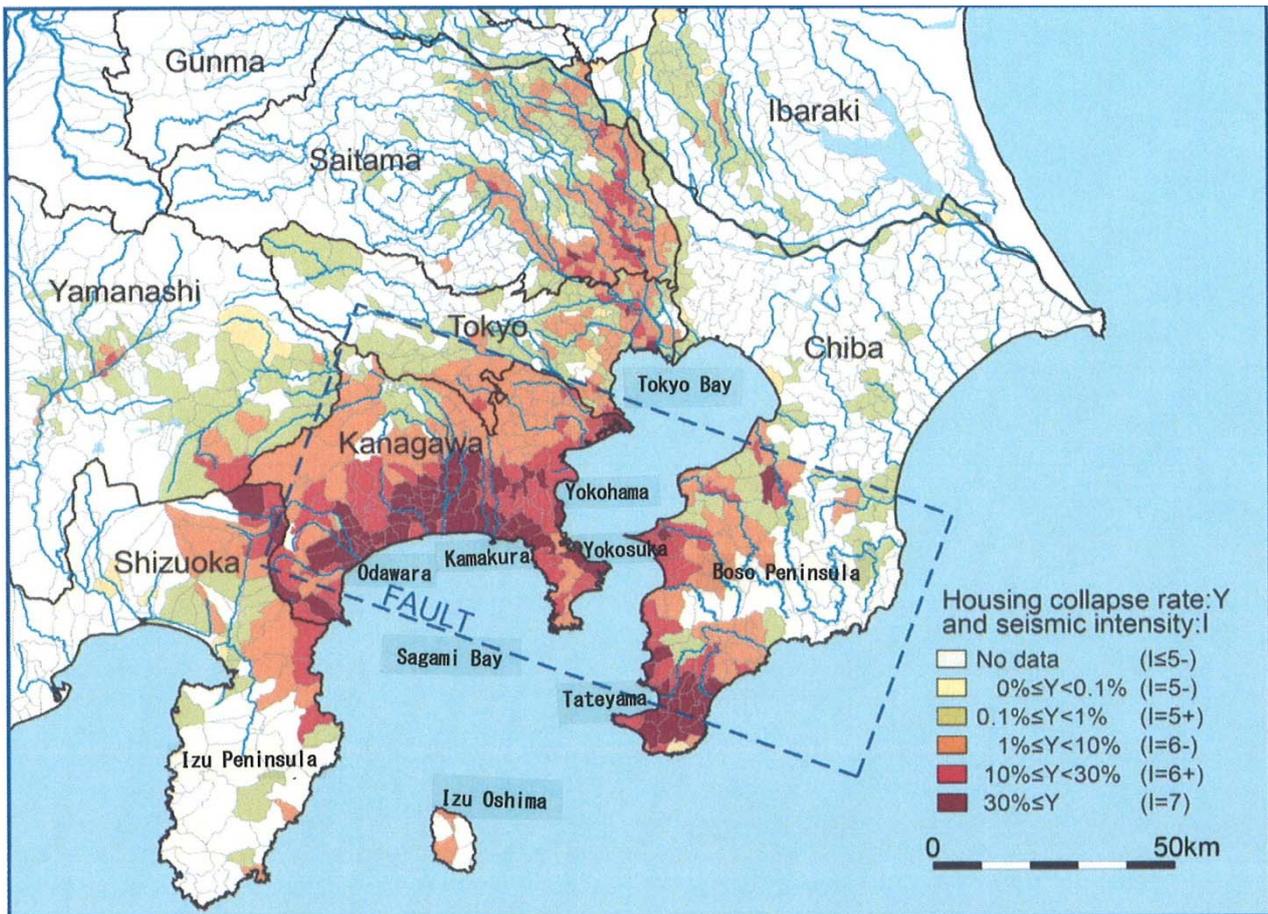
Figure 1 is a distribution diagram of the total housing destruction ratio (the number of totally destroyed houses/the total number of houses) of the Great Kanto Earthquake damage by a district unit. Since the total housing destruction ratio is closely related to the seismic intensity scale of Japan Meteorology Agency (JMA), this diagram may be read as a seismic intensity distribution diagram of the Kanto Earthquake. The fault plane location of the epicenter zone of the Kanto Earthquake is shown in this figure.

The area immediately above the fault plane of the epicenter zone, shown with a broken line, records over 1% in total destruction ratio in almost the entire area. This suggests that strong motions, which, at a minimum jolted at 6 or greater on the JMA scale, occurred in those areas. In particular, a total destruction ratio of over 30% was observed in the Sagami Plain and the Ashigara Plain in Kanagawa Prefecture as well as the Tateyama Plain at the front end of the Boso Peninsula. These plains were hit by strong motions measuring 7 in seismic intensity.

**Fig. 1** Distributions of the total housing destruction ratio and seismic intensity of the Kanto Earthquake (Moroi and Takemura, 2002, and Moroi, 2008)

areas away from the fault plane. A seismic intensity of 6 plus or 7 was recorded sporadically from the eastern part of Saitama Prefecture to the waterfront of Tokyo Bay, with a total destruction ratio of over 10%.

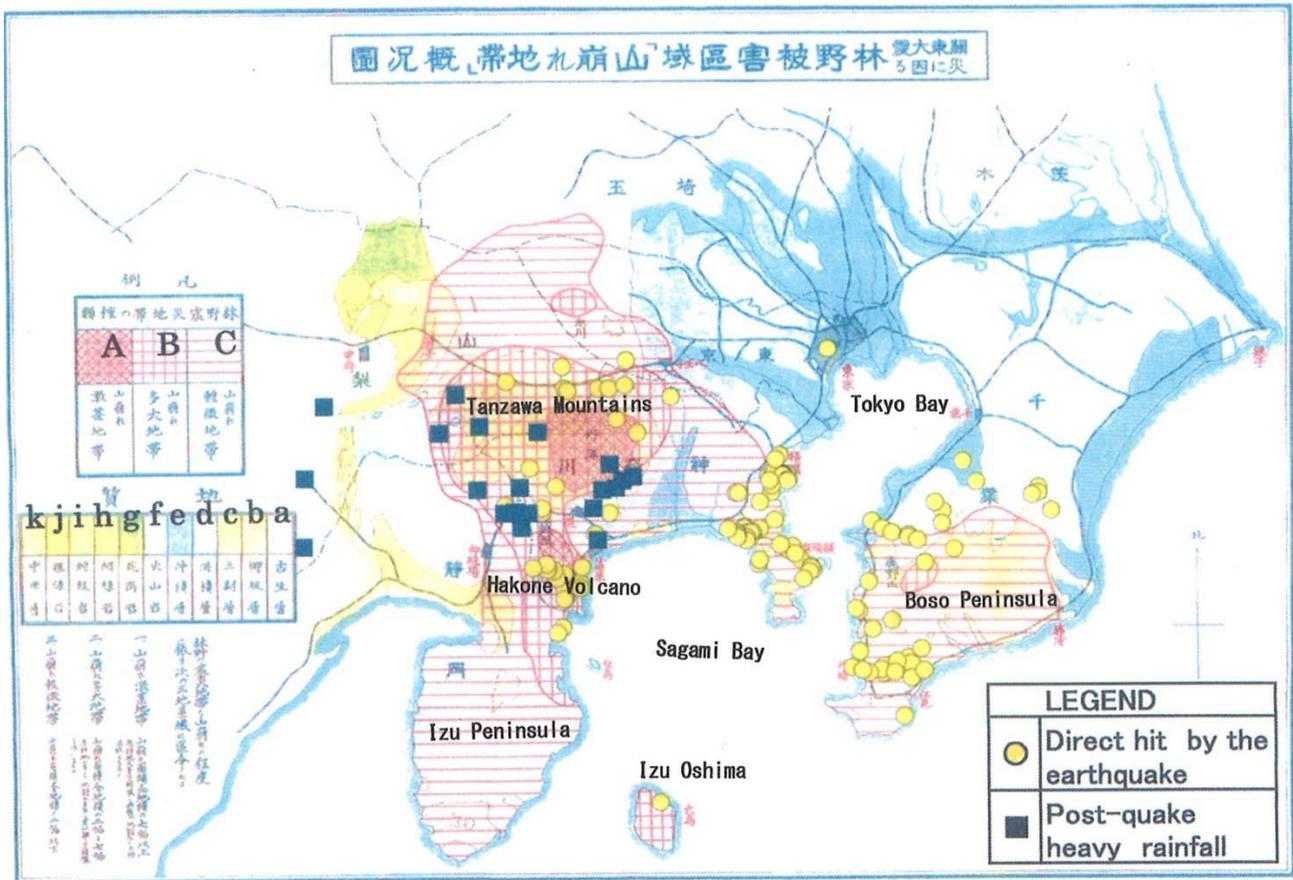
Figure 2 is a schematic diagram of the landslide zones in the wooded areas damaged by the Kanto Earthquake and it was attached to the back of the Taisho Earthquake Report (Social Bureau of the Home Ministry, 1926).

The background of the diagram is a geologic map of the Kanto Region.

The landslide zone in the damaged wooded area is divided into three types.

- A: devastating landslide zone
- B: frequent landslide zone
- C: minor landslide zone

This figure additionally indicates 167 locations of sediment disasters caused by the Kanto Earthquake, including 66 in the eastern part and 35 in the eastern part of Kanagawa Prefecture, 7 in the eastern part of Shizuoka Prefecture, 12 in Yamanashi Prefecture, 5 in Tokyo Metropolis, and 42 in the southern part of Chiba Prefecture. The schematic landslide diagram is in good agreement with the distribution of sediment-related disasters.

Fig. 2 Schematic diagram of the landslide zones in the wooded areas damaged by the Kanto Earthquake (Modified from Social Bureau of the Home Ministry, 1926) and the landslide disaster locations by the same earthquake (Inoue, 2013a, b).

The eastern part of the Tanzawa Mountains in the western area of Kanagawa Prefecture falls under A: devastating landslide zone, while the area around the Tanzawa Mountains and the Hakone volcanic area fall under B: frequent landslide zone. Sediment-related disasters was frequently caused by the direct impact of the Earthquake and the heavy rainfall two weeks thereafter.

As shown in Figure 2, many sediment disasters occurred in Yamanashi Prefecture, the eastern part of Shizuoka Prefecture, Tokyo Metropolis (including Izu Oshima Island), and the southern part of Chiba Prefecture.

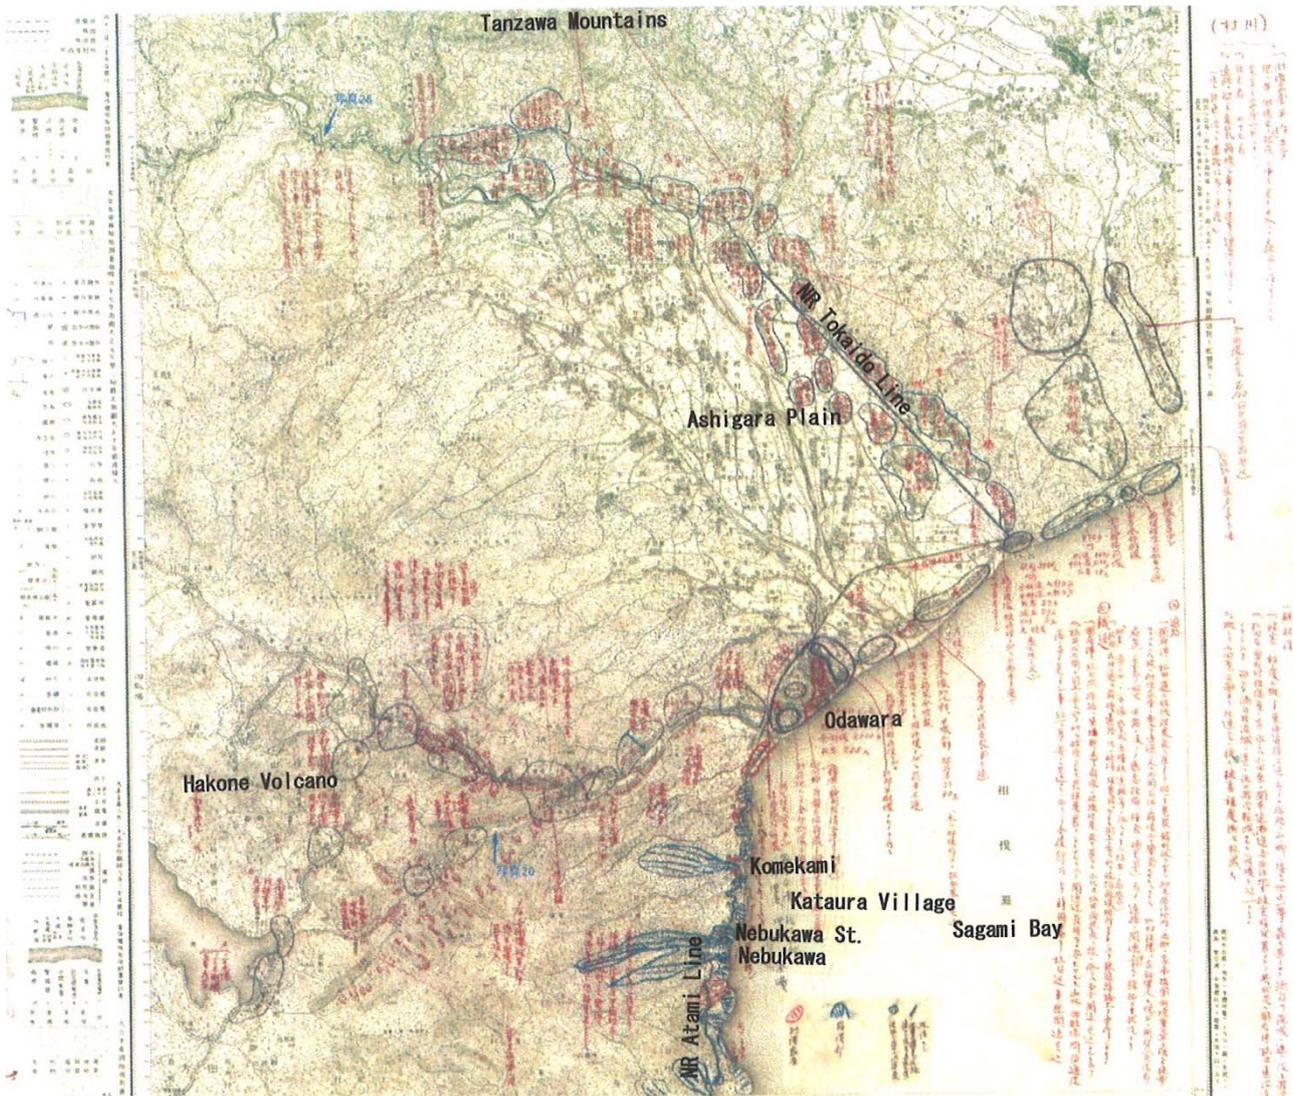
lished in those days (made up of 63 topographic maps). Figure 3 is an original emergency survey map of the damaged area in the southern part of Odawara City based on a 1:50,000 scale map "Odawara" corrected in 1916. The status of sediment-related disasters and the conditions of earthquake damage are written on the map in detail.

Fig. 3 Earthquake damage emergency survey map (1:50,000) of Odawara (Society of Historical Earthquake Studies, 2008)

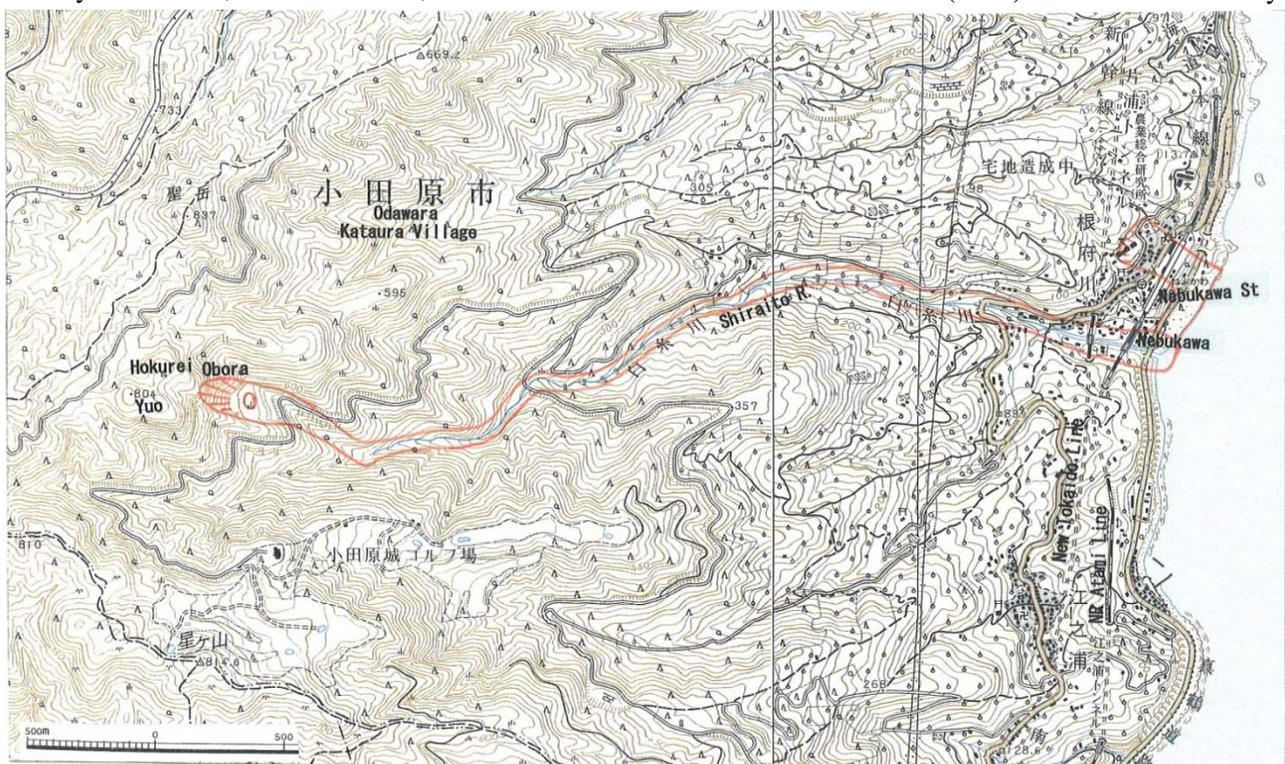
the Great Kanto Earthquake. Figure 4 is a distribution map of the debris flow in the Shiraito River and the landslide that hits Nebukawa Station. Accurate information on the debris flow and the landslide was obtained from survey maps prepared in 1975 by Kazumasa Uchida. He was 10 years old at the time of the earthquake, and later became a mandarin orange farmer who served as a village assemblyman, made efforts to pass his records of the Great Kanto Earthquake down to other generations. He wrote his personal notes 60 year after and his son, Akimitsu Uchida published in 2000.

Fig.4 Distribution of the debris flow in the Shiraito River and the landslide at Nebukawa Station

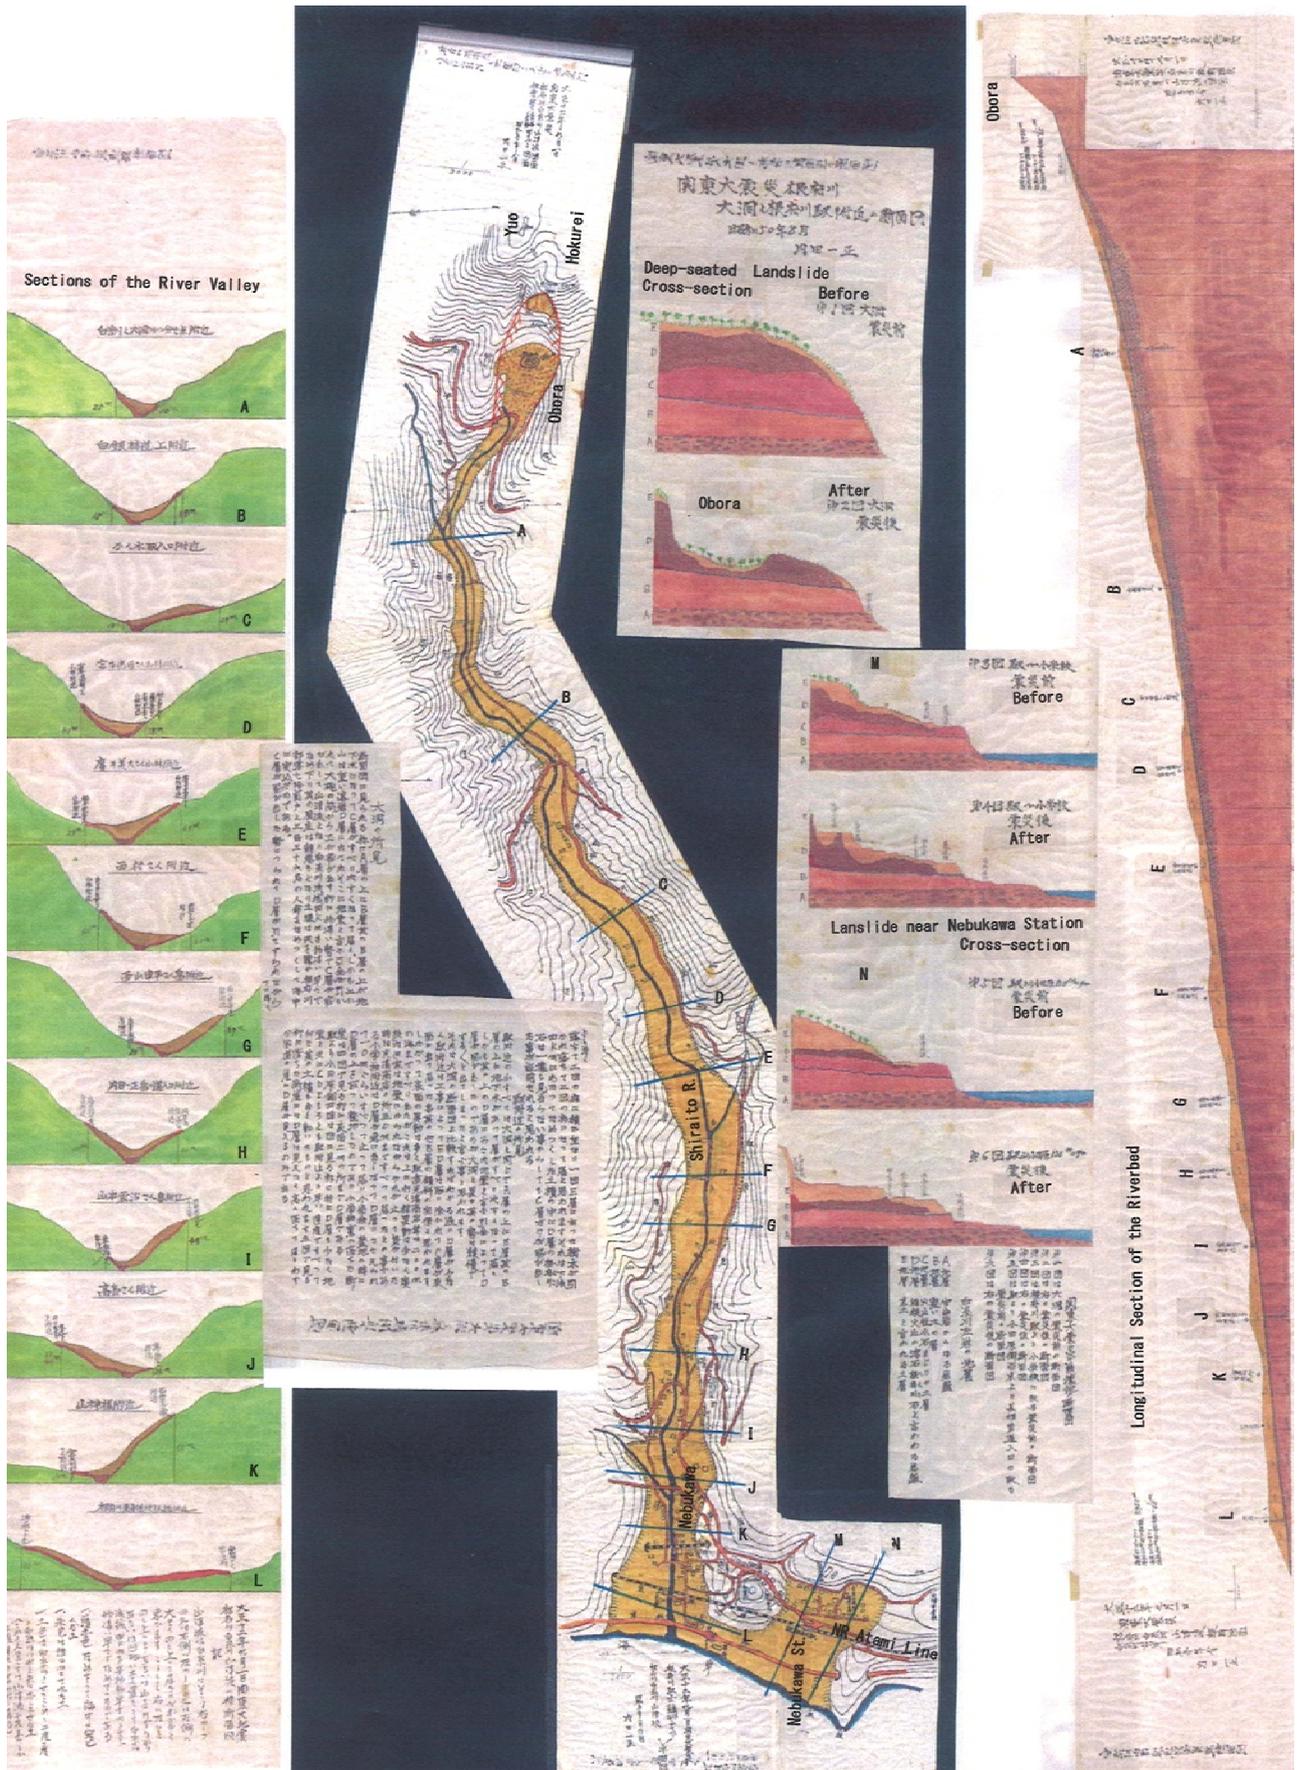
Figure 5 shows the status of sediment-related disasters compiled by Uchida in 1975, and clearly shows the status of debris flow. The center figure shows the plain of the downstream movement of the debris flow, the right figure shows the longitudinal sections of the riverbed and the left figures shows the sections of the river valley of the Shiraito River. Kobayashi(1979) and Kamai(1990, 1991) conducted detailed topographic and geological surveys in this area, with Kazumasa Uchida as a guide.

**Fig.5** Sediment related-disaster in the Shiraito River basin (Nebukawa hamlet and Nebukawa Station)  
 (Uchida 1975, source : Kanagawa Prefectural Archives)

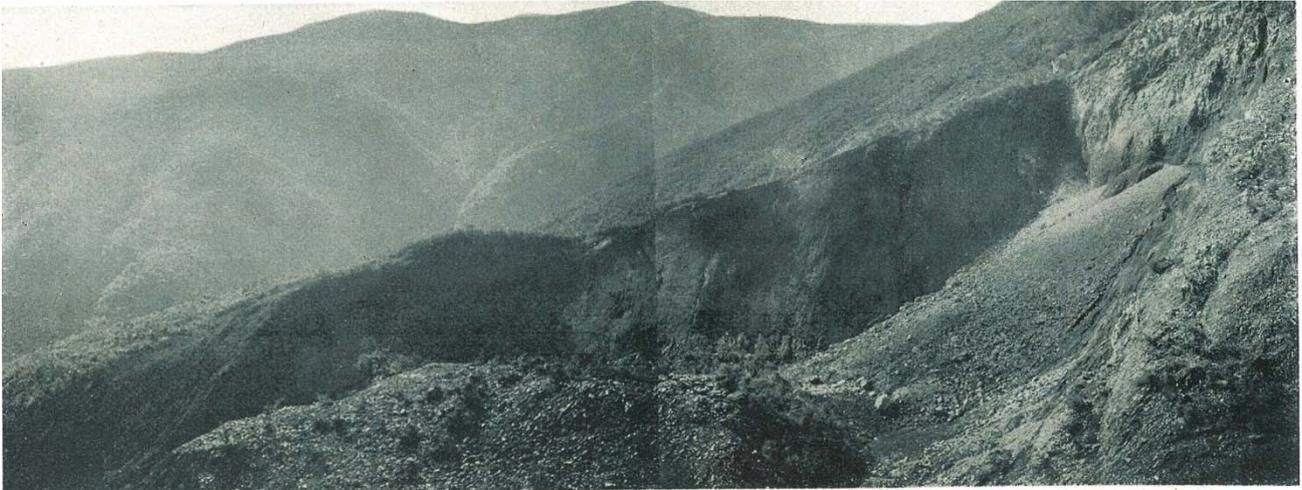
**Photo 1** Topography of the Obora failure site and flow mound at the lower part of the failure site (Restoration Bureau, 1927)

Photo 1 is a picture taken by an employee of the Restoration Bureau who climbed up the headwaters of the Shiraito River, to a point near Obora as part of the survey to develop restoration measures for the Atami Line of the National Railways (since there was an ongoing plan to complete the constructing the Tanna Tunnel and open the Tokaido Main Line). It shows a flow mound (small hill) formed at the lower part of the slope as a sign of the large-scale, deep-seated landslide.

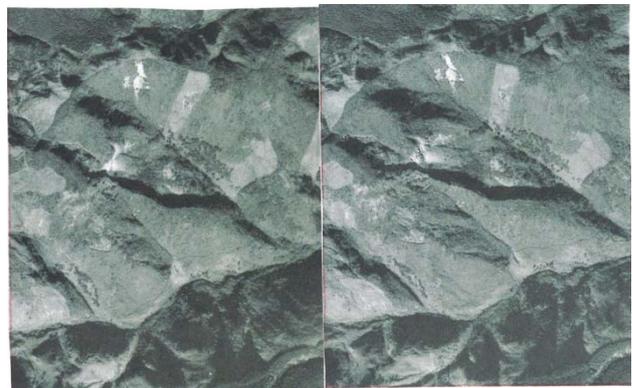
Photo 2 is a three-dimensional aerial photo of the area near Obora, upstream of the Shiraito River, and it was taken in 1962.

The Shiraito River is a steep river flowing eastward from the somma of the Hakone volcano. From an old topographic map, it is estimated that 1,080,000 m<sup>3</sup> of debris collapsed in the deep-seated landslide at Obora. Of this volume, an estimated 260,000 m<sup>3</sup> remained at hummocky hills (small hills) immediately below the collapsed site. The remaining 820,000 m<sup>3</sup> ran down the Shiraito River as debris flow over a channel length of 3,500 m and with an elevation difference of 500 m. Since the debris flow hit the Nebukawa hamlet in five minutes, the flow is estimated to have moved at a velocity of about 12 m/s (42 km/hr.).

According to a geological exploration, we found that two lava domes, called Hokurei (North Peak) and Yuo (South Peak), as well as a number of linear depressions existed near Obora. The deep-seated landslide of Obora is characterized by lava with conspicuously developed tabular joints (Nebukawa Lava and O<sub>18</sub> lava as defined by Kuno, 1938), and the flow mound (small hill) at the foot of the slope contains a large amount of tabular lava pieces.

**Photo 2** Three-dimensional aerial photos of Obora, upstream of the Shiraito River (taken in 1962, CKT-62-3X, C6-10, 11)

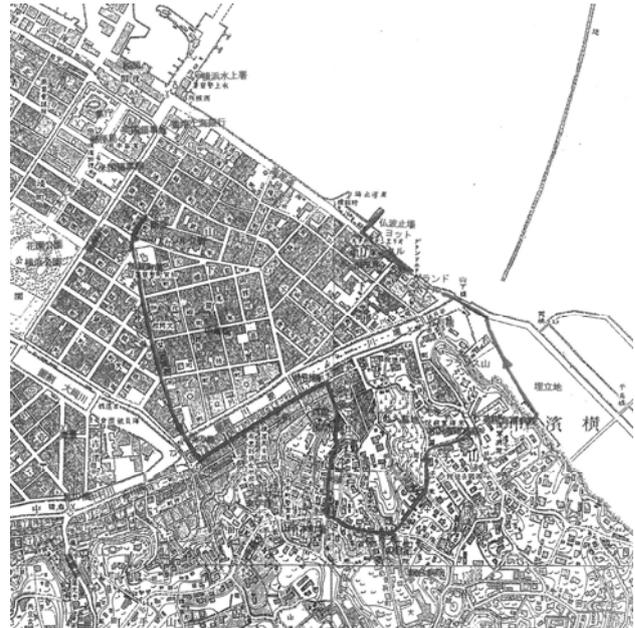
I walked along his escape route for the purpose of the survey based on Figure 6 (survey map in 1922), Figure 7 (survey map in 2005) and Table 2 (View Point). The view-points related to the sediment-related disasters were given in the following. The office of Dodwell & Co. Ltd. was located in Kannai (Point 0, 72-banchi, Yamashita-cho).

**Fig. 6** Escape route taken by O. M. Poole  
1:10,000 scale topographic map of the southern part of Yokohama neighborhood (survey map in 1922)

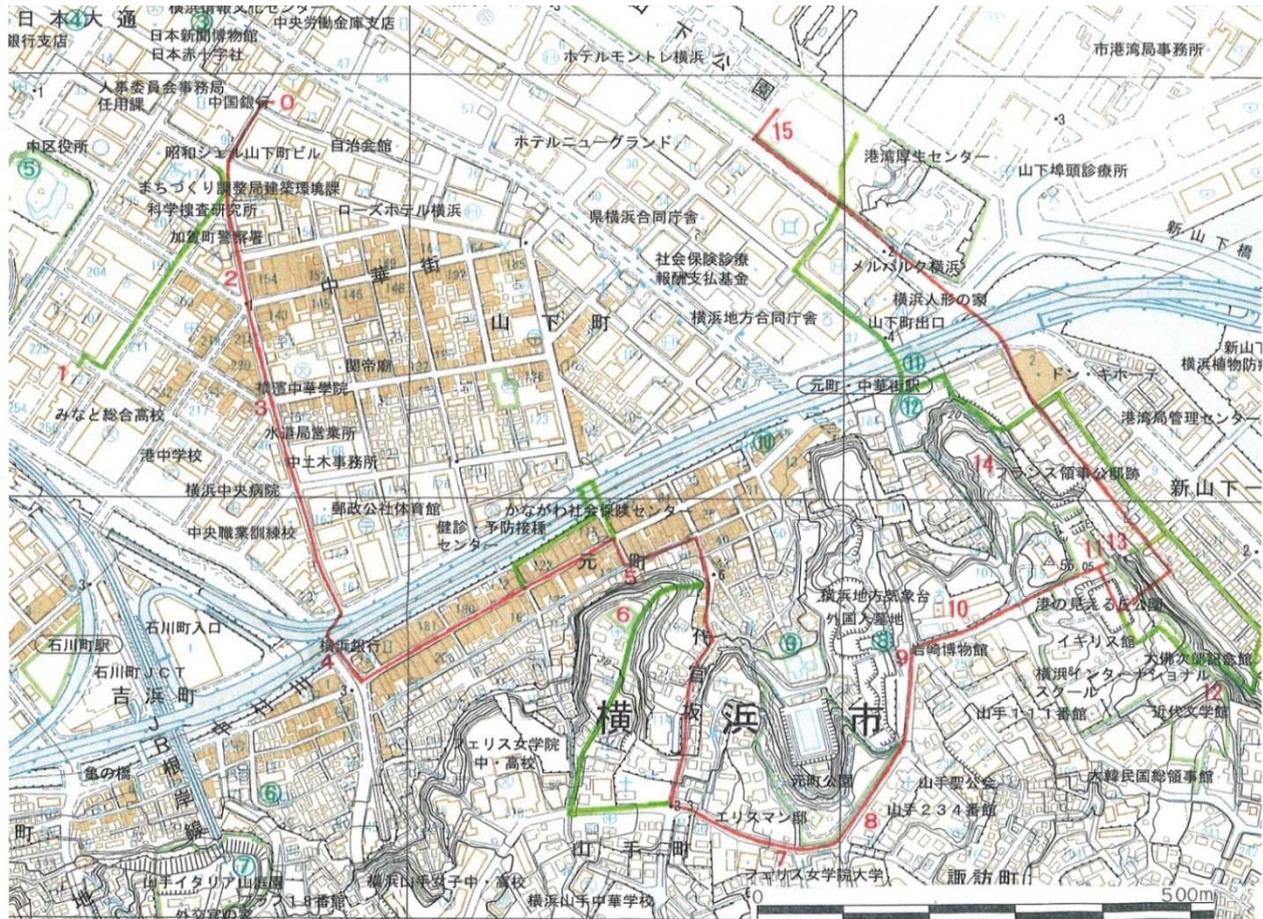
Fig. 7 O. M. Poole's escape route (red line) and the route taken by the field tour (green line)  
The background is the 1:10,000 scale map of Kannai (edited in 2005).
