APPLICATIONS BY NARA PREFECTURE FOR UTILIZING LESSONS LEARNED FROM THE GREAT FLOODS ON KII PENINSULA

¹ Deep-Seated Landslide Control Office, Infrastructure Management Department, Nara Prefecture
(30 Noboriojicho, Nara-shi, Nara 6308501, Japan)

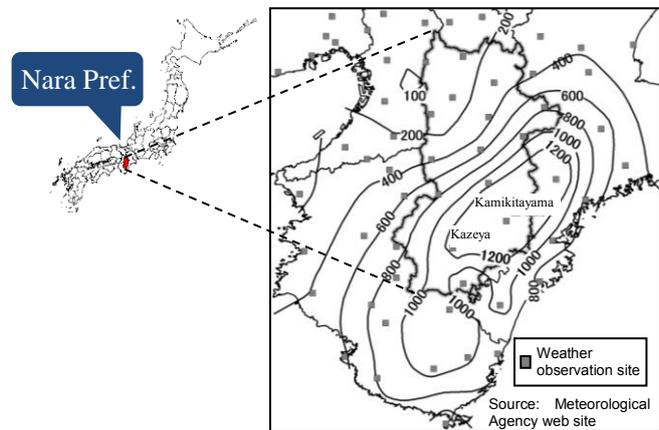
Fig. 1 Total rainfall contour map
(From 18:00, 8/30 to 24:00, 9/4 in 2011)

The total rainfall from August 30 exceeded 1,000 mm in a wide range of the area mainly on Kii Peninsula, and it had reached 1,808.5 mm in Kamikitayama of Kamikitayama Village in Nara Prefecture where the total precipitation marked 60 % of the annual average rainfall (Fig. 1). A maximum of 72 hours of rainfall in Kamikitayama of Kamikitayama Village in Nara Prefecture had reached 1,652.5 mm, which greatly exceeded the observation record in Japan of 1,322 mm (Mikado, Misato-cho, Miyazaki Prefecture) since 1976 (Fig. 1 and Fig. 2).

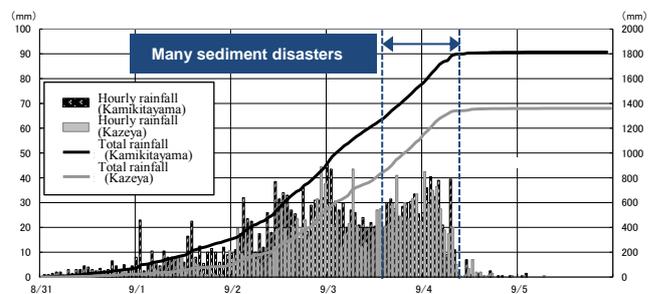
Fig. 2 Time series variation of rainfall at Kamikitayama, Kamikitayama Village and Kazeya, Totsukawa Village in Yoshino Dist.

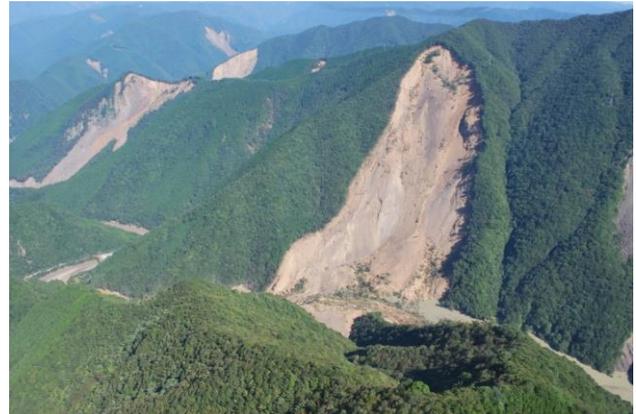
Fig. 4 Deep-seated landslide in Akadani (Gojo City)

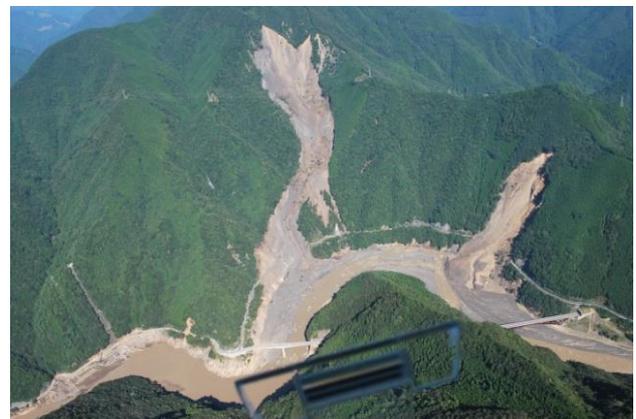
Fig. 5 Deep-seated landslide in Nigori-tani and Okuzure (Totsukawa Village)

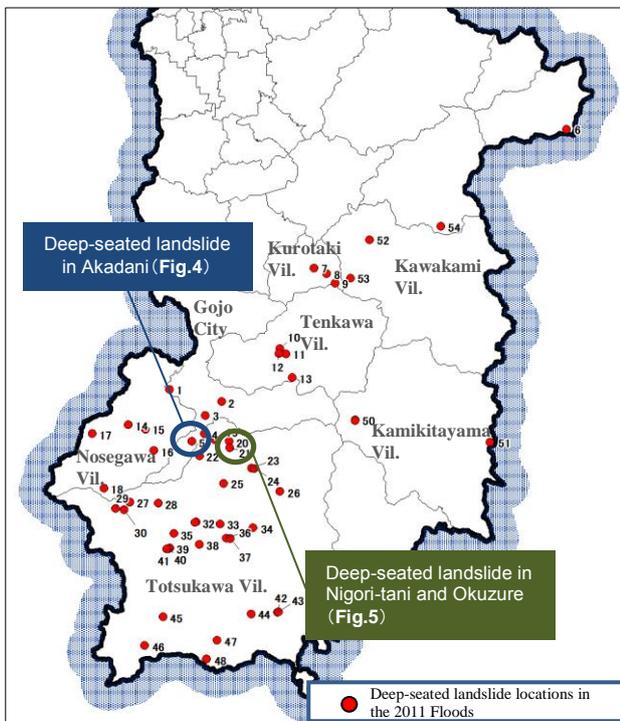
Fig. 3 Deep-seated landslide locations in the 2011 Floods

“Deep-seated landslide” in which the breaking up of bedrock on the sides of the mountains was seen in 54 locations in the 2011 Floods (Fig. 3).

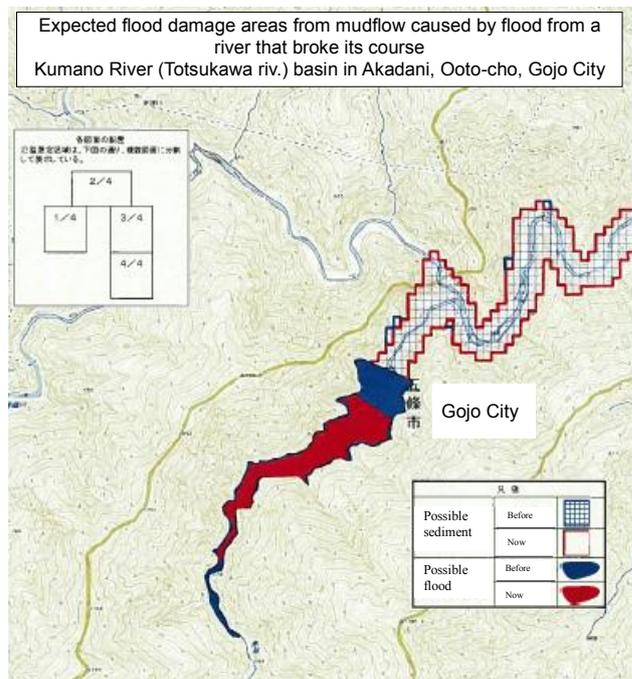
Fig. 6 Expected flood damage areas from a river that broke its course (Source: Ministry of Land, Infrastructure and Transport)

A long period of warnings and evacuation became necessary because there was a possibility that significant damage would occur in the neighborhood, etc. located downstream, if the river course was broken. In the large-scale river course blockage areas that occurred in the 2011 Floods, “warning zones” were announced as expected flood damage areas if the rivers were to break their courses, so that the residents of such specified zones were forced into long-term evacuation (Fig. 6).

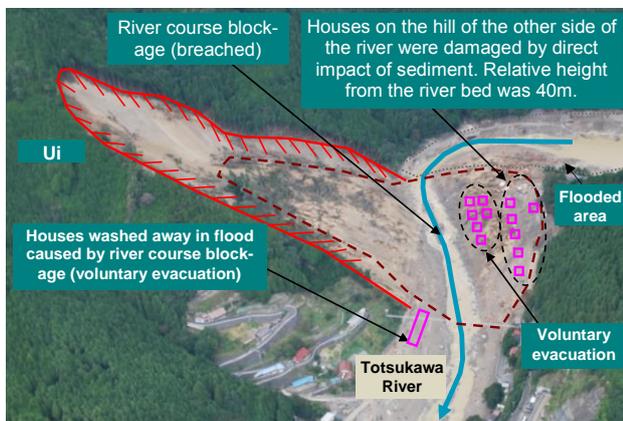
Fig. 7 Ui where the neighborhood on the other side of the river was damaged

Many residents escaped disaster events through voluntary evacuation, before warnings were issued. Some, however, were killed or injured while at the evacuation centers (Fig.8 Nagatono), or upon leaving the evacuation centers to go home when the rain ceased (Fig.7 Ui).

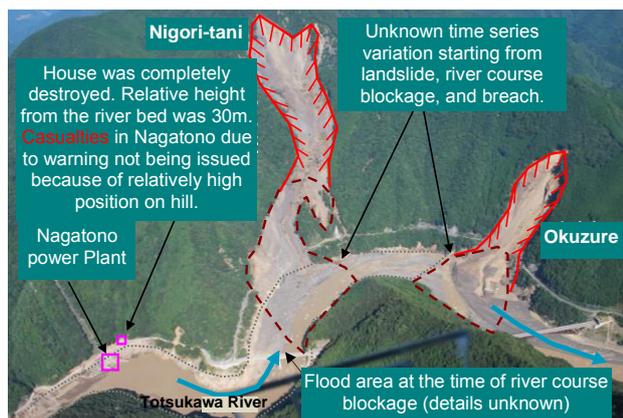
Fig. 8 Nagatono after damage from the overland flow

In addition, in Nagatono of Totsukawa Village, it became evident that the residents there were isolated due to the road cut-off caused by a small-scale landslide disaster, so that they were not able to evacuate when the Sediment-Related Disaster Warning was announced around 10 a.m. After 21 hours in isolation, electricity, telephone, etc., were also cut off,

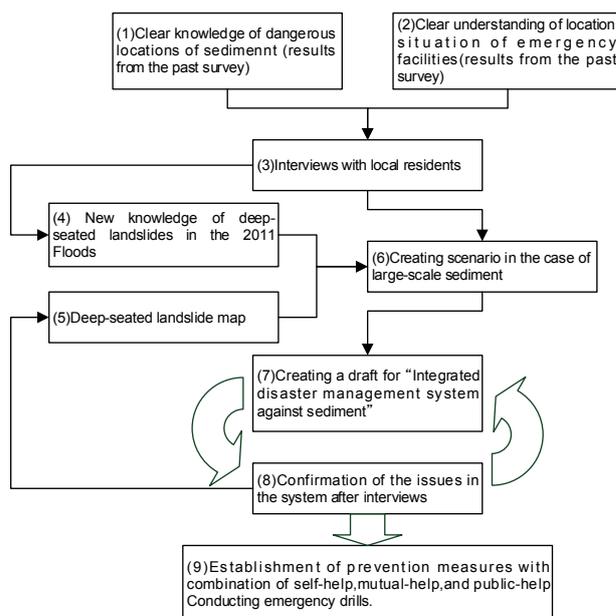
Fig. 9 Integrated approach to establishing a disaster management system

Nara Prefecture considers it important use the lessons learned from the 2011 Floods, and also, to reflect regional characteristics and local opinions in the process of establishing a feasible system of community disaster management. Thus, several study sites have been selected, and collaboration with local municipalities and community disaster prevention organizations are now underway (Fig.9).

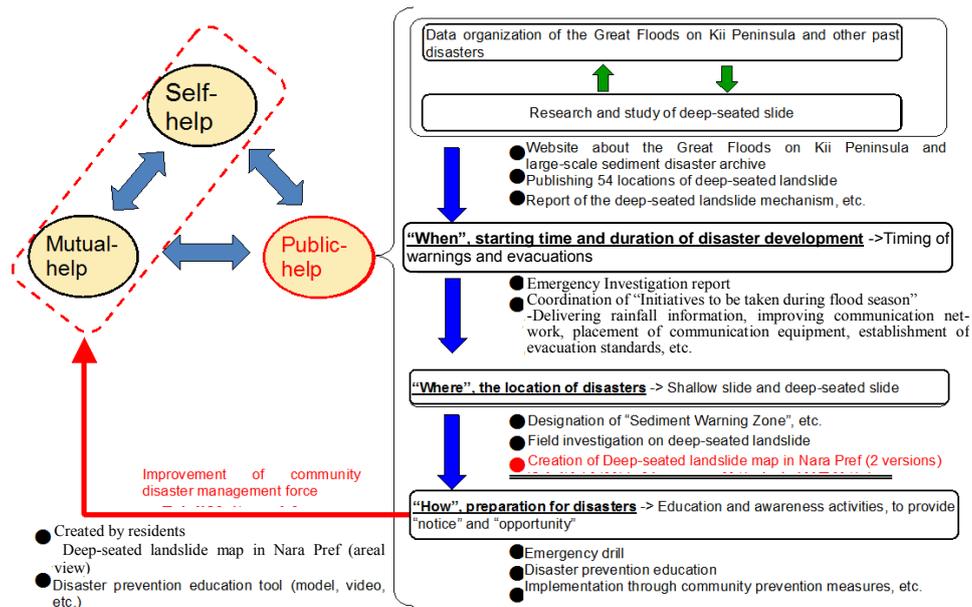
Fig. 12 Integrated disaster management system diagram

Establishment of an integrated disaster management system should focus on “When”, “Where” and “How” to improve the community disaster prevention force (Fig. 12).

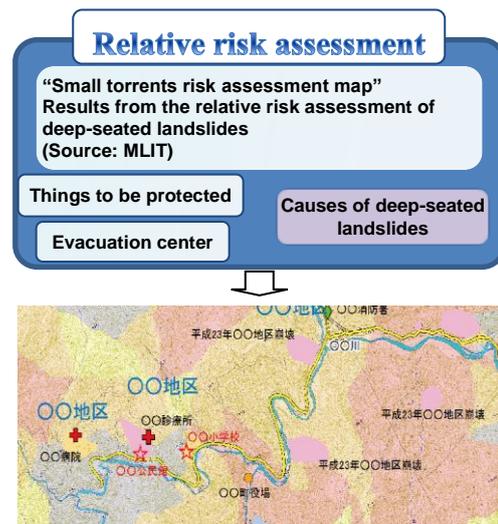
Fig. 13 Deep-seated landslides map in Nara Prefecture (city view)

A “Deep-seated landslide map in Nara Prefecture (city view)” will be created for the purpose of relative risk assessment in a wide area, which is in accordance with “Draw-off manual of mountain streams likely to cause deep-seated landslides (draft), No. 4115 by Public Works Research Institute”, with additional information from the results of deep-seated landslides that have occurred in the 2011 Floods, for the southern prefecture (Fig. 13).

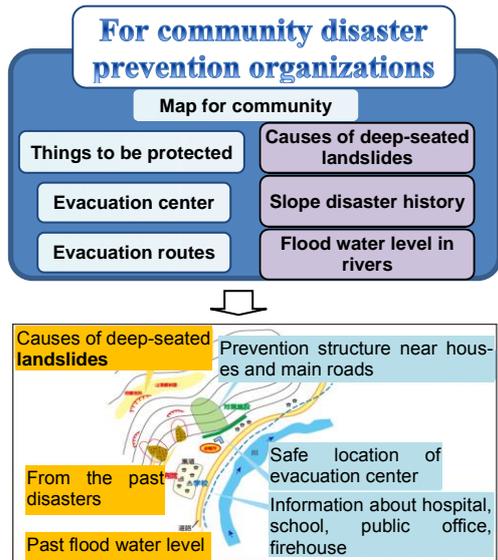
Fig. 14 Deep-seated landslides map in Nara Prefecture (areal view)

A “Deep-seated landslide map in Nara Prefecture (areal view)” will be created for use in disaster prevention on the local level, providing information about compound sediment disasters including shallow slides as well as deep-seated landslides (Fig. 14).
