# UNRAVELING THE MECHANISM OF MULTIPLE DEEP-SEATED LANDSLIDES FROM THE 2011 GREAT FLOODS IN KII PENINSULA

**Key words:** deep-seated landslide, landslide, mechanism, archive, Kii Peninsula, Typhoon Talas

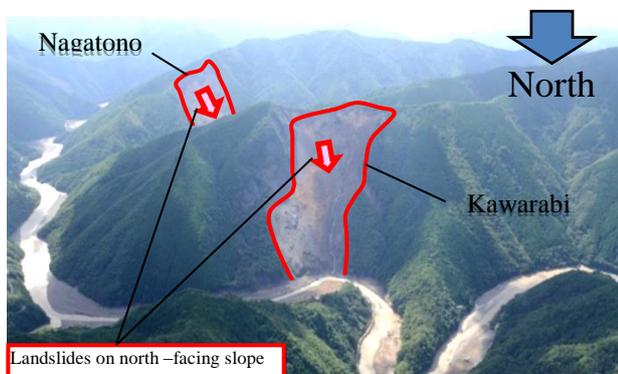
Fig. 5.4 Aerial photograph of the slopes where deep-seated landslides site in Kawarabi and Nagatono

The aspects of the slopes where deep-seated landslides occurred were confirmed in the aerial photographs and the topographic maps in which many of them occurred on the slopes exposed to the north.

In Nara Prefecture, 35 among 54 deep-seated landslides occurred on the north facing slopes (Fig. 5.4).
