# History of Debris Production and River-beds Rising in Kyoto District - A historical interaction between environmental changes and society-

Toshitaka KAMAI<sup>1,\*</sup> and Ryo NAKATSUKA<sup>2</sup>

<sup>1</sup>Disaster Prevention Research Institute, Kyoto University (Gokasyo, Uji, Kyoto 6110011, Japan)

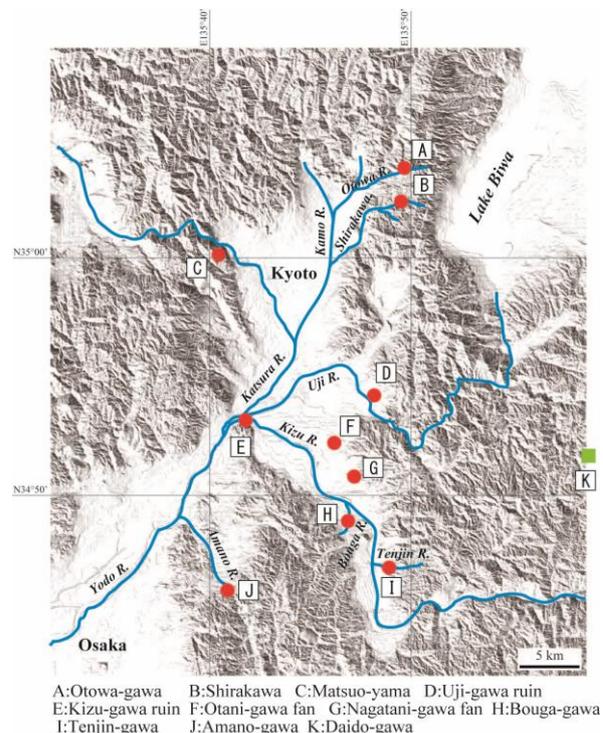
**Fig.1** Distribution of sampling sites for dating around Kyoto basin

Fig.1 shows distribution of sampling localities of landslide deposits, fan, and river sediments for dating around Kyoto basin. Dating samples of slope deposits were collected from sites A, B, and C in Fig. 1 in mountain regions. Historical river flood deposits found in archaeological sites were collected

from sites D and E, and fan deposits were found in archaeological site of localities F and G in Fig.1. Samples collected from sites H, I, and J are sediments of raised-bed rivers, that are historical Tenjo-gawa in southern Kyoto district.

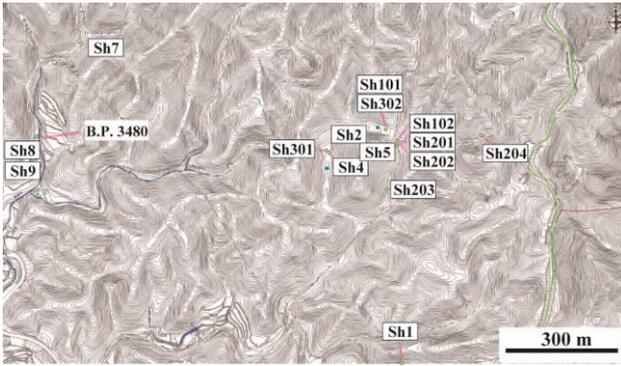
**Fig.2** Detailed distribution map of sampling localities for dating around Site B in the upper river basin of the Shira-kawa

**Fig.2** shows distribution of sampling localities around Site B in **Fig.1**.

In the upper river basin of the Shira-kawa, humid black soil layers were buried by landslide deposits in several horizons (ages). Valleys with flat valley floor that were filled by the repeated landslides are shown in **Fig.2**, i.e. the valley from Sh2 to Sh203. In this valley, the buried soil layer about 20 cm in thickness covers directory weathered granite (saprolite) as shown in **Fig. 4**. This buried black soil layer is confirmed as lowest horizon in this area, and dated from cal. AD 753±22 (774-891) at base (Sh202 in **Fig. 2**) to cal. AD 956±23 (990-1150) at top of the soil (Sh201 in **Fig. 2**).

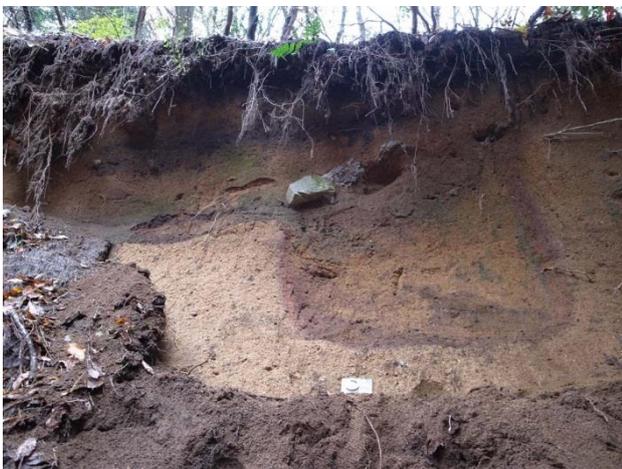
**Fig.3** Cross section of artificial pit that is filled by burned soil and charcoal aggregation (Sh2 and Sh4 in **Fig.2**)

An archaeological site was discovered in the upper river basin of the Shira-kawa (Sh2 and 4 in **Fig.2**). As shown in **Fig.3**, we perceived a square shaped pit,

in depth and width about 1.2 m. The inside of the pit was filled by burned soil with abundant charcoals. The results of dating on this burned soil and charcoals, cal. AD 677-782 and cal. AD 762-873, indicate that the developments in this region started 7<sup>th</sup> to 9<sup>th</sup> century. In ancient ages, logging forest was difficult by common people because of religious taboo. Development of mountain area was progressed by large temple and shrine. The age of the burned soil in this archaeological site indicate just before age that is Enryakuji temple, the largest temple in Kyoto, was founded in 8<sup>th</sup> to 9<sup>th</sup> century.

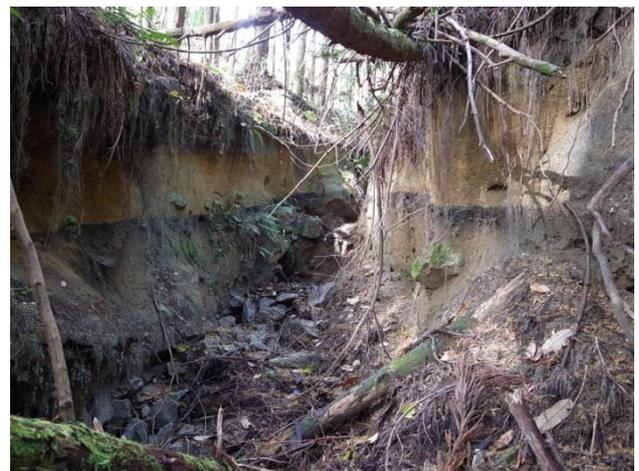
**Fig.4** Outcrop in a valley by gully erosion (Sh5 in **Fig.2**). The black soil layer at the middle part is covered by landslide deposits

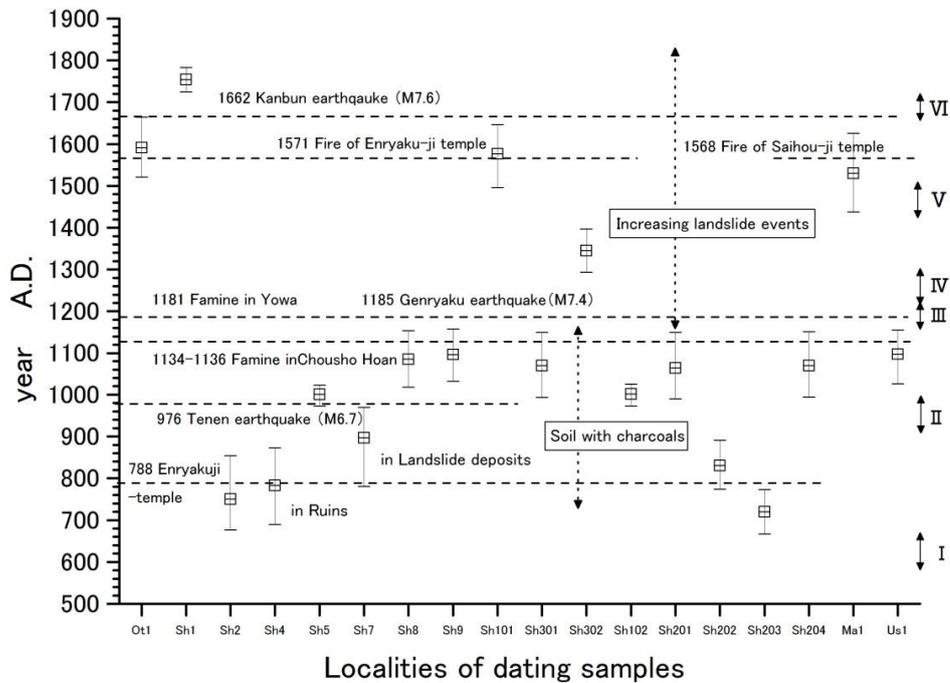
**Fig.5** Corpus of dating results of landslide deposits, valley filling deposits, and buried soils in mountain region around Kyoto basin (A, B, and C in **Fig.1**). Ot1 sample was collected in A, Ma1 in B. Others were collected in B as shown in **Fig. 2**. The ages of buried soils directly covered by landslide deposits (e.g. Sh8) will indicate the ages of just before landslide events. The ages of soils covering landslide deposits, and valley filling deposits (e.g. Sh1) will indicate the ages after the events. Based on these considerations, “I-VI” indicates landslide events detected by results of dating of these sediments.

Corpus of dating results is shown in **Fig.5** and **Table 1**. **Fig.6** show road cutting slope that is Sh8 and Sh9 in **Fig.2**. Here, landslide mass slid down from the steep slope of left hand side, and covered on the humid soil layer at the top of weathered granite. Based on the results of dating on the buried top soil, this landslide event occurred just after cal. AD 1020±23 (1032-1158). As shown in **Fig. 5**, landslide events that would occur in 12<sup>th</sup> century were widely discovered in the upper river basin of the Shira-kawa (i.e. Sh204).

In the eastern mountain of Kyoto, the Higashi-yama district, the Genryaku earthquake (M7.4) in 1185 should be a noteworthy event as its serious damages between Kyoto basin and Lake Biwa district. This earthquake is a well-known as a practical and vivid description of the disaster by Kamo-no-choumei in his great essay “An Account of My Hut”. After the 1185 earthquake, frequency of landslide was increased as shown in **Fig. 5**.

As shown in **Fig. 5**, four landslide events were found from the 1185 event to the end of 17<sup>th</sup> century, while only two landslides events were detected before 12<sup>th</sup> century during 600 years from 7<sup>th</sup> century. Although the series of developments from 7<sup>th</sup> century destroyed forest cover in mountainous slopes around Kyoto basin, the serious damages in mountainous slopes by the 1185 earthquake was an accelerating trigger of deforestation and landslides in this region.

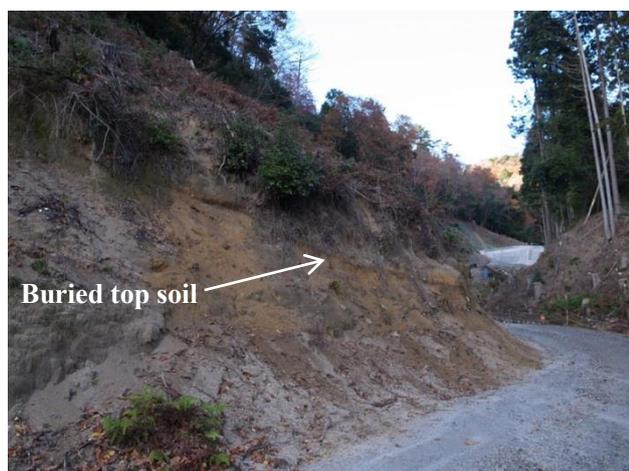
**Fig.6** Outcrop of landslide deposits (Sh8 and Sh9 in **Fig.2**).

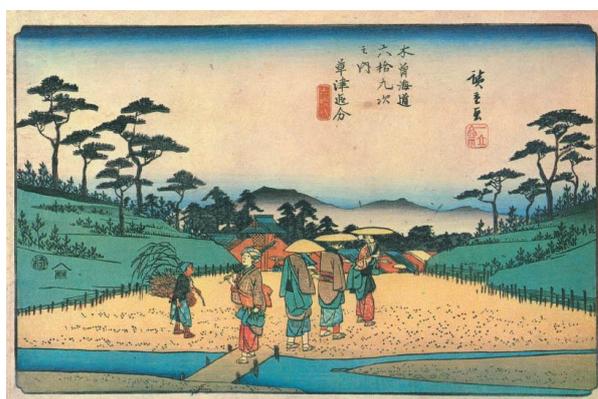
**Fig.7** “Ukiyoe” of rivers of higher river bed in early 19<sup>th</sup> century. (by Hiroshige Andou)

**Fig.7** is a famous historical painting, the ukiyoe, in Edo era (19<sup>th</sup> century). The travelers could go across the Kusatsu River by walking because that the river has very little water flow. The roof of houses was painted behind travelers at almost same level. It means the ground level of village was so lower than the level of the river bed. These rivers of higher river bed (floor) than the ground level of surroundings are called “Tenjo-gawa”. It means “the river on the roof” in Japanese.

**Fig.8** shows the tunnel of modern age passing just below the river in **Fig.7**. The river runs from right hand side to left above the level of road. Like this scenery between river and villages, the Tenjo-gawa, are common in western part of Japan because that the Tenjo-gawa was formed artificially during historical urban developments. The western part of

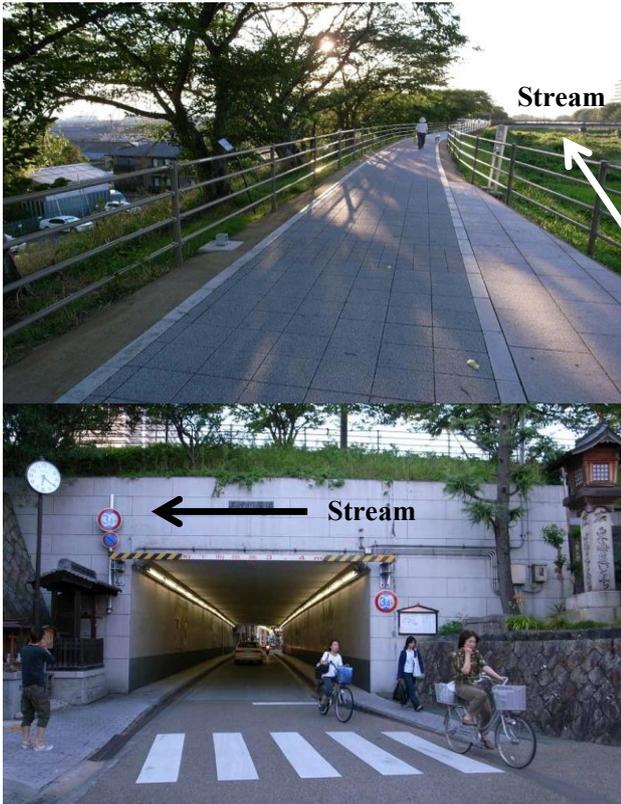
**Fig.8** Present Kusatsu River and tunnel under the river of Fig.7

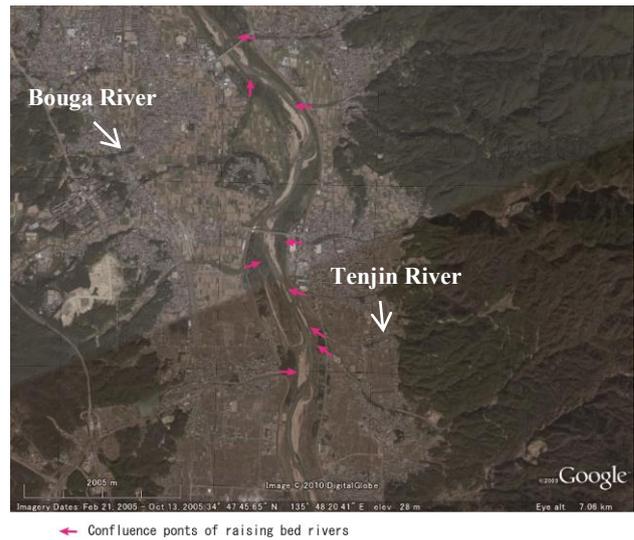
**Fig.9** The Kizu River and its tributaries. Red arrows are confluence points of the Tenjo-gawa to the main stream

As shown in Fig. 9, the Kizu River and its tributaries forms typical raised bed river system in the Minami-Yamashiro district. Landslides in mountainous slope surrounding the basin supplied huge amount of sediments to the river system. As a result of rapid rising river bed including mainstream (the Kizu River), catastrophic floods were recorded in 1590, 1712, and 1802 in this district. In 17<sup>th</sup> century, the government repeatedly declared to prohibit soil loss from mountains and promoted afforestation programs in the whole upper river

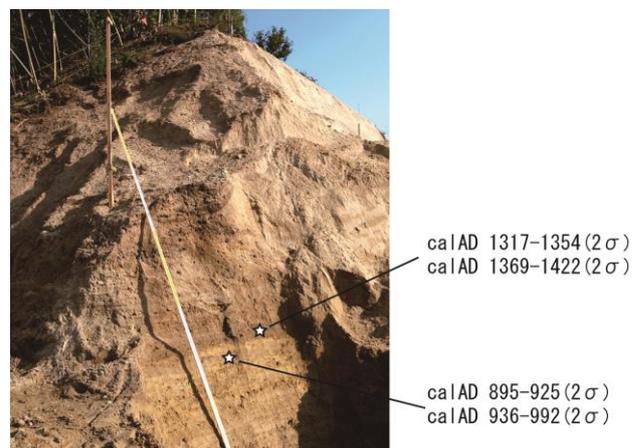
**Fig.10** Excavated cross section of Bouga River. The Tenjo-gawa sediments (light colored) accumulated on alluvial floods deposits (yellowish colored).

It was well known that the rising rate of river bed increased in 17<sup>th</sup> century [Chiba, 1973], however, the ages of the base of the Tenjo-gawa, in other word, when river bed start to rise was not clear. Fig.10 shows that alluvial flood deposits of 10<sup>th</sup> century are overlaid by the Tenjo-gawa sediments of the Bouga River of 14<sup>th</sup> century (Site H in Fig.1).

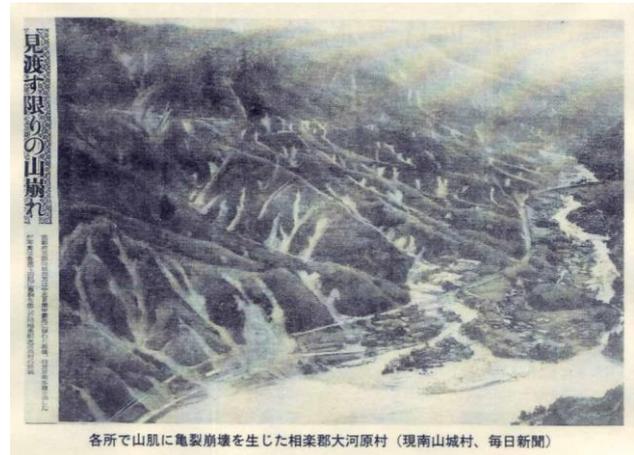
**Fig.11** Photograph of newspaper reported about the 1953 disaster

Deforestation in mountainous slope during WW2 to take woods for fuel was one of major causes of serious flood disaster in 1953. As shown in **Fig.11**, shallow landslides on bare slopes were induced by heavy rainfall. It was considered to be similar scenery in the medieval ages in this district.

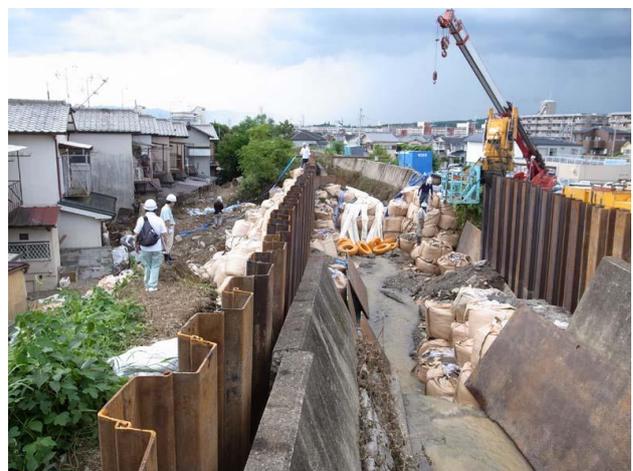
**Fig.12** Flood of Midajiro river in 2012

Especially, washout of the Midajiro river caused severe floods in recent rapid urbanized residential region in Uji, Kyoto (**Fig.12**). The Midajiro river is a typical Tenjo-gawa with raised river bed higher than few meters from the residential level of grounds. This river has flooded in 1967, and made serious damages to farmland of 7 ha. However, this district was urbanized during 1970's after this flood, and residents were not informed about the flood event of the river. We can recognise the typical relationship between the high risk river and new coming residents around the river here. Thus, Tenjo-gawa has been a high risk river form still in their modern times.
